Simplified report of safety investigation

**COLLISION BETWEEN *SALVATORE CAFIERO*
AND *NAUSICAA* ON 22 APRIL 2012
IN THE WESTERN APPROACHES TO THE ENGLISH CHANNEL**

Bureau d'enquêtes sur les événements de mer

Report published on : July 2013

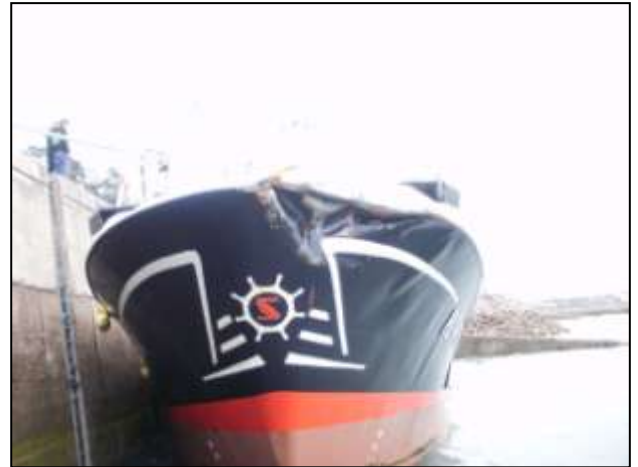
Distortions can be observed on and under the deck at the bow, which do not impair the buoyancy of *NAUSICAA*.

NAUSICAA damage repairs had been done in Saint Malo during a 8 day period.

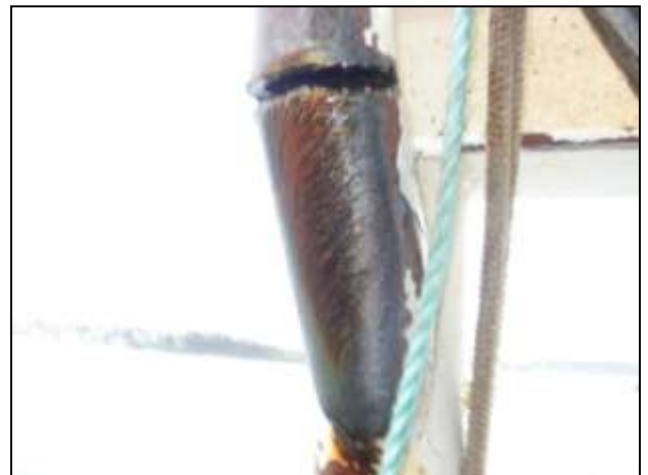
A port supporting beam of the gantry had been broken at the level of a weld.
