**TECHNICAL
REPORT OF THE
INQUIRY INTO THE
EXPLOSION**

ON BOARD THE OIL TANKER

CHASSIRON

ON 13TH JUNE 2003

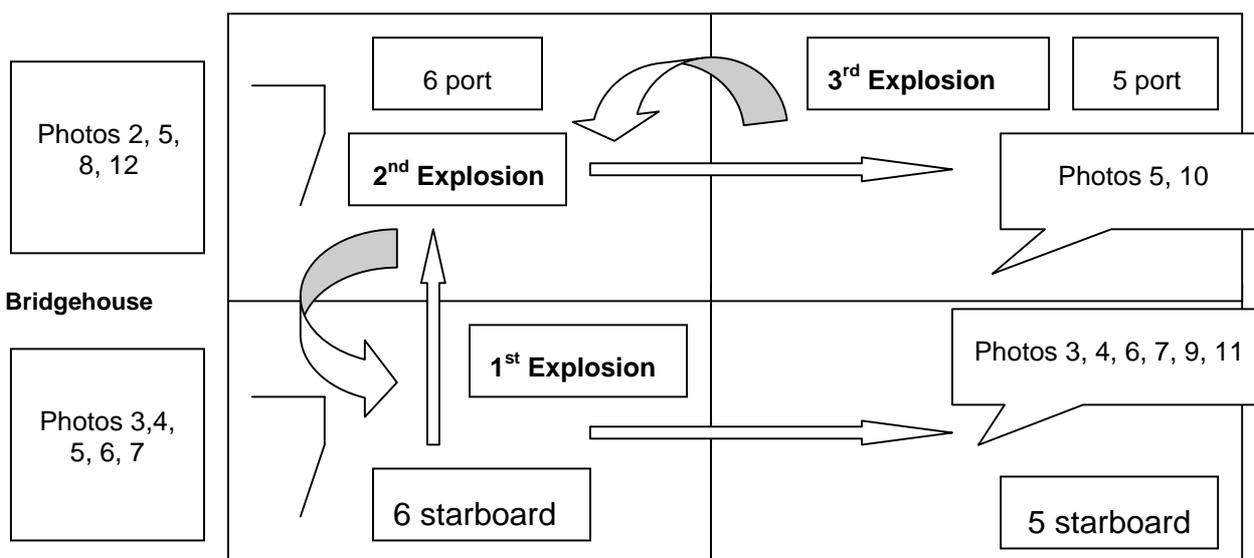
- **phase 2** : An initial explosion of the air/unleaded grade 98 mogas ATEX, which, taking into account the extremely serious damage observed, must have occurred in Tank 6 starboard, the ignition source being of mechanical or electrostatic origin. The explosion blasted the deck plating over Tank 6 starboard into the sea, breached the transverse bulkhead between Tank 6 starboard and Tank 5 starboard and the longitudinal bulkhead between Tank 6 starboard and Tank 6 port. The explosion propagated into Tank 6 port; Tank 5 starboard apparently did not explode, but judging by the damage incurred, suffered blast damage from the explosion in Tank 6 starboard

- **phase 3** : A second explosion of the air/unleaded grade 98 mogas ATEX in Tank 6 port caused by the heat of the first explosion. The explosion then propagated into Tank 5 port. The plating over Tank 6 port was torn from the deck (it was not thrown into the sea but remained hanging over the port side of the vessel against the sideshell plating). The transverse bulkhead between Tank 6 port and Tank 5 port was breached.

- **phase 4** : A third explosion caused by auto-ignition of the gas oil vapours in Tank 5 port. The blast of the explosion projected the bulkhead separating Tank 5 port from Tank 6 port into the after part of Tank 6 port.

After studying the damage, notably the way in which the bulkheads separating the tanks buckled, it is possible to assert that the explosion in Tank 6 starboard was more powerful than that in Tank 6 port, which was, in turn, more powerful than the one in Tank 5 port.

Simplified description of the explosion scenario and references of the photographs showing damage (source INERIS).
