Safety Investigation Report

**Collision with a channel buoy then striking
of the chemical/oil tanker vessel**

DORIS

on 3 April 2009

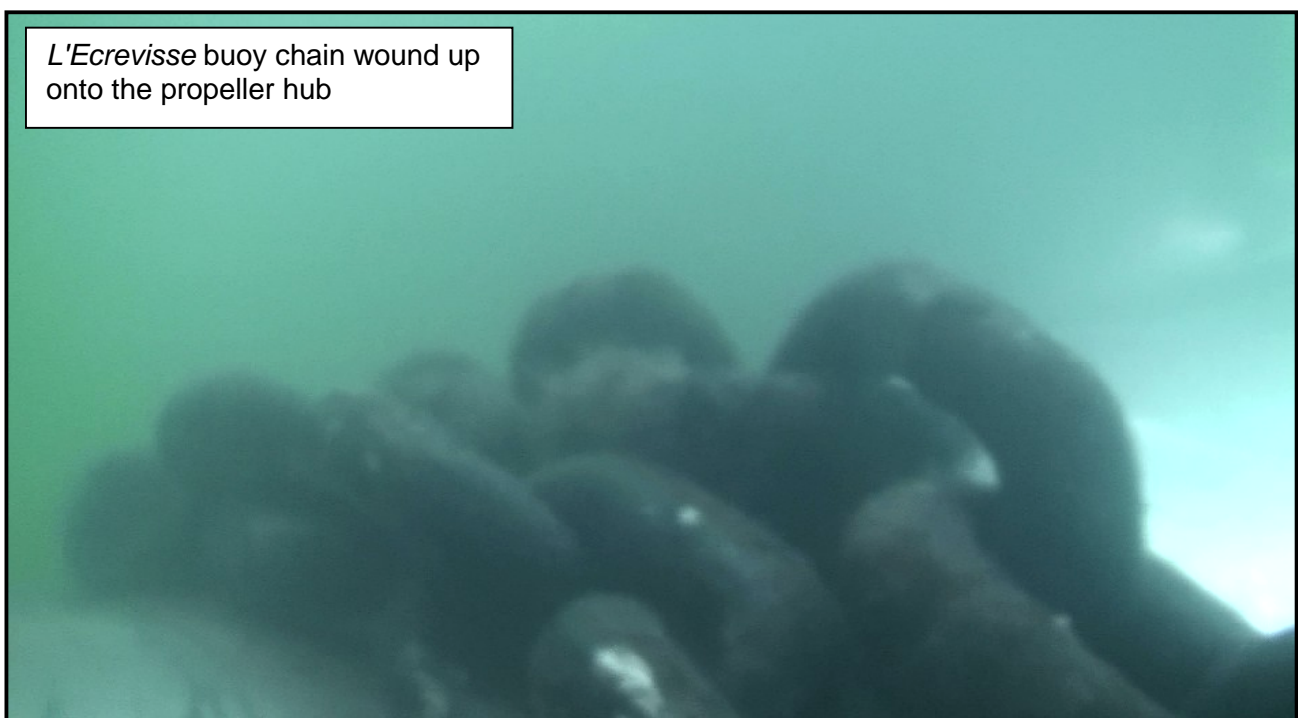
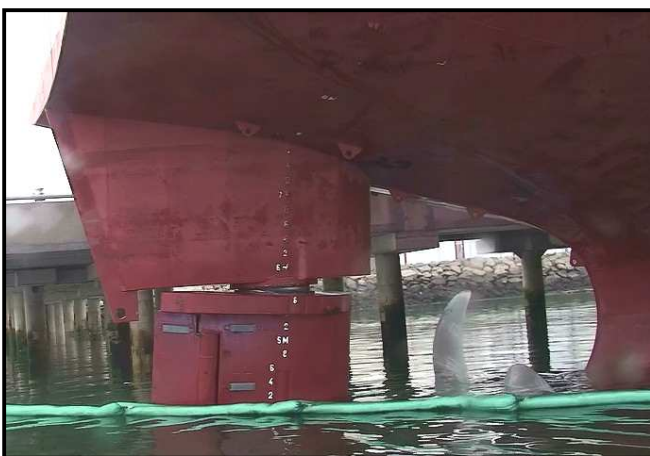
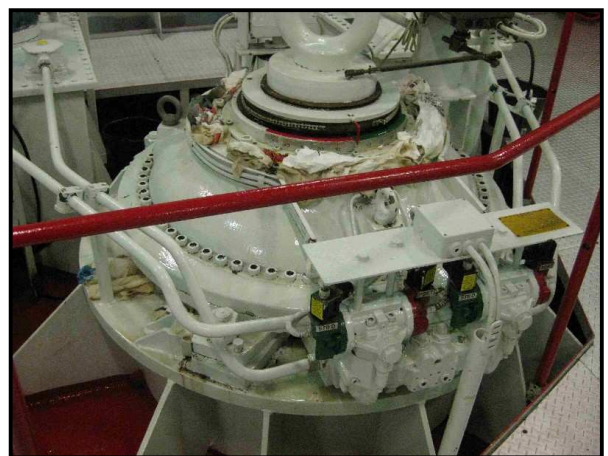
The accident had led to important damages depriving the vessel of part of her propulsion and of her manoeuvring capacity. In fact, about 20 metres of chain had been wound up onto the propeller hub. All the blades were damaged as well as the rope cutter; the rudder was bent on starboard. The probable impact between the concrete mud anchor of the channel buoy and the rudder had broken the clamping bolts of the steering gear bottom part.

Lastly a light chafing 2 m long and 20 cm wide between rib 149 and rib 152 on starboard aft from the bow thruster, as well as a distortion of frame 150 could be observed. These damages did not prevent the vessel to be towed at sea.

Taking into account these damages, as these works could not be undertaken in *Lorient*, and in order to allow a transit in tow to a shipyard, the rudder had been blocked in a neutral position.

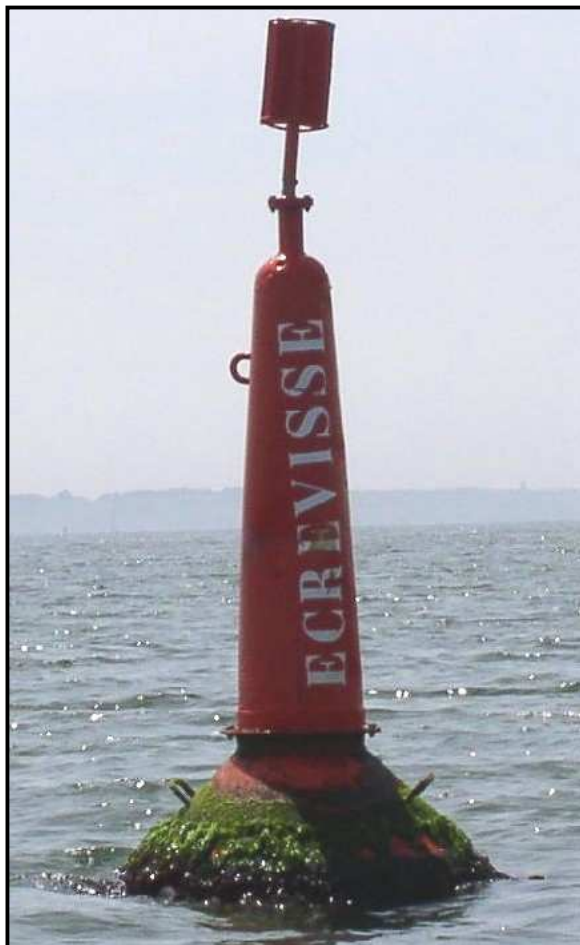
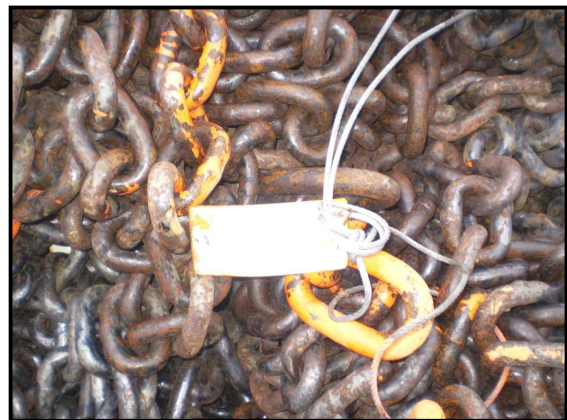
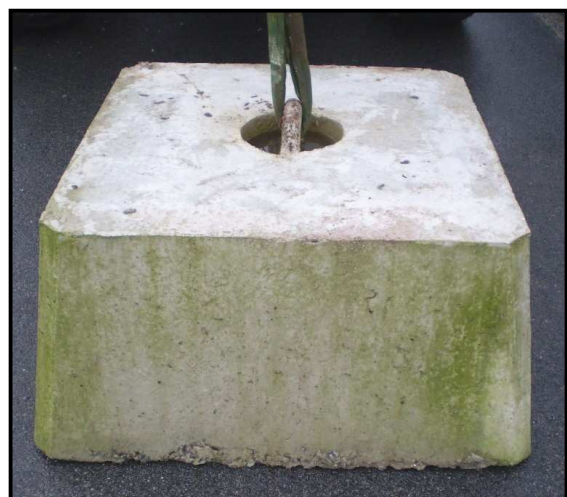
The impact had caused the total loss of the mooring gear, made of 15 m of 30 mm chain and its concrete 1.2 tonne mud anchor.

The buoy itself had no damage.
