SAFETY INVESTIGATION REPORT

REPORT NO.: 02/2013

MV PADNA Serious injury to crew member during a free-fall lifeboat annual inspection in the port of Marseille on 17 February 2012

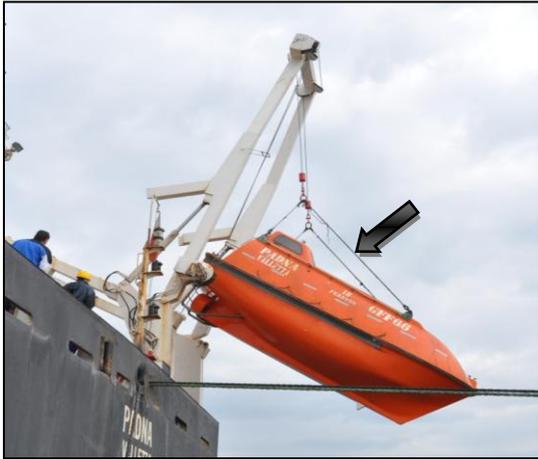
Figure 2: Hoisting slings

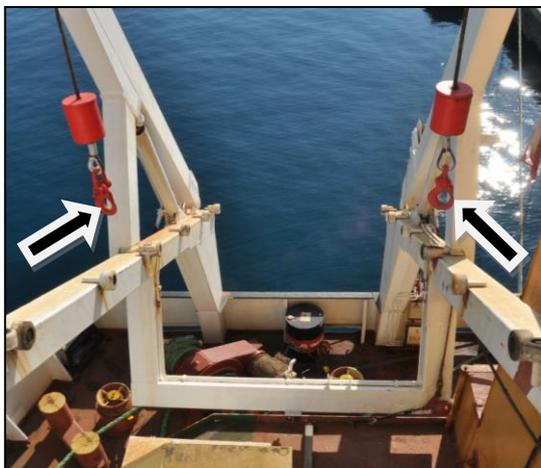
Figure 3: Port and starboard falls and hooks

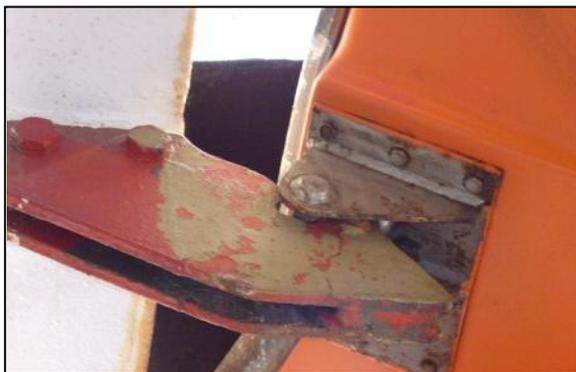
Once the forward and aft lashings were removed, the free-fall lifeboat was only kept on the davit by a hook on the release bracket to the boat (Figure 4). The hook, which held the lifeboat in place, was firmly secured to the davit.

Figure 4: The hook, which keeps the lifeboat in position

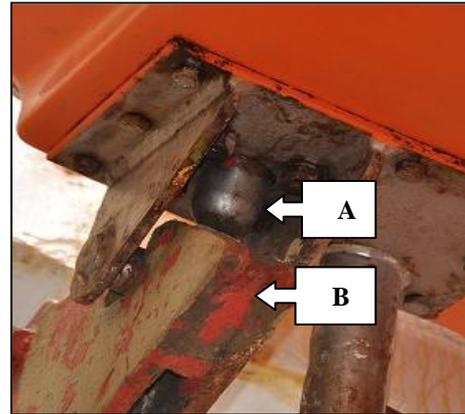
To release the lifeboat, a hydraulic piston had to be pumped out of its cylinder either by the main or the emergency hydraulic pumps. The piston (Figure 5) lifts the aft end of the boat and when the transverse bolt on the release bracket clears the davit's hook, the lifeboat becomes free to slide down.

A post-accident examination of the hydraulic piston revealed that it was almost completely out of the cylinder. This suggested that the hydraulic line from the hydraulic pump to the cylinder was still under pressure and so the hook at the aft end was just holding the lifeboat in the stowed position.

Figure 5: The hydraulic piston (A), which lifts the lifeboat's aft end from the hook (B)

The physical condition of the hydraulic piston was therefore considered to be the cause of the inadvertent release of the lifeboat.

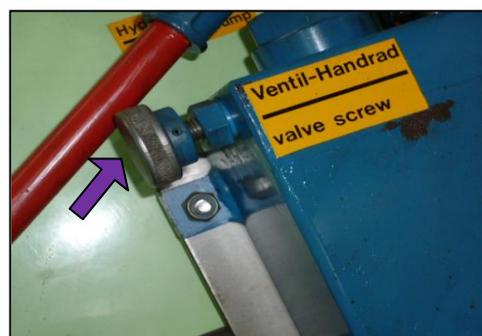
The verification of the piston's position was a missed procedural step and it was critical. The hydraulic system was designed as such that before the boat is retrieved, a pressure relief valve (Figure 6) had to be opened in order to relieve the hydraulic pressure from the line and reset the hydraulic piston back into its prelaunch position.

Figure 6: The valve, which had to be operated in order to reset the release piston.

In fact, the relief valve was found faulty and unable to relieve the hydraulic pressure in the line. Under such conditions of hydraulic lock, there was no way for the piston to fully reset.

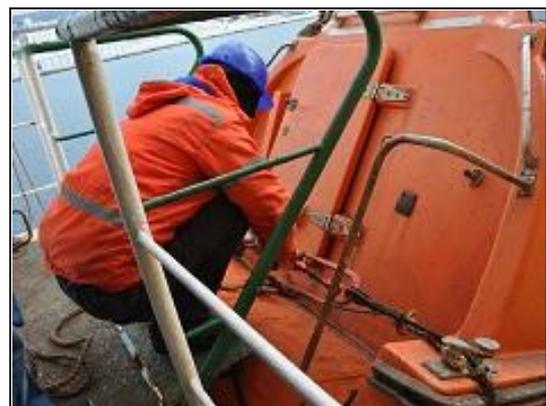
Access into the lifeboat was not possible unless the aft lashings were removed (Figure 7).

Figure 7: One of the crew member removing the aft lashings in order to gain access into the lifeboat

The scope of lifeboat lashing is to secure the lifeboat for sea and for maintenance purposes. Their removal for inspection purposes defied

their intended scope; a defence mechanism, which had to be deactivated in order to gain access into the lifeboat.
