Report on the investigation of the contact
and grounding of the ro-ro passenger ferry

Pride of Kent

Calais, France

REPORT NO 3/2019

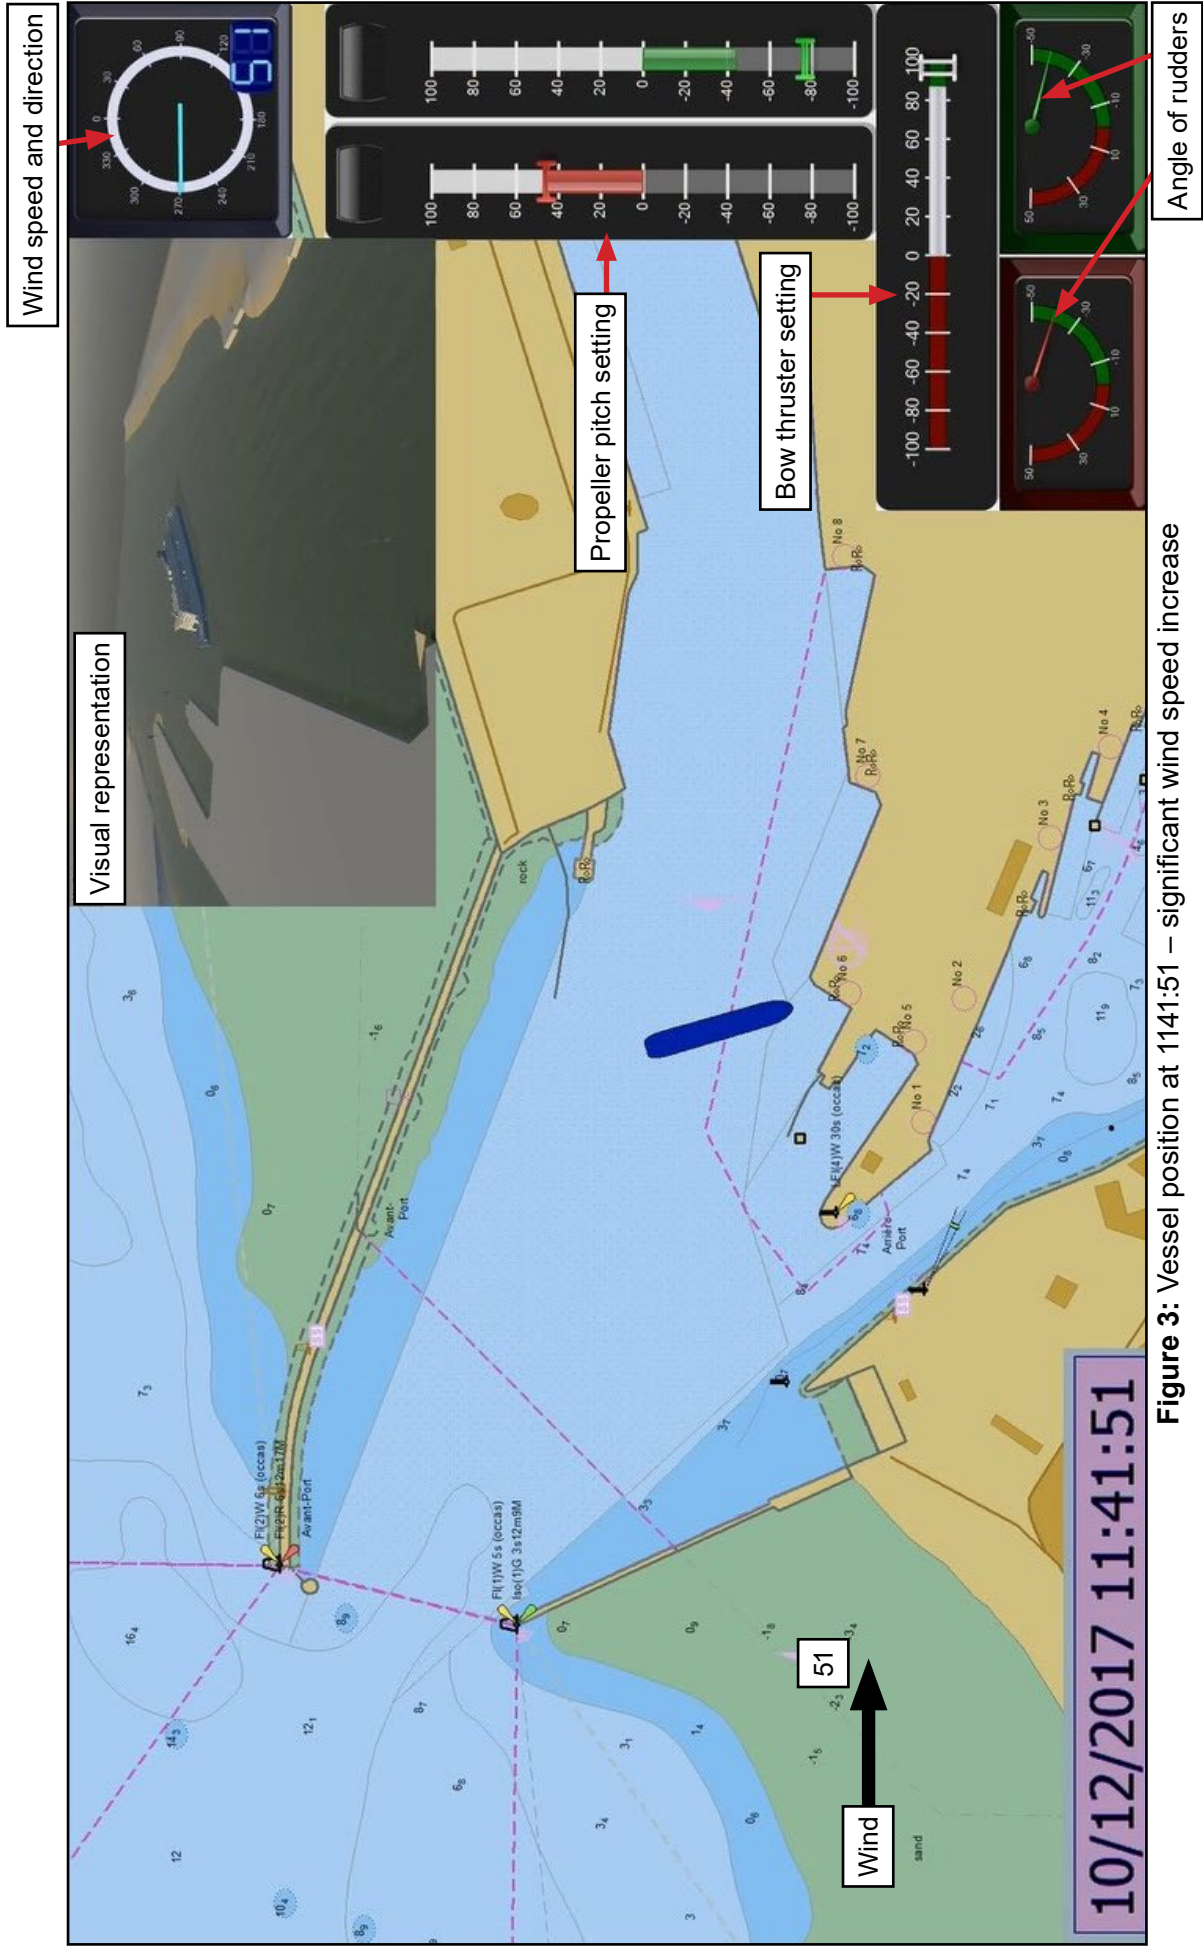
By 1140, the mooring lines were clear and the stern had started to lift from the berth as intended. At 1141, the master manoeuvred the ferry astern, and then started to swing its bow to starboard (**Figure 3**). Seconds later, the wind speed increased to a steady 45kts, gusting to 55kts.

Figure 3: Vessel position at 11:41:51 – significant wind speed increase

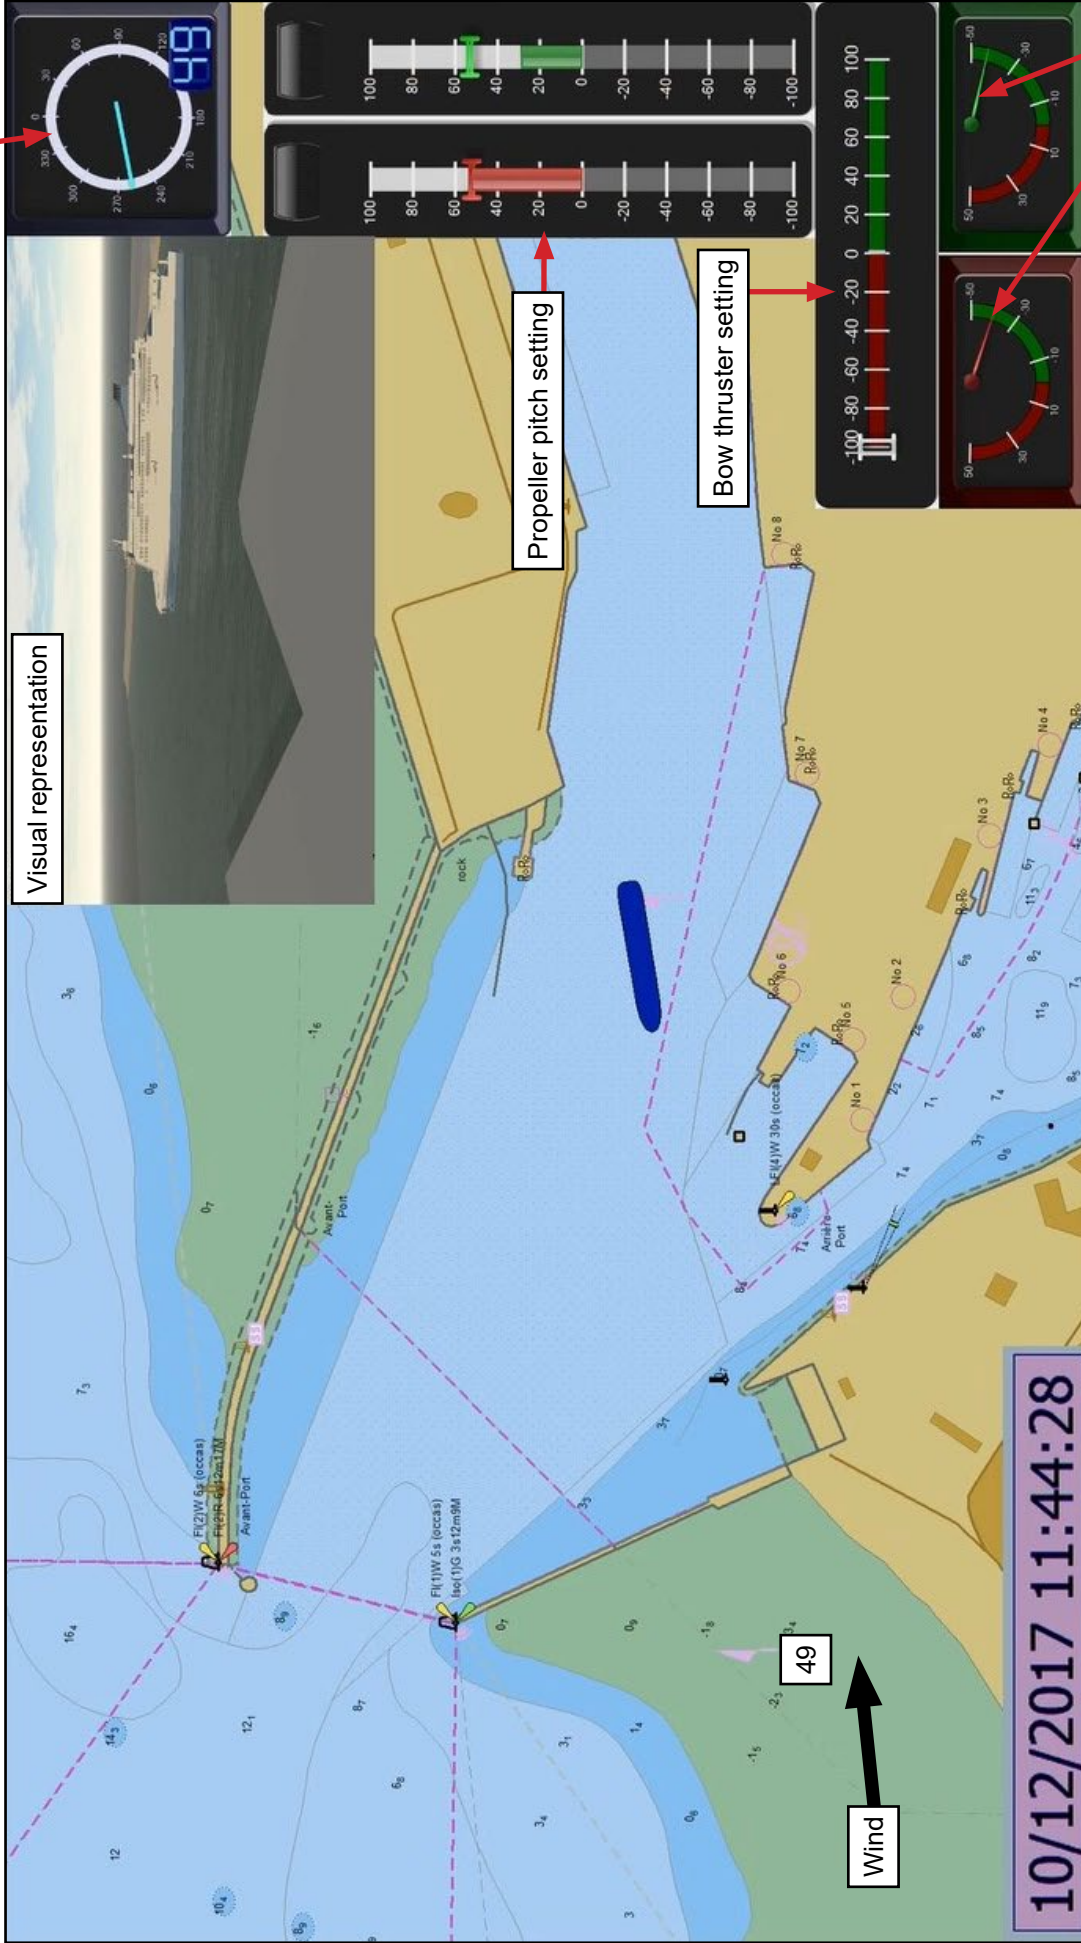
Pride of Kent's master continued to turn the ferry using the No.2 bow thruster and main engines, and at 1144:28 it was heading into the wind (**Figure 4**). At this point, the master changed the thrust direction of the bow thruster from starboard to port in order to slow the rate of turn, which had reached 58°/min.

Figure 4: Vessel position at 1144:28 – head to wind

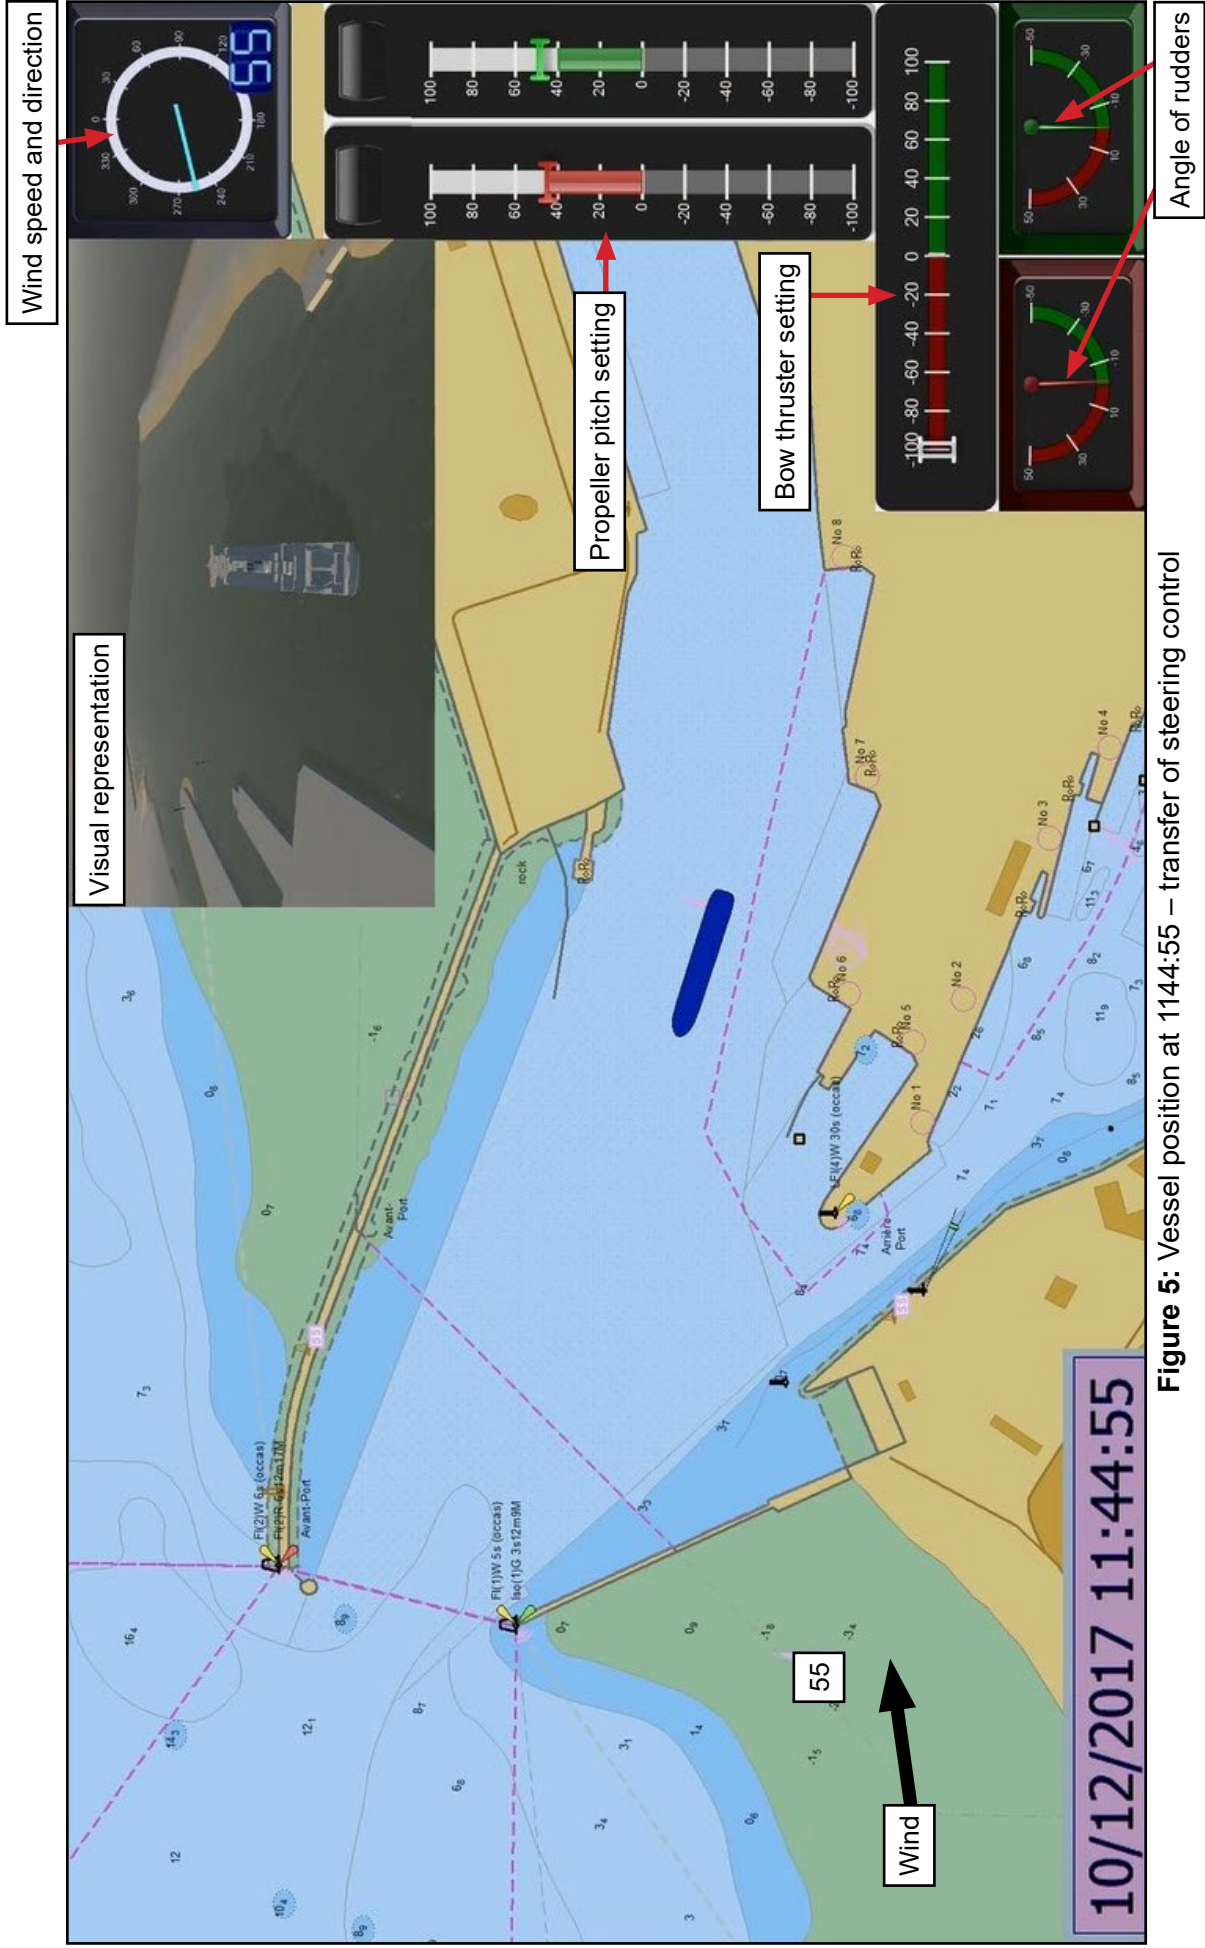
At 1144:55, *Pride of Kent's* master put both rudders to amidships as the ferry's heading approached 289° (**Figure 5**). He then requested the helmsman to take steering control at the centre console and steer for the green light on the southern breakwater. The helmsman pressed the take-over button and moved the port (master) control lever⁴ (**Figure 6**) to port 40°. The starboard helm control lever remained at amidships.

Figure 5: Vessel position at 1144:55 – transfer of steering control

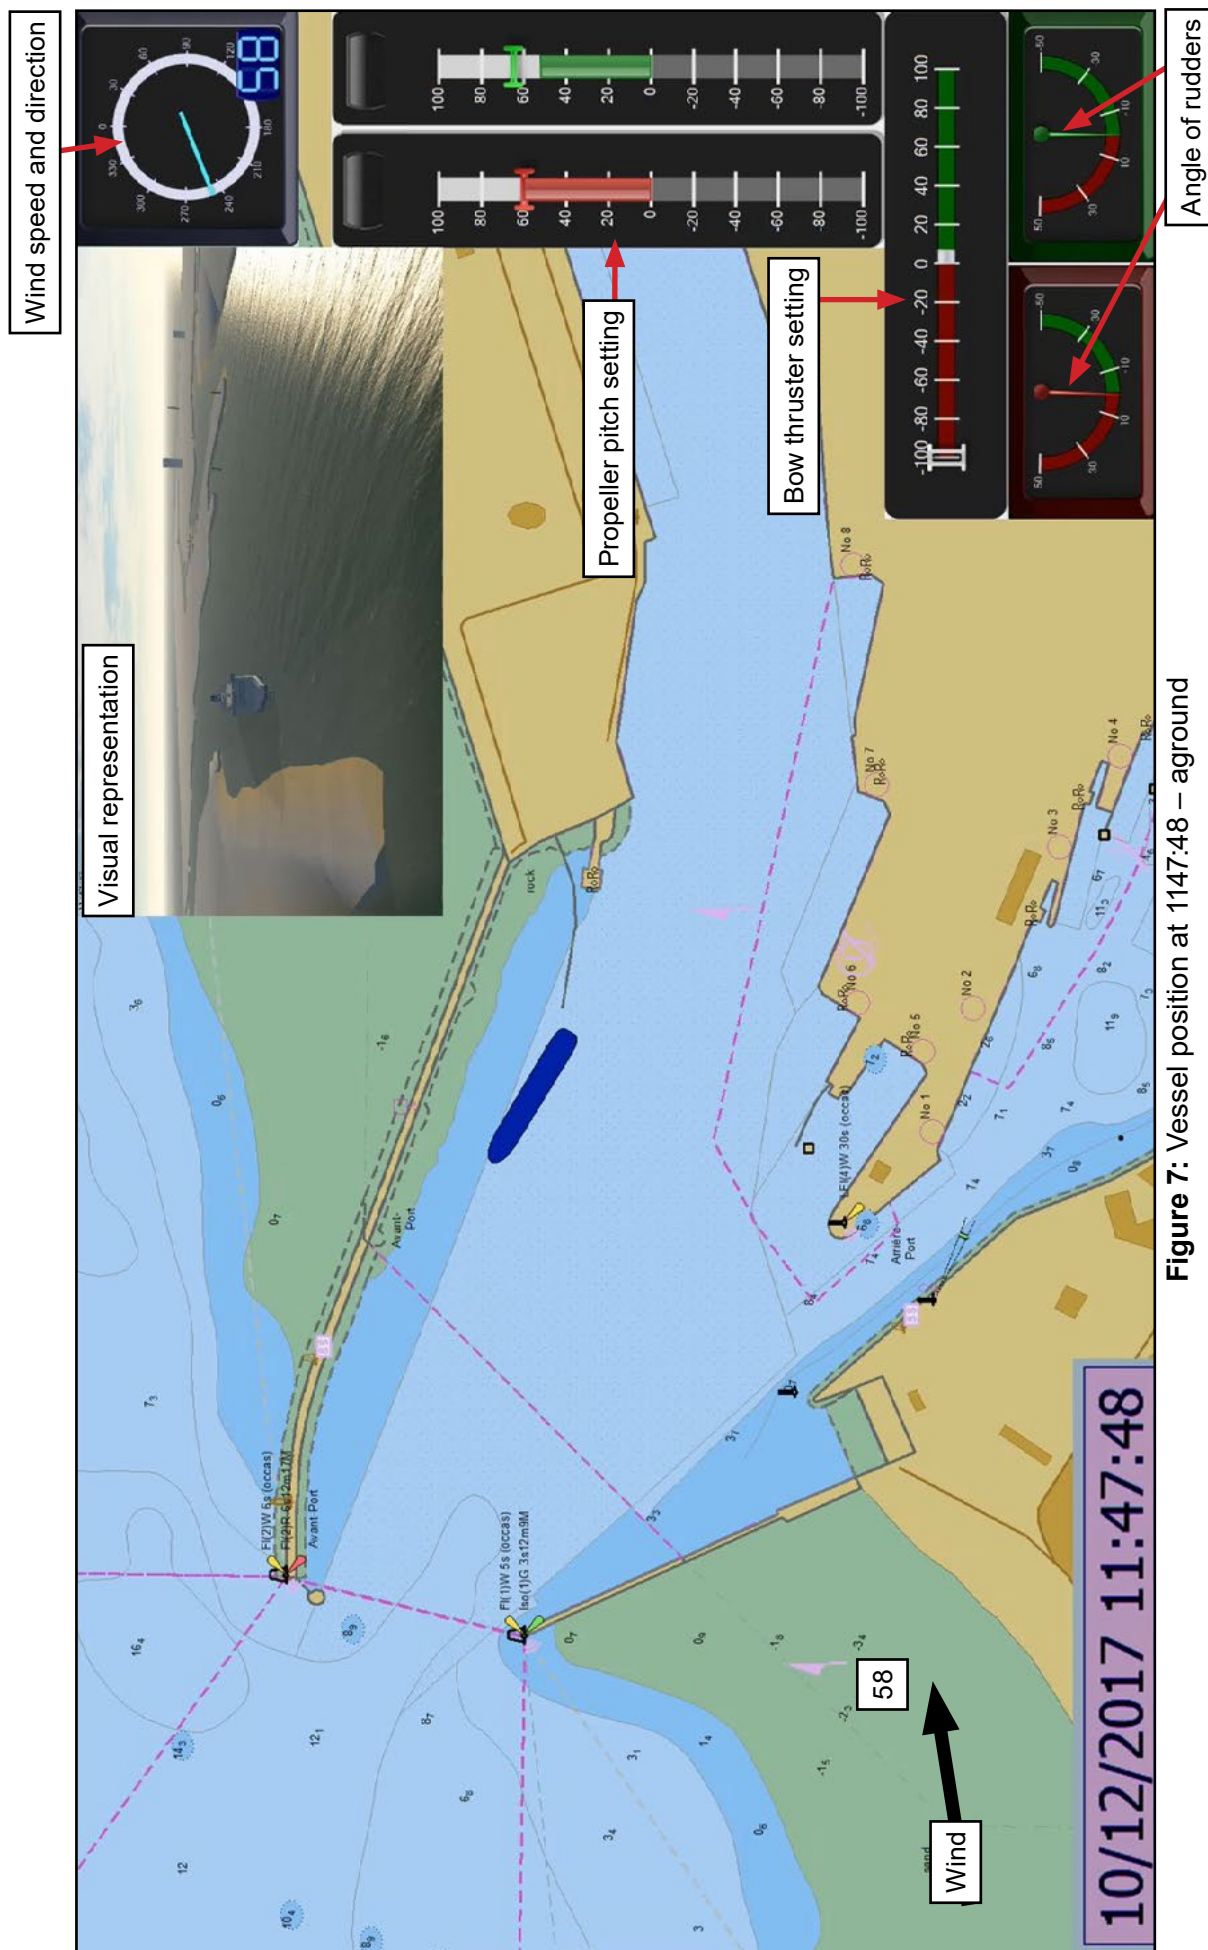
Pride of Kent continued to close T1 and, at 1146:14, the ferry's starboard side struck the jetty piles. The ferry moved ahead with the propellers still turning and the rudders full to port. About 20 seconds later, the starboard propeller shaft stopped on overload and the ferry then grounded in the shallow water to the west of the jetty (**Figure 7**). The wind was now gusting up to 70kts.

Figure 7: Vessel position at 1147:48 – aground

Pride of Kent was inspected by its crew and a Lloyd's Register surveyor. Damage to the starboard tail-shaft and propeller resulted in the ferry being taken out of service and dry docked in Dunkirk for repair. The walkway and piles on the T1 ro-ro berth were also damaged.

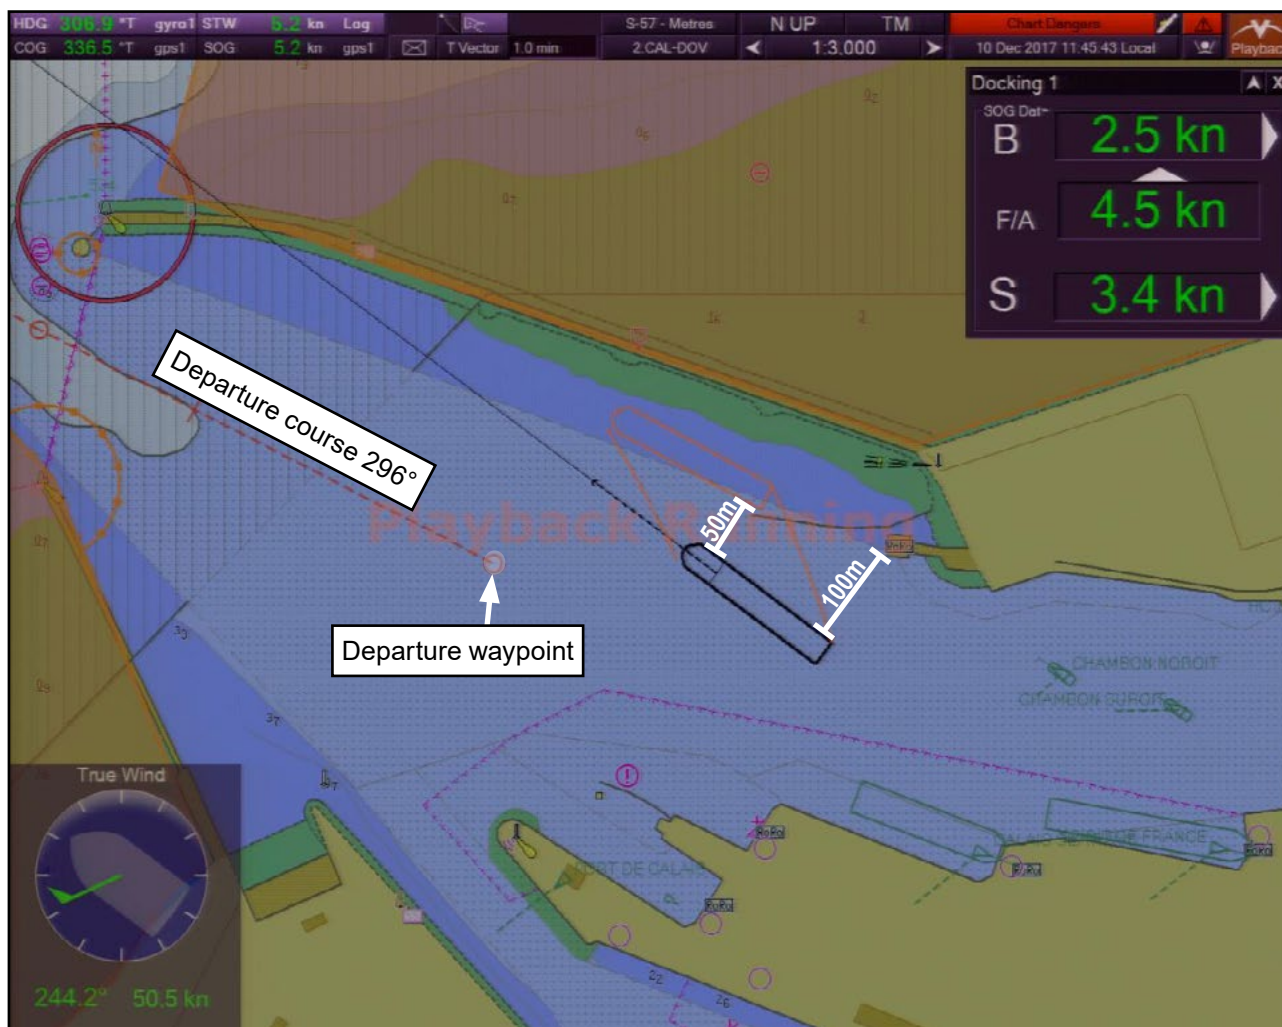
Wind information based on data from *Pride of Kent's* anemometer is shown graphically at **Annex B**. **Figure 8** is a screen shot of the ferry's electronic chart display and information system (ECDIS) playback, which shows the intended route, position and heading shortly before grounding. It also shows the ferry's predicted position and heading.

Figure 8: ECDIS playback screenshot at 1145:43 showing lateral speed and bow/stern clearances

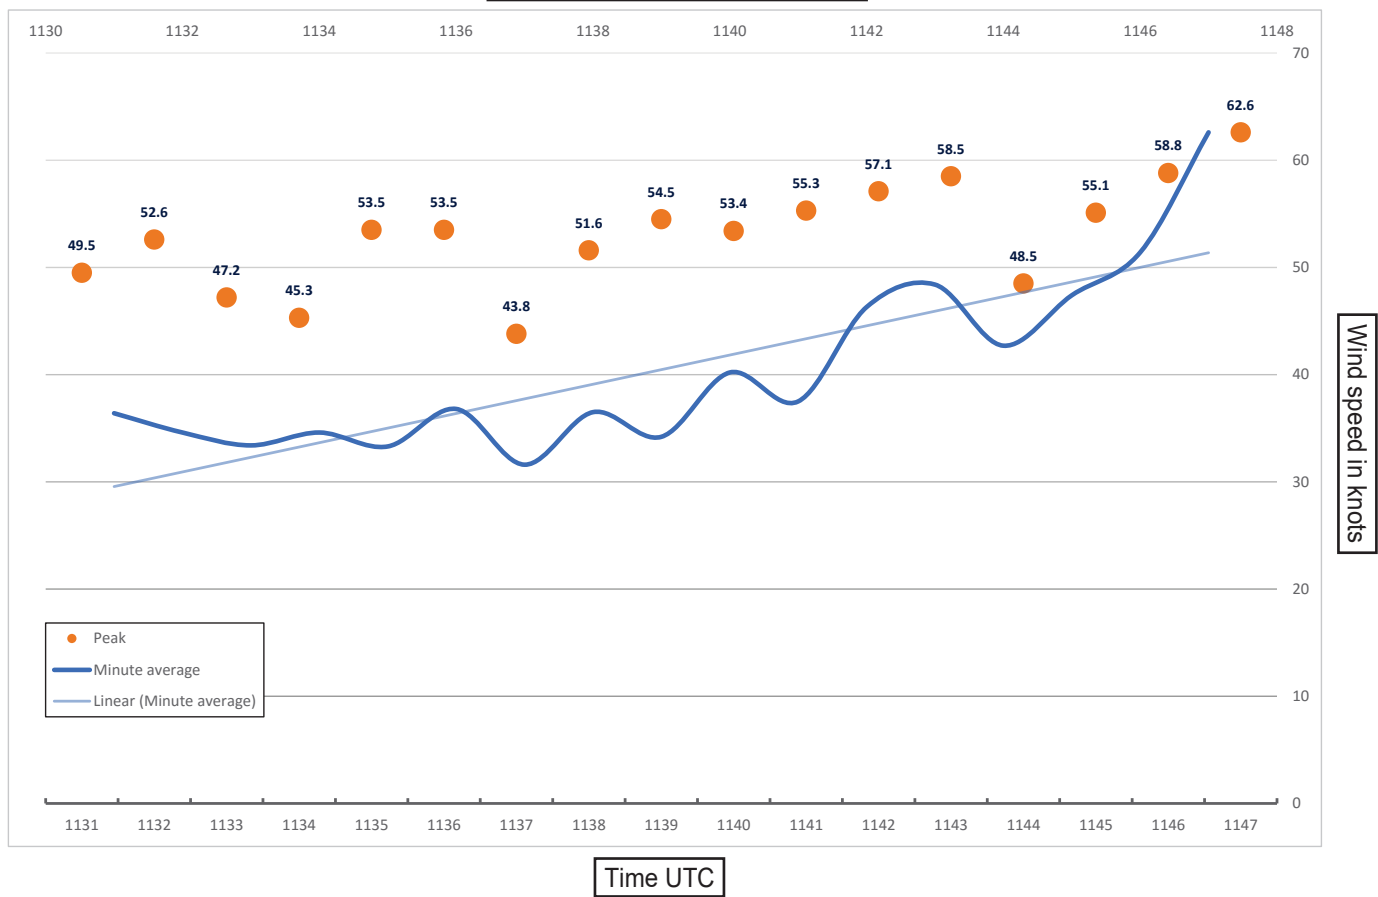
Wind speed and direction between 1131 and 1147 (based on ship's anemometer data)
