Report on the investigation  
into a collision between  
**fv Z.85 – ALEXIS II and mts LS JAMIE**  
on March 31<sup>st</sup> 2021

in TSS Dover Strait  
with serious damage to the fishing vessel.

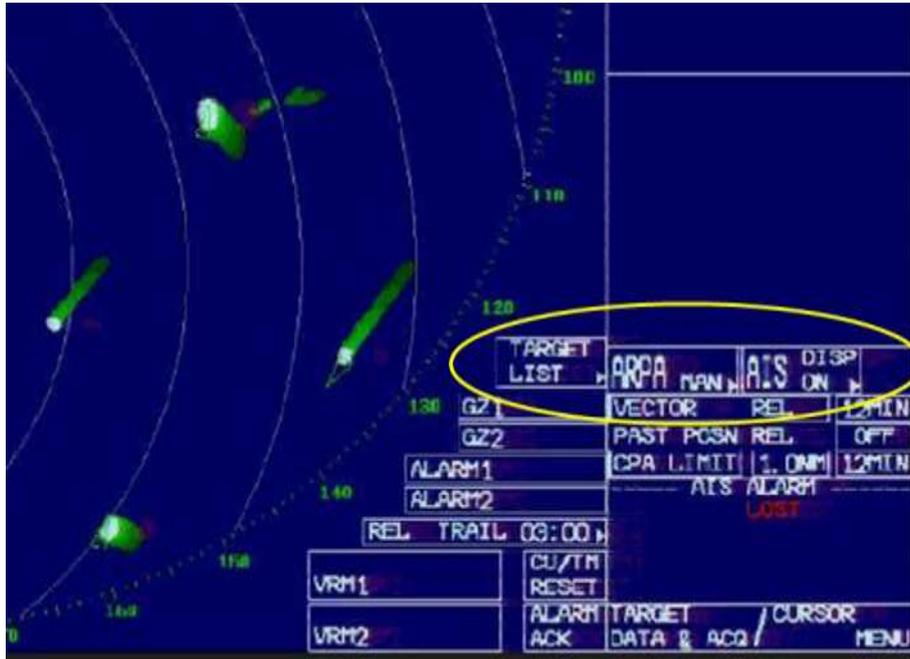
Figure 5 – Radar settings on board mts LS JAMIE

The radar was set off centre on a range of 6 nm, relative motion. The AIS overlay function on the radar was activated. Radar targets without AIS signal had to be acquired manually, as the ARPA function was set on manual acquisition<sup>2</sup>, see Figure 5.

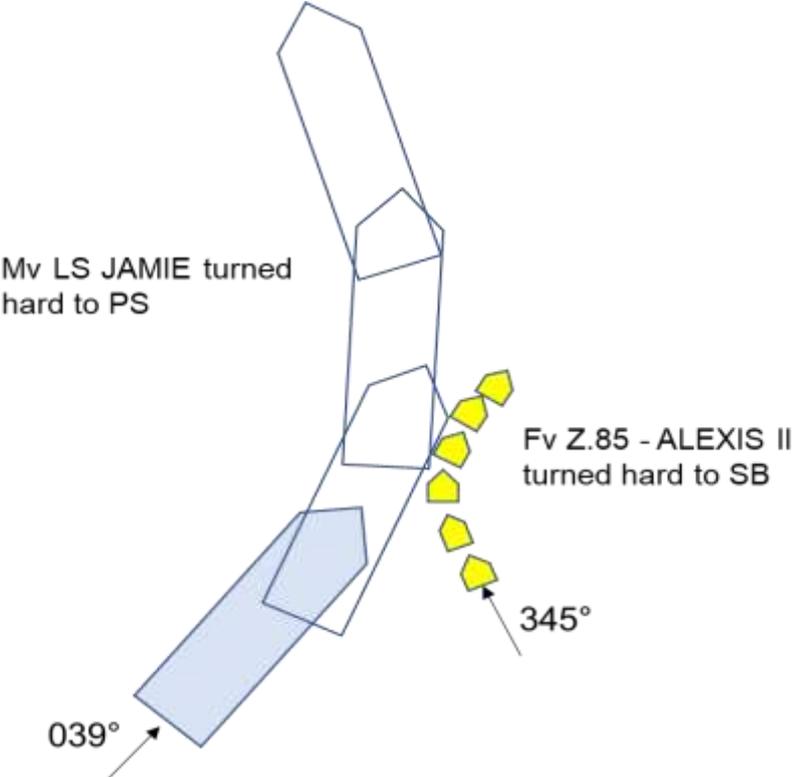
Figure 6 – Pictorial representation of the manoeuvres to avoid a collision

Figure 6 gives an indication of the manoeuvres of both vessels. The manoeuvres were started at 03:11 hours. Mts LS JAMIE turned a little bit earlier than fv Z.85 – ALEXIS II. No sound signals were given, no VHF contact had taken place.

As a result of the manoeuvres, the PS hull of fv Z.85 – ALEXIS II scraped against the SB hull of mts LS JAMIE.

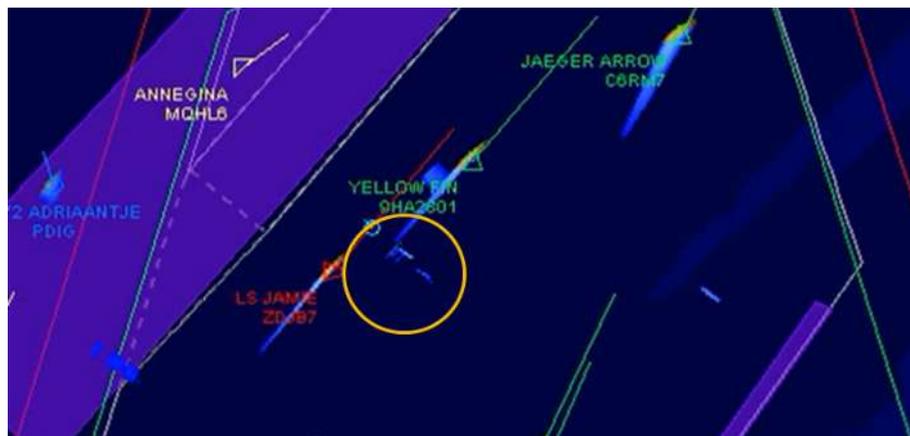
Figure 7 - Radar image of VTS/MRCC Gris Nez

Gris Nez Traffic centre<sup>3</sup> had not observed the collision on radar. The reflection of Fv Z.85 – ALEXIS II was very poor and hardly visible on the radar of Gris Nez traffic centre, as indicated in Figure 7.

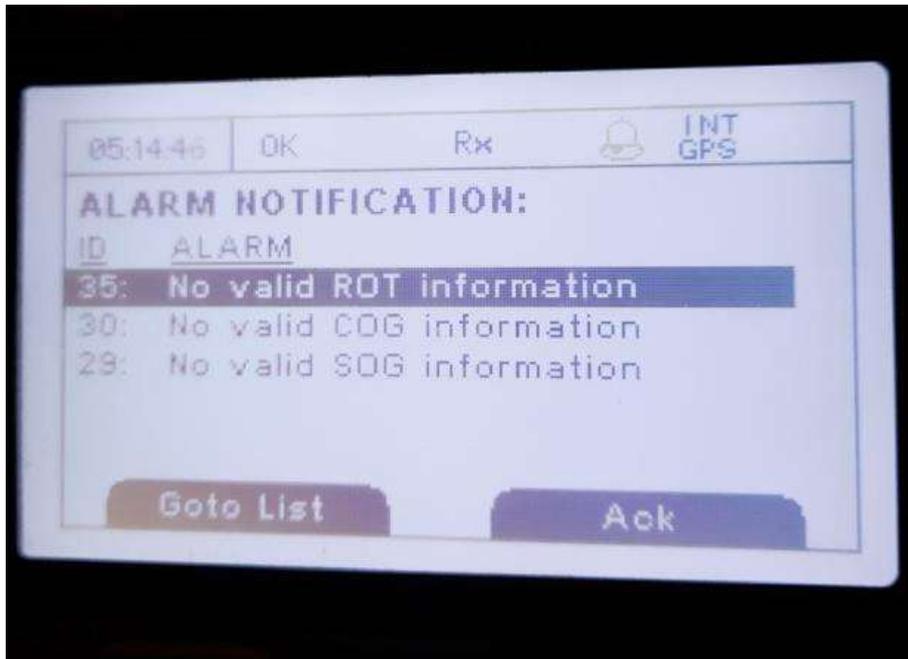
Figure 8 - AIS with error

On March 31st 2021, Port State Control visited fv Z.85 – ALEXIS II at the port of Dunkirk. The PSC officer stated that the AIS displayed several alarms, as indicated in Figure 8.

The navigation lights of the fishing vessel were found damaged. Port sidelight was not working, and the lighting sector of the masthead light was not as required by regulations in vigour.

A revision of the AIS on board fv Z.85 – ALEXIS II learned that the alarms were generated because of the failure of the internal GPS of the AIS.

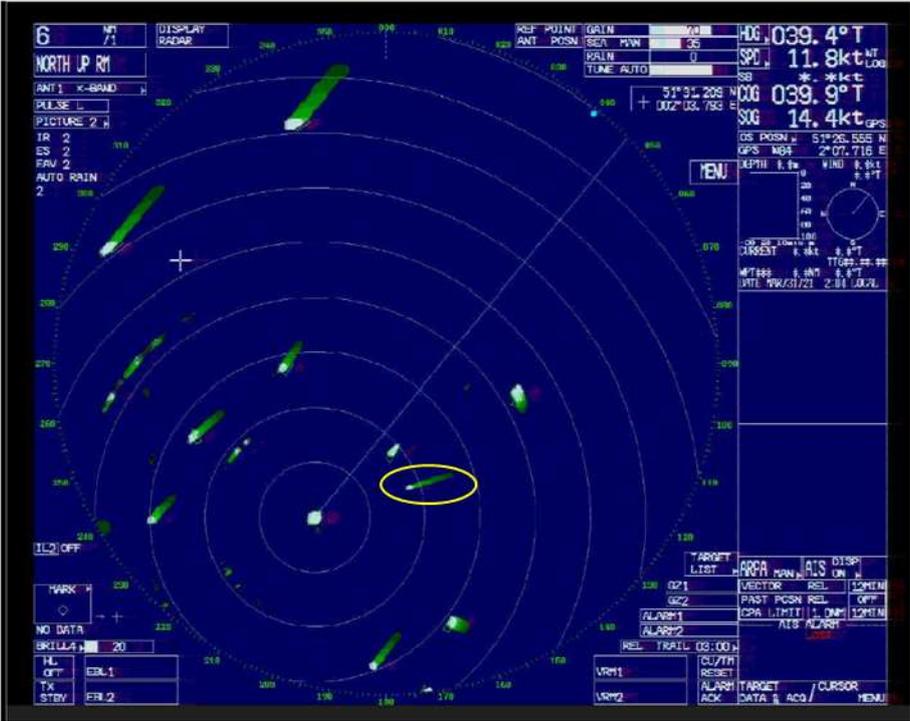
Figure 9 - Fv Z.85 - ALEXIS II on the radar of mts LS JAMIE at 03 :05 hours

The radar on board mts LS JAMIE was set in relative motion, so the course and speed of fv ALEXIS II were represented relatively to the movement of the mts LS JAMIE. The radar image did not show the true course and speed of fv Z.85 – ALEXIS II<sup>4</sup>.

The collision between fv Z.85 – ALEXIS II and mts LS JAMIE stemmed from fv Z.85 – ALEXIS II not being observed on radar on board mts LS JAMIE. The echo of fv Z.85 -ALEXIS II was clearly visible on radar but had not been observed.

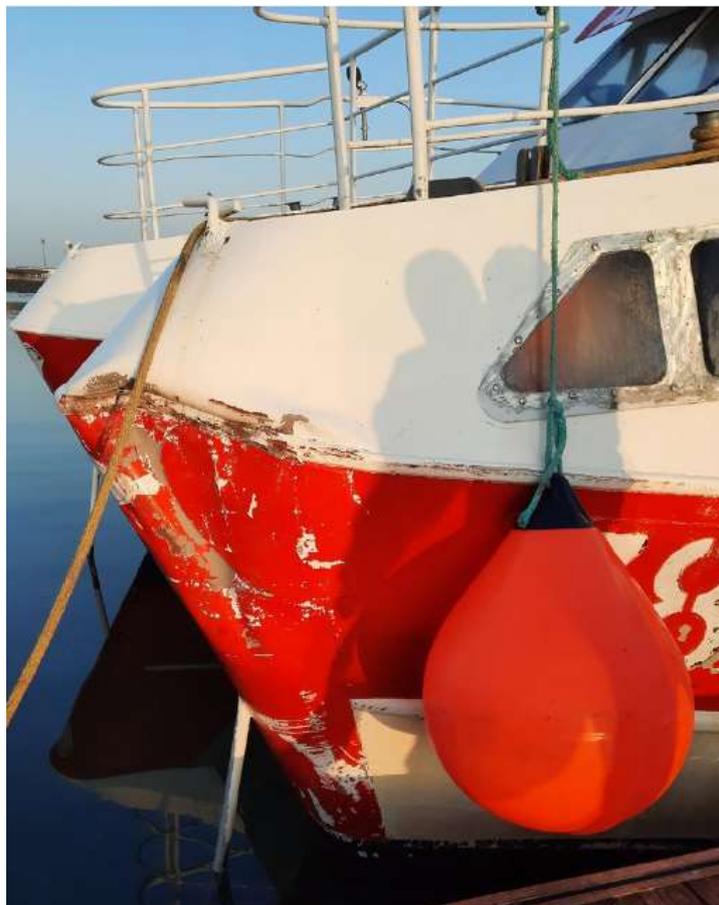
*Figure 13 – Dent in PS bow of fv Z.85 – ALEXIS II*

Fv Z.85- ALEXIS II was damaged on PS approximately 1 m from the PS bow and the hull was cracked at PS winch opening. The PS funnel was partly teared off.

This resulted in a dent of approximately 1 metre in length on PS bow of fv Z.85-ALEXIS II, as indicated in Figure 13.

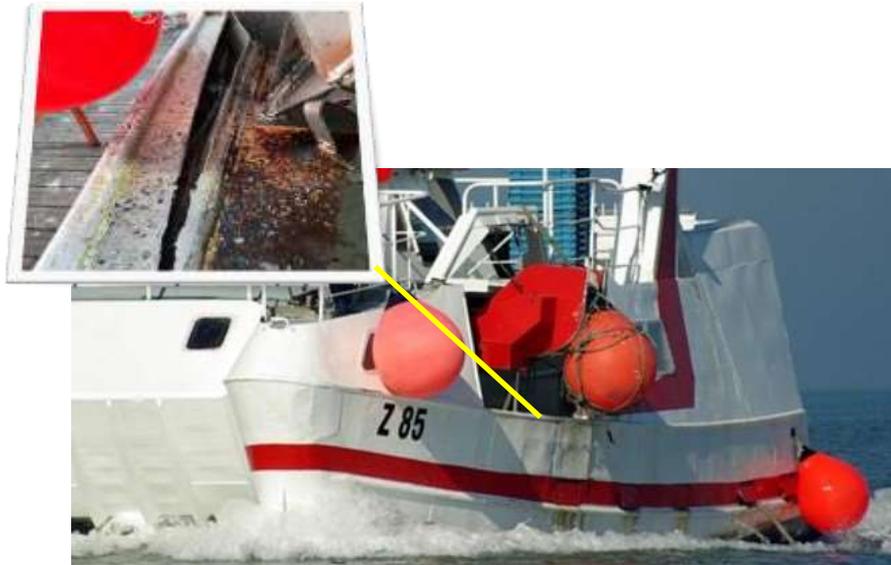
*Figure 14 – Rupture in the hull at the PS winch opening of fv Z.85 - ALEXIS II.*

The bulwark near the winch on PS of fv Z.85 – ALEXIS II was ripped open, as shown in Figure 14.

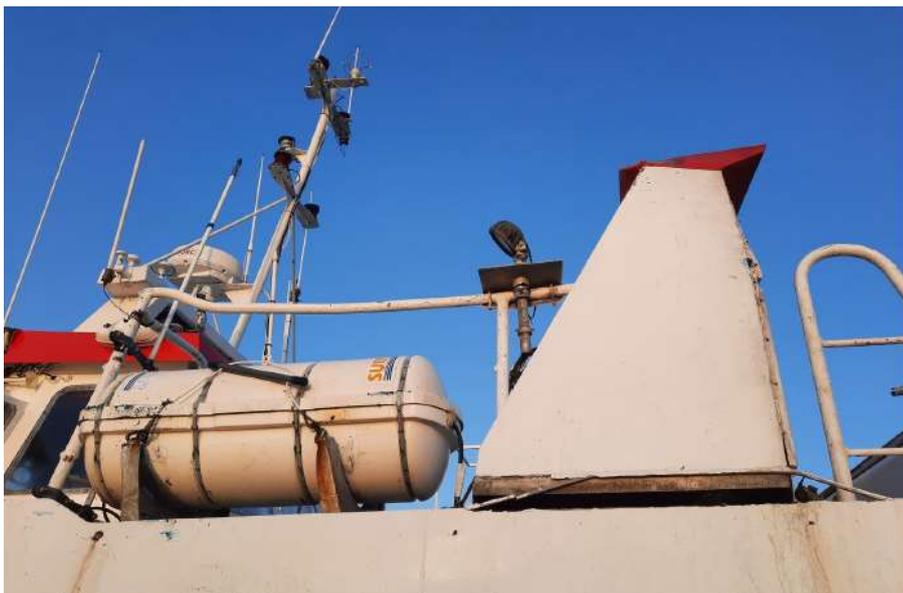
*Figure 15 – Chimney of fv Z.85 – ALEXIS II torn off*

Figure 15 shows the funnel of fv Z.85 – ALEXIS II that was torn off the deck plate by the impact of the collision.

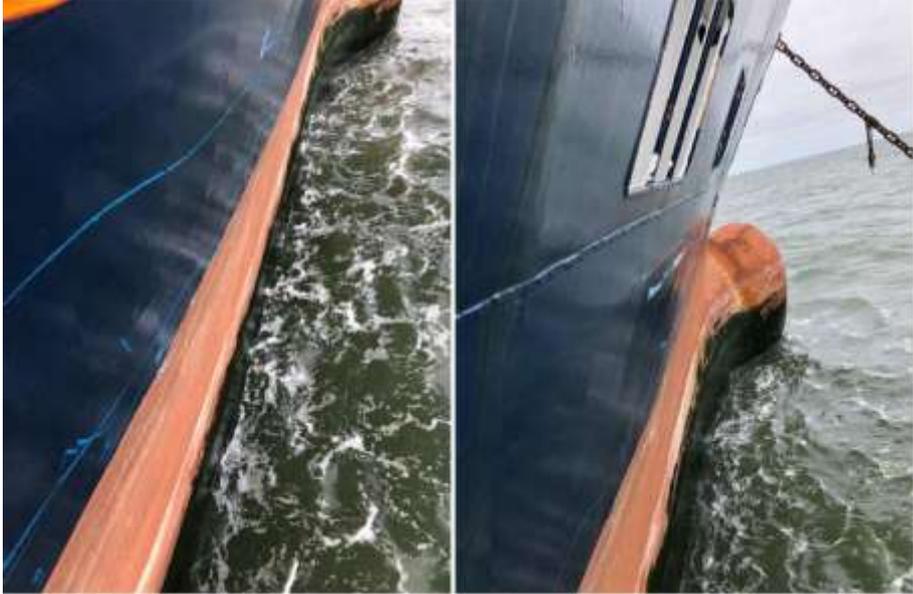
*Figure 16 – Damaged coating on board mts LS JAMIE*

Mts LS JAMIE hit fv Z.85 – ALEXIS II with her SB side, resulting in damage to the hull coating on SB side forward on board mts LS JAMIE.

Figure 16 shows the scratches in the hull coating on board mts LS JAMIE.
