Report of safety investigation

GUNAY 2

Safety Investigation Report

GROUNDING **OF THE CARGO VESSEL** ***GUNAY 2*** **ON 21 JANUARY 2009** **ON PLANIER ISLAND, OFF MARSEILLE**

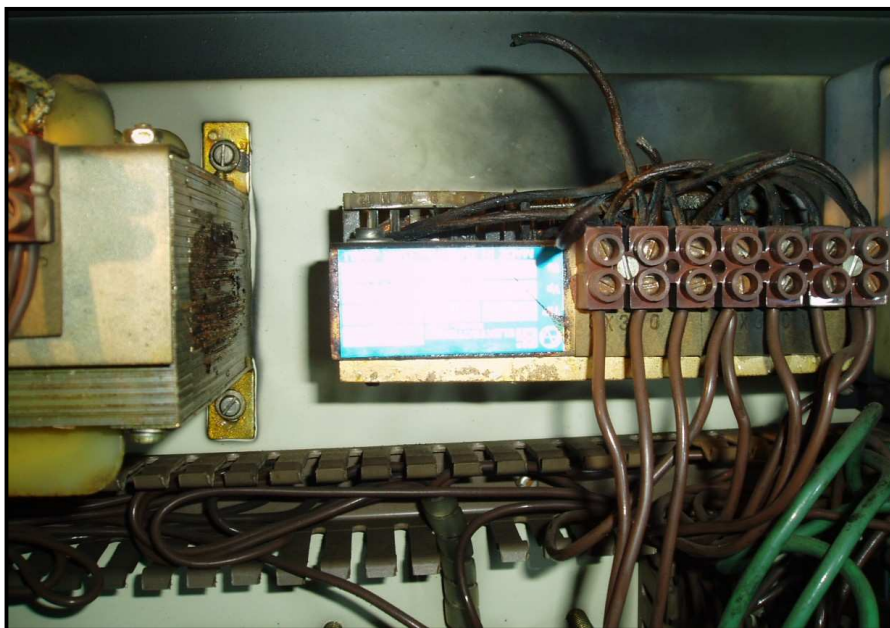
The trials done before getting underway had not shown any deficiency. In addition, the chief engineer did not detect anything abnormal during his watch. Nevertheless, an overheating of the hydraulic pump n°1 engine main transformer and of the terminal block next to the main transformer (equipment box located in the steering gear room) had been noticed during the investigations done by CSN Marseille. This overheating could have been induced by the important stress undergone by the relays due to yawing in heavy seas during previous passages. Moreover, 3 wires connected to this terminal block (ins and outs of which remain undetermined) are cut.

During the 7 minutes before the grounding (from 02.07am to 02.14am as shown on the monitoring display) the headings recorded by the VTS are :

104,2 – 108,5 – 115,1 – 103,1 – 106 – 109 – 108 – 104 – 103 – 109 – 112,7 – 105,3 – 102 – 108,6 – 107 – 108,1 – 112,1 – 104 – 103,4 – 104,3 – 108,5 – 105,8 – 103,3 – 108,4 – 106,2 – 104,1 – 103,6 – 107,8 – 107,5 – 106,9 – 104,3 – 105,4 – 105,6 – 103,8 – 101,5 – 104,9 – 107,5 (zero speed at 02.14 am).

The average heading is 106.3° and no yaw or loss of control that could be due to a failure of an element of the steering chain made up of the gyro compass, the autopilot and the steering gear can be pointed out.

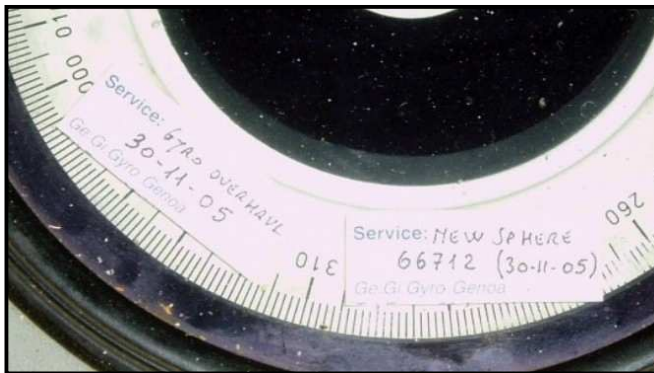
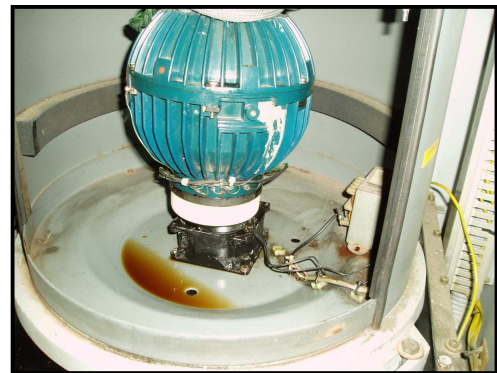
An oil leak had been detected in the cup located under the gyrocompass bowl. The last control of this equipment had been done in November 2005. Despite these anomalies, no kinematical element before the grounding gave evidence of a failure of the gyrocompass.

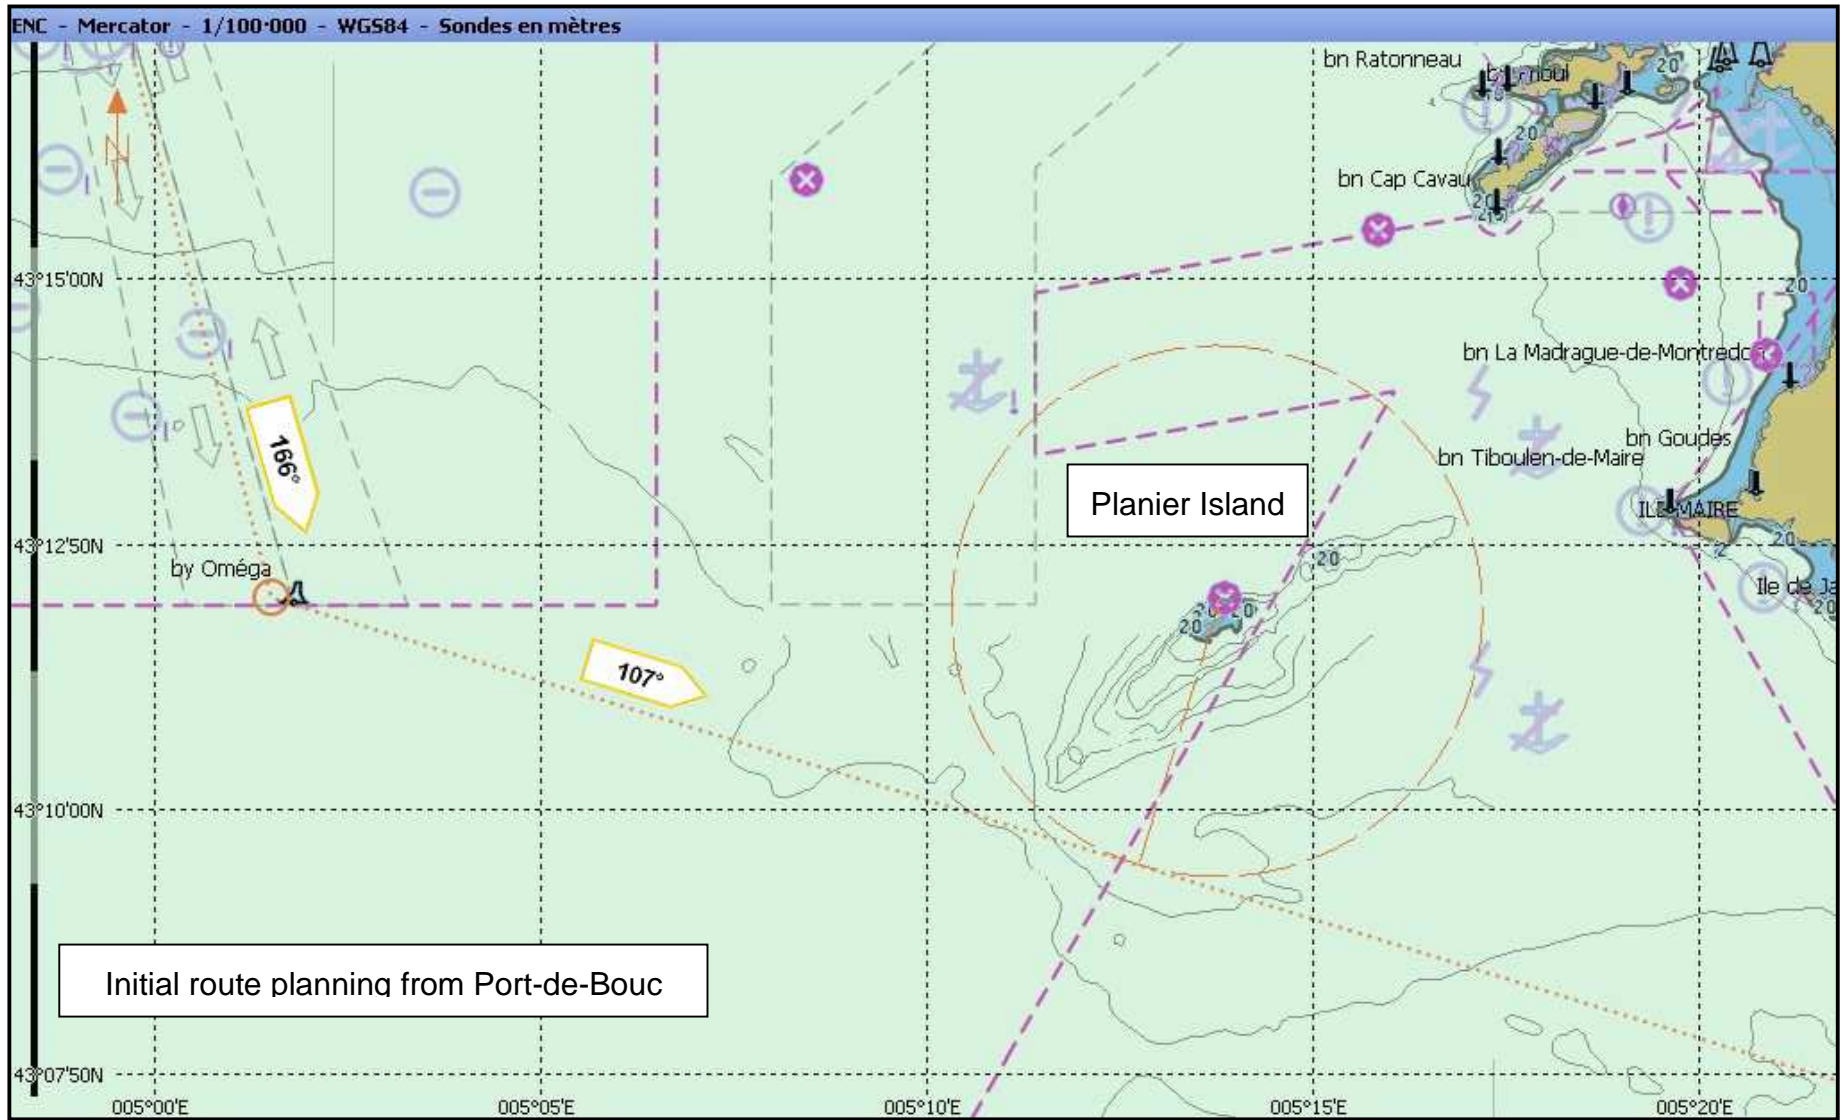
Chart

At **02.19 am**, despite this manoeuvre, the vessel grounded at 9.1 knots, heading 107.5° (see SPATONAV record appendix C) on the south-western part of Planier Island at position 43°11',87 N – 005°13',64 E.

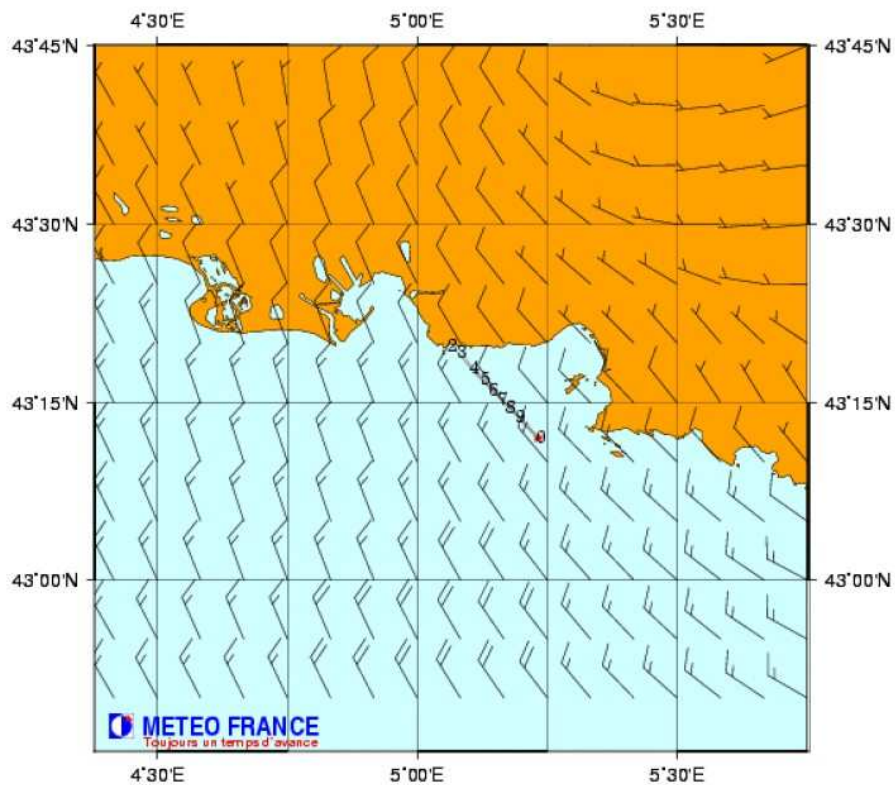
MOTHY/ALADIN REBOURS Prévision pour le 20/01/2009 à 06 utc

The drifting simulation done with the MOTHY software by Météo France (see appendix D) confirms that the leeway had a south-east axis which was favourable to GUNAY 2 as long as the set point was 107° as planned in the voyage planning, as it would have increased the distance with Planier Island.

In this version the drift of a floating object (rectangle parallelepiped⁴ having the cargo vessel size, with various hypotheses on the percentage of immersion (from 20% to 100%)). The figures on the chart, represent these various percentages of immersion. We have observed, during previous drifting simulation of this kind, that the most often observed values for a cargo vessel were in the 60 to 90% range of values.
