Marine safety investigation report

**GROUNDING OF THE OCEANOGRAPHIC VESSEL
MARION DUFRESNE
ON 14 NOVEMBER 2012 IN THE WESTERN APPROACHES
OF ÎLE DE LA POSSESSION (CROZET ARCHIPELAGO)**

Bureau d'enquêtes sur les événements de mer

Report published on : November 2013

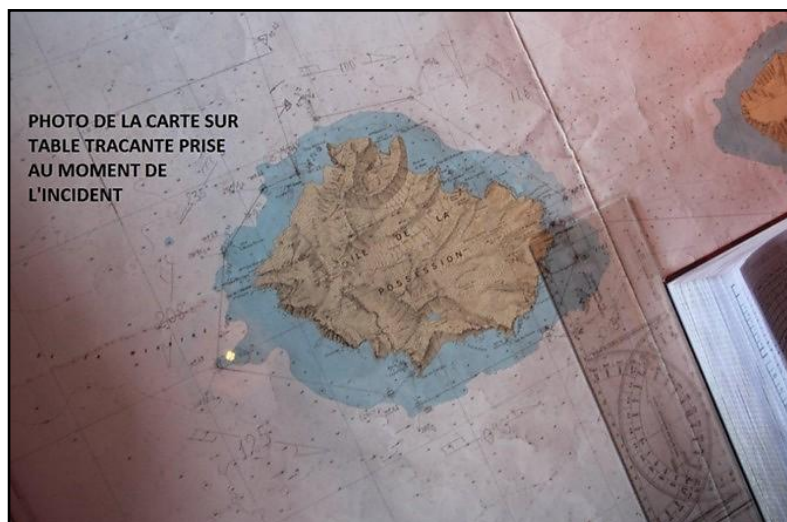
The proper use of this plotter supposes that the chart has been perfectly positioned and that its positioning is checked on a regular basis.

Picture of the Nautoplot plotter taken by a passenger.

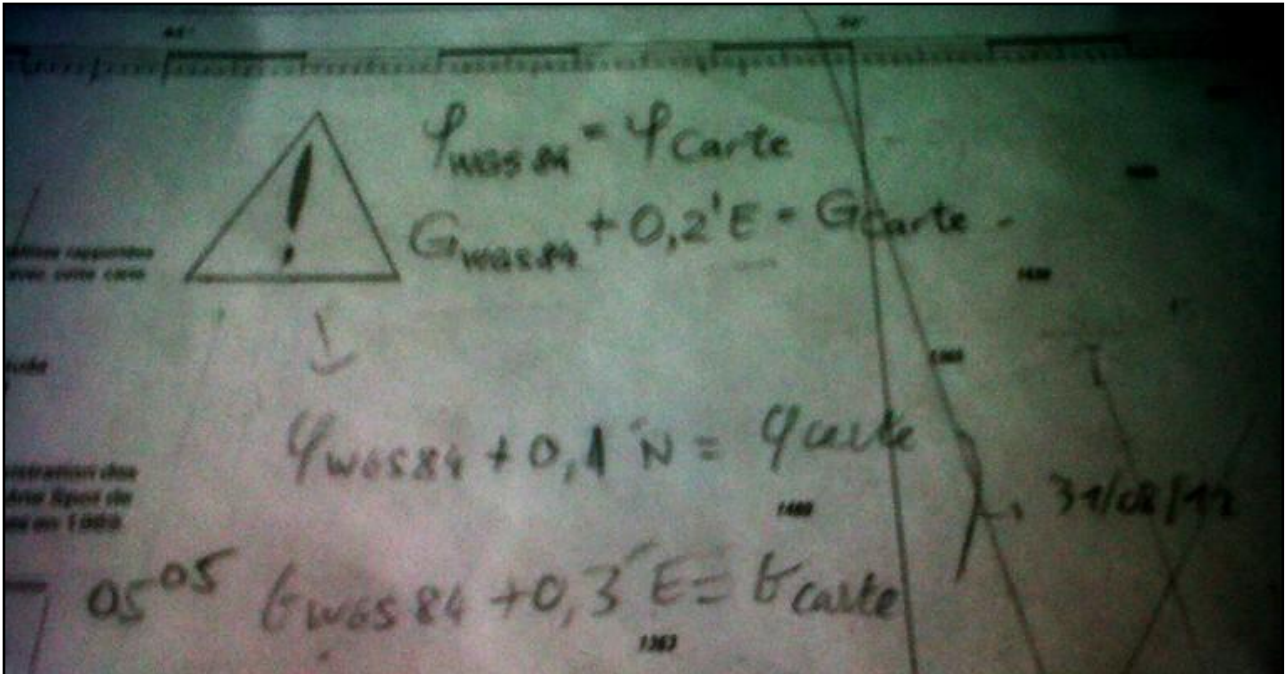
Corrections « done aboard » written on the paper chart SHOM 6497. The second one corresponds to an observation done by the crew before the exact values had been received from the SHOM.

However it had not been taken into account for the use of the ECS (see § 6.2.2.1).

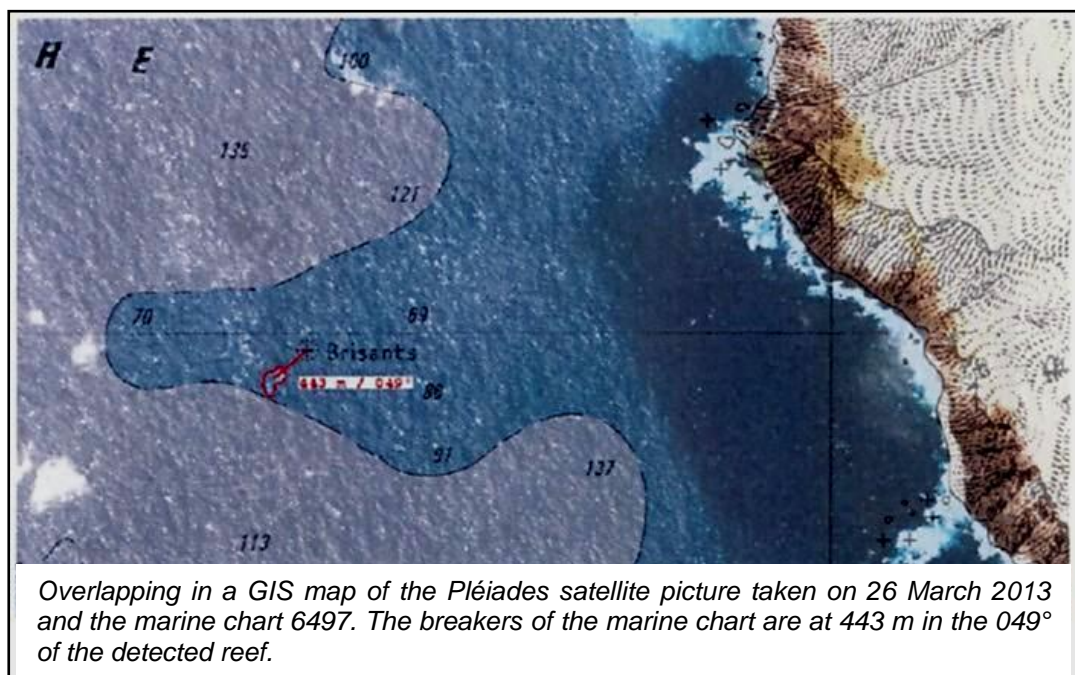
Following this maritime casualty, the SHOM, concerned by the safety of navigation in the areas where the bottom is not fully charted, has ordered satellite pictures of this coast of Île de La Possession. The processing of these pictures had been complex, because the area is frequently cloudy and the submerged rocks are difficult to identify. The picture above, got on 26 March 2013, overlapped with the marine chart 6497, proves that the breakers are located on the marine chart at 443 m in the 049° of the detected reef (this picture had been provided to BEAMer by the SHOM).

MARION DUFRESNE could not, in November 2012, be informed of the true position of these breakers. They have been re located in the vicinity of the broken 100 metres line of soundings, just on its inshore side.

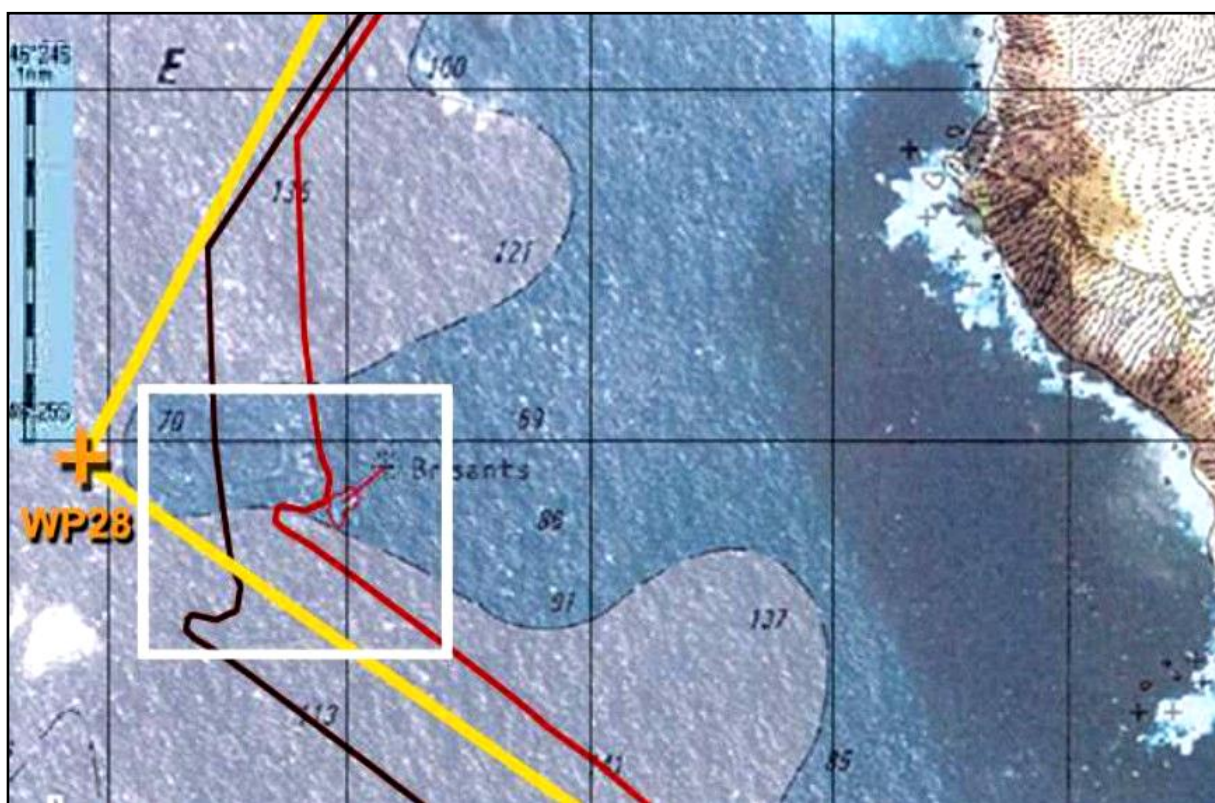
This picture is the result of the overlapping of chart 6497 processed by the SHOM (cf. § 6.2.3), data from satellite imagery which shows the real position of the shoal and the chart used by the ECS.

the red track represents the actual course on the ground reconstructed by BEAmer given the real position of the collided reef, the grounding sequence of events and the damages observed on the hull of the vessel (port bow).

The error between point **B** (« Brisants » (breakers) indicated on chart 6497 before change 13.19.158) and point **A₃** is the result of the repositioning of the reef done by the SHOM which put the hazard closer to the 100m line of soundings.

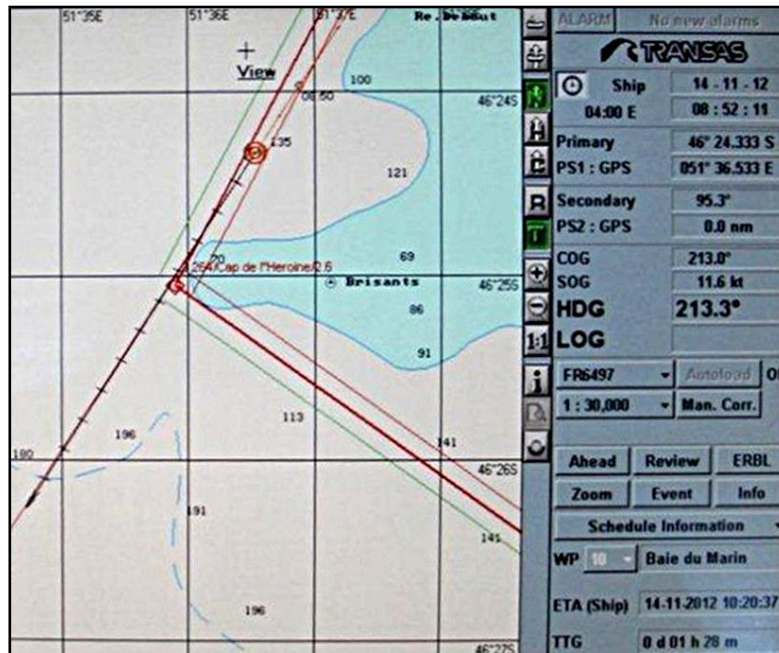
Although GPS fixes positioned *MARION DUFRESNE* on the inshore side of the laid off track, the OOW anticipated the course altering by cutting the corner between the current heading 213° and the next 125°.

It appears that at this time, the OOW was confident in the position displayed on the ECS to the detriment of the positions that he laid off himself on the chart from radar bearings and distances.

This ECS picture had been recorded at 8.52 am, a moment before the vessel altered course to 180°. The heading was then 213°.

The reference displayed on the device is chart 6497, but the line of soundings appears as a continuous line.

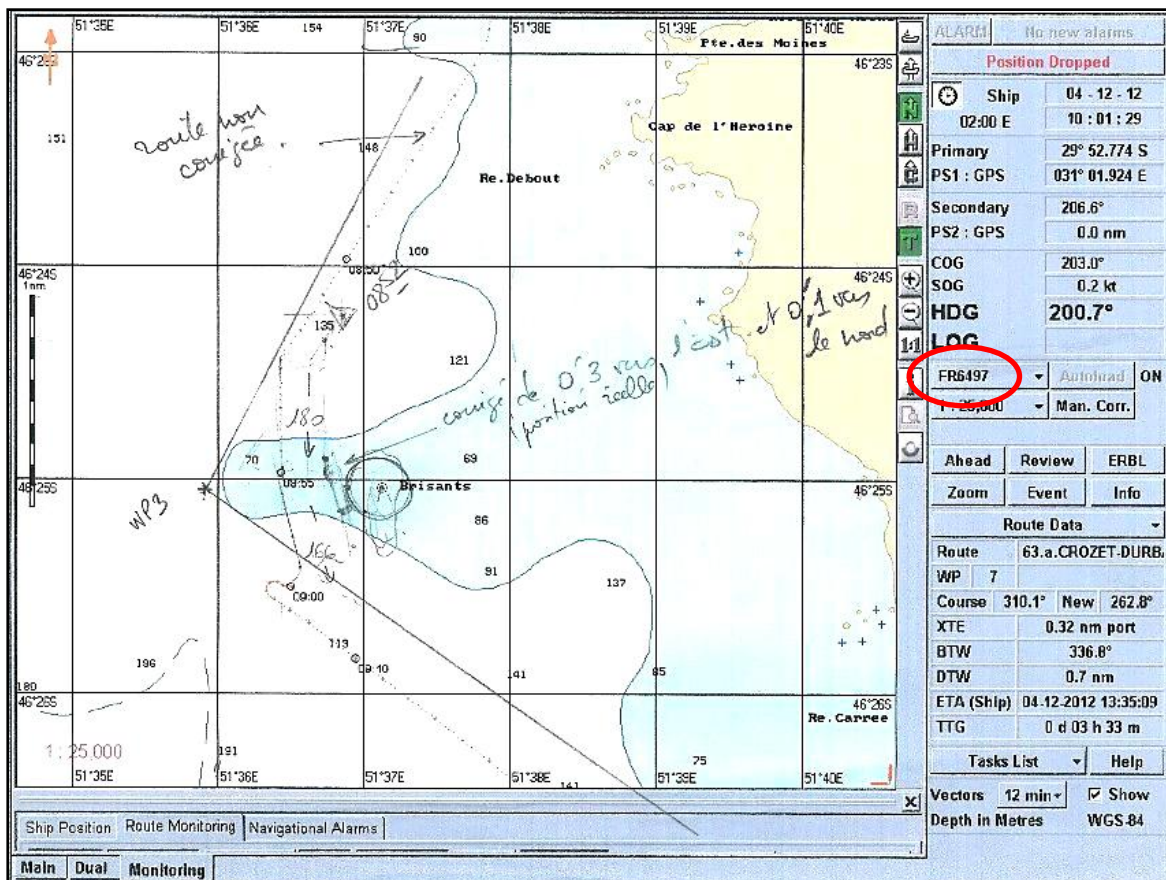
This picture of the display had been taken a few days after touching the ground while the vessel was approaching Durban for repairs.

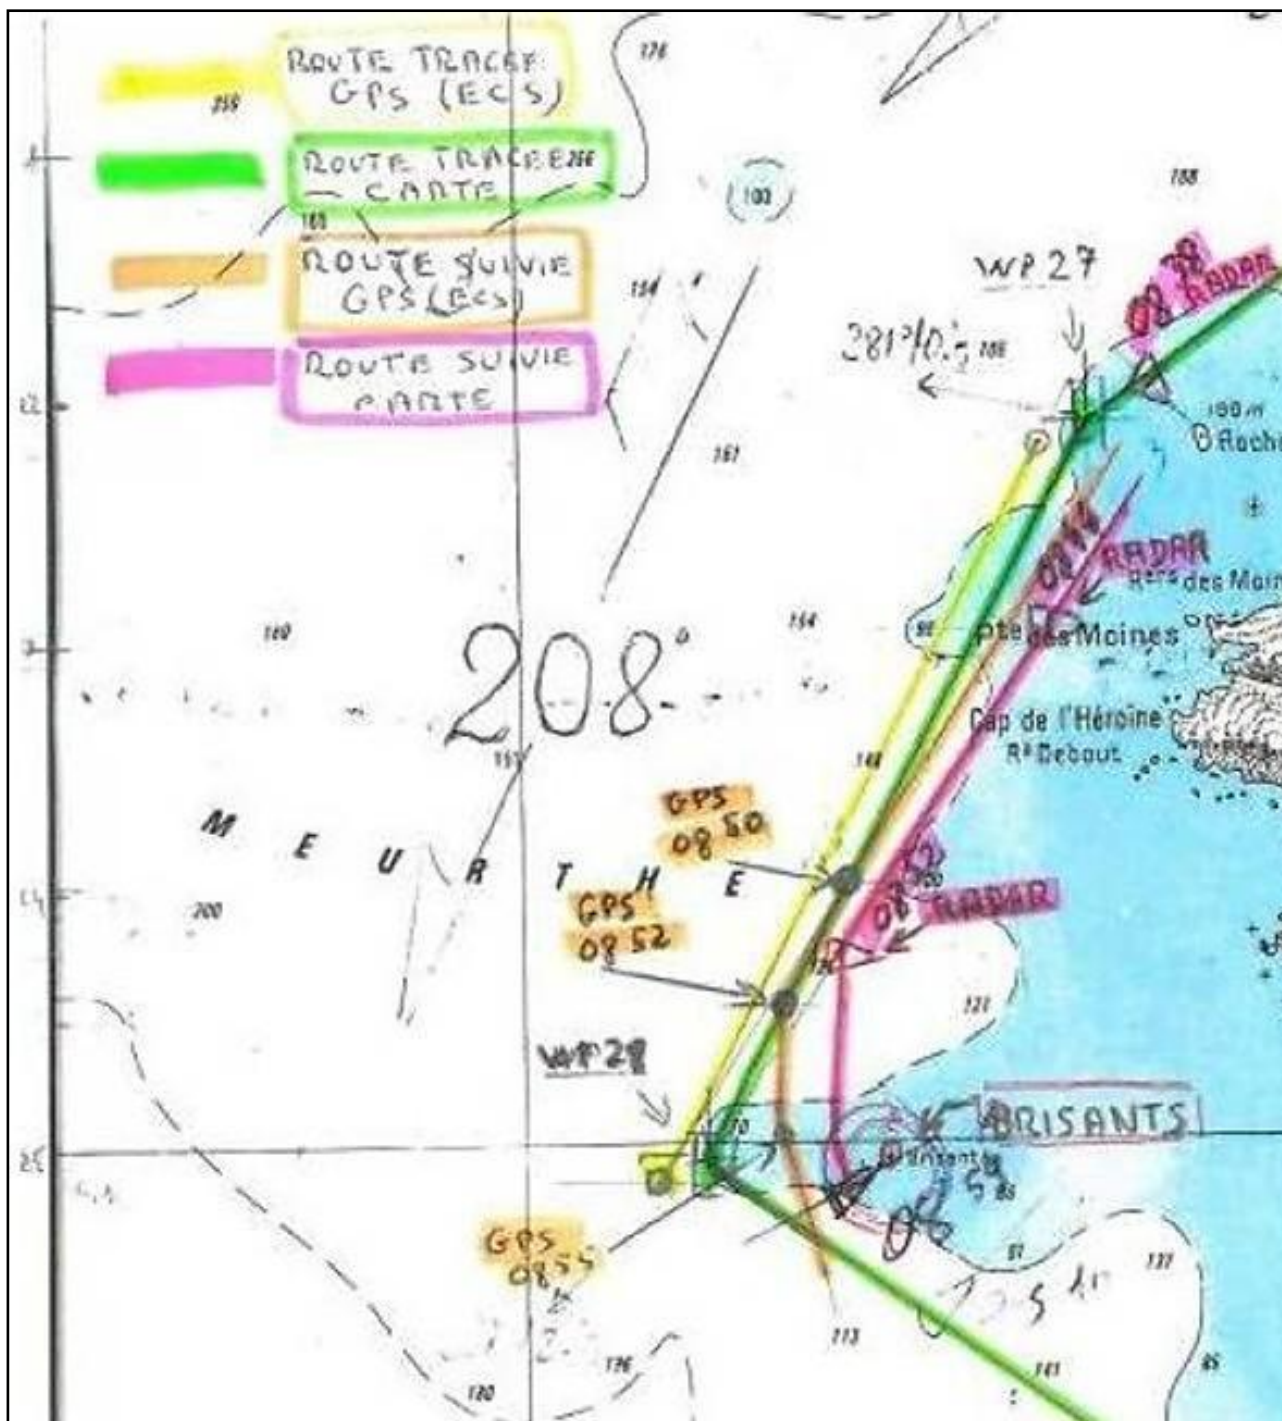
Reconstruction of the courses on paper chart 6497

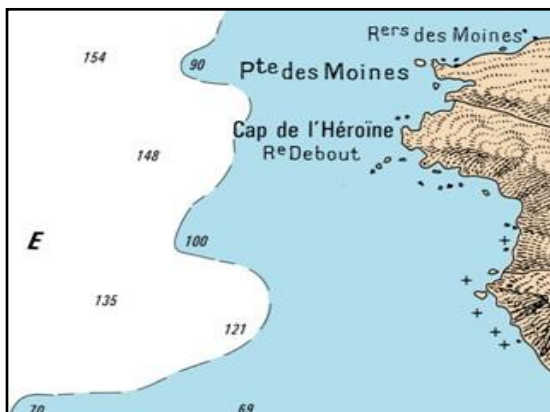
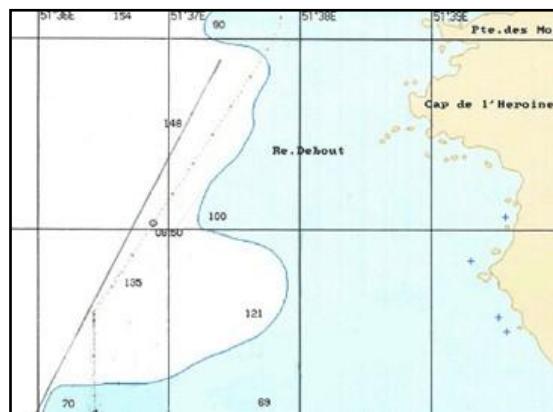
On chart SHOM 6497, the 100 m line of soundings which is located in the west of *cap de l'Héroïne* is a broken line. This means that the position of this isobath is unaccurate. It is observed on the ECS display that, although the reference mentionned is chart SHOM 6497, this 100 m line is a continuous line (see appendix page 48).

The chart used by the ECS is therefore slightly different from the reference chart as at least one information is found lost.

Here below, on the left, an extract of SHOM chart and on the right an extract of the chart used by the ECS TRANSAS system.
