Marine safety investigation report

***FOUNDERING OF THE TRAWLER PANAMERA, ON 3 NOVEMBER 2013
IN THE SOUTH-EAST OF LIZARD POINT (WESTERN CHANNEL)***

FOUNDERING OF THE TRAWLER

**ON 3 NOVEMBER 2013 AT 25 MILES
IN THE SOUTH-EAST OF LIZARD POINT
(WESTERN CHANNEL)**

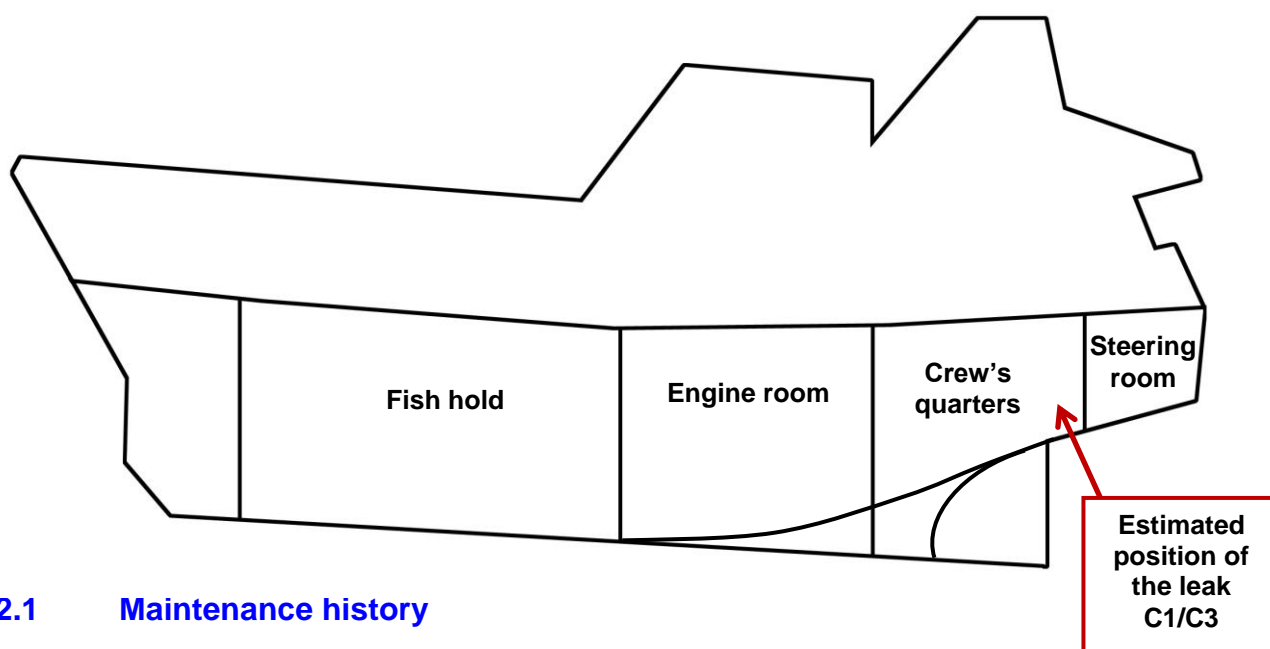
4.2.0 Location of the leak aboard *PANAMERA*

On 3 November 2013 around 4.14 am, the fishing vessel *PANAMERA*, on her way back to her home port Saint-Quay-Portrieux in poor weather, foundered off the south-eastern coast of Cornwall (UK) (in the bearing 144° at 25 miles from Lizard Point), further to the flooding of the crew's quarters subsequent to a leak initially located at frame C1/C3.

The crack was not located beneath the berth, but in the space (escape hatchway) located between the watertight bulkhead of the steering room, the crew's quarters and the wooden bulkhead at the end of the starboard berth (cf. the drawing thereafter).

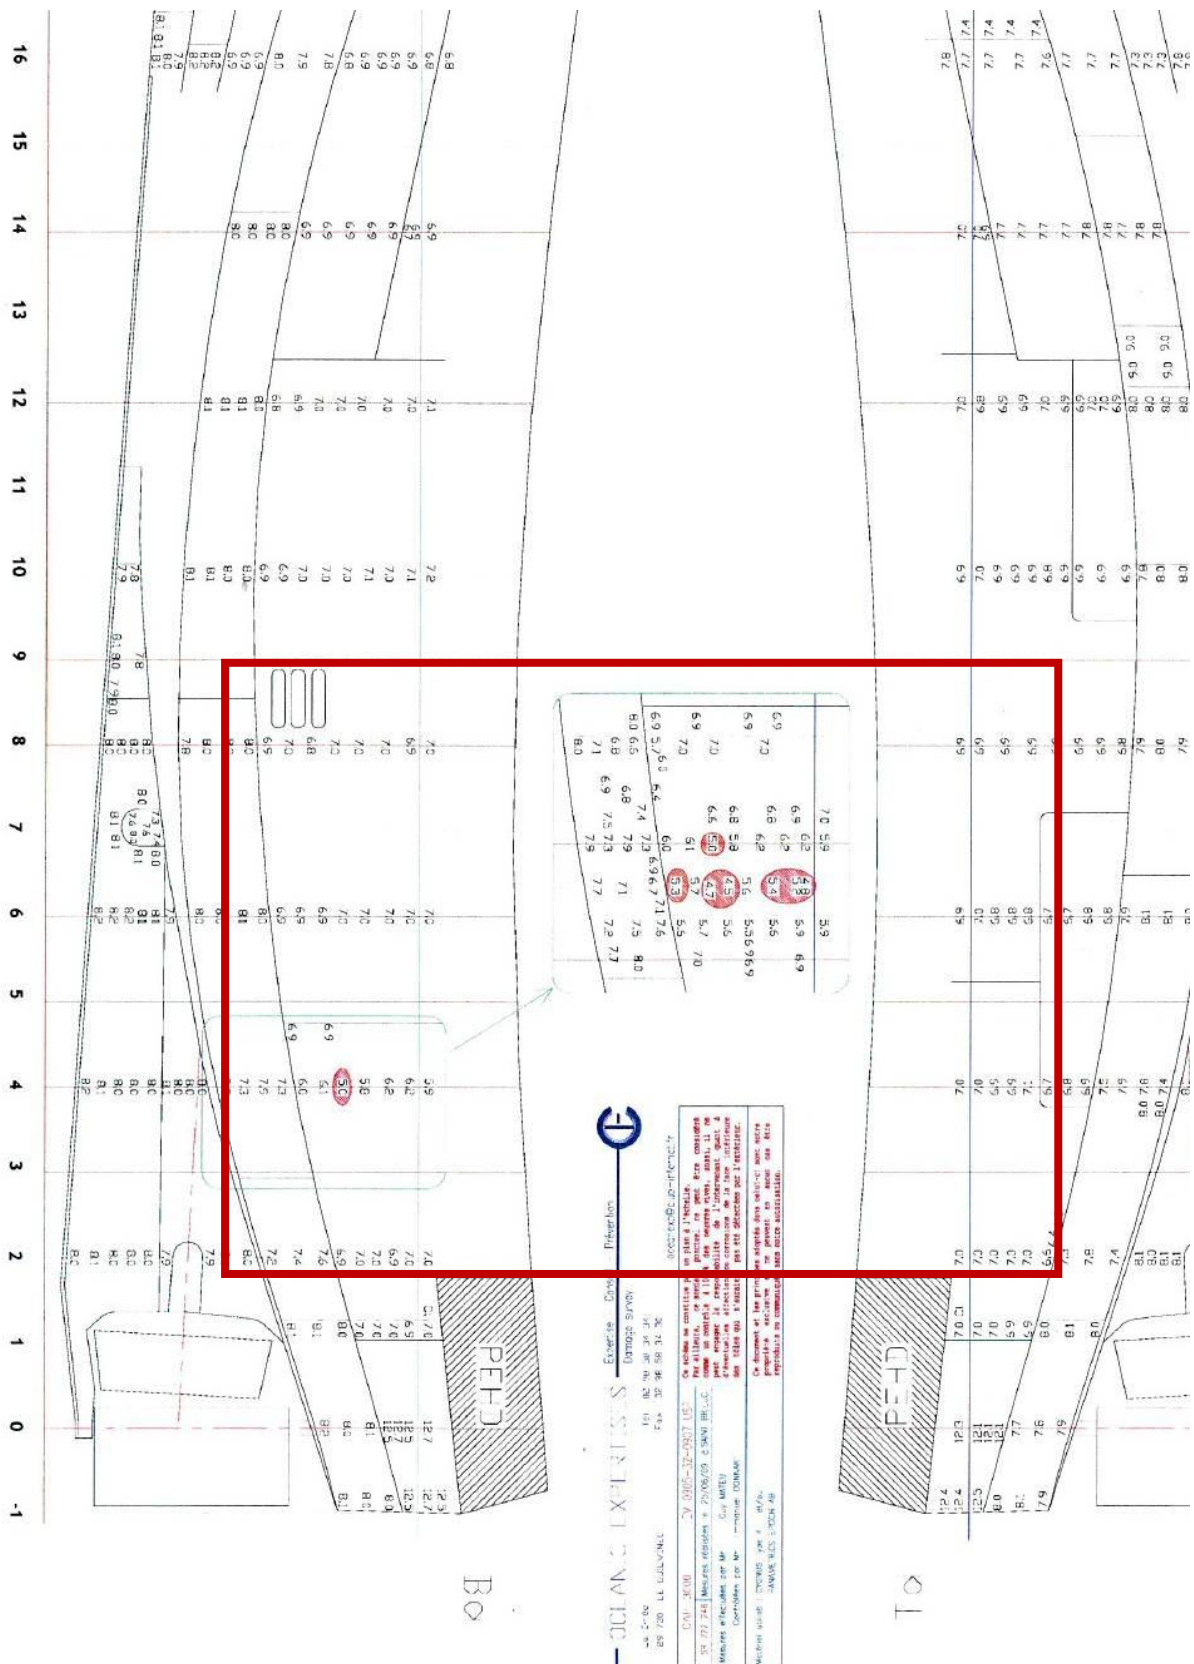
An alert had been raised after the thickness test of the plating in June 2009: an around 50 % thickness loss on the port and starboard plating in the area C3/C5, had been observed. If the replacement of the critical areas had been actually carried out, there does not appear to be any research on the causes of this anomaly.

***Zoom on the area marked out on page 28,
displaying abnormal values of the hull thickness***

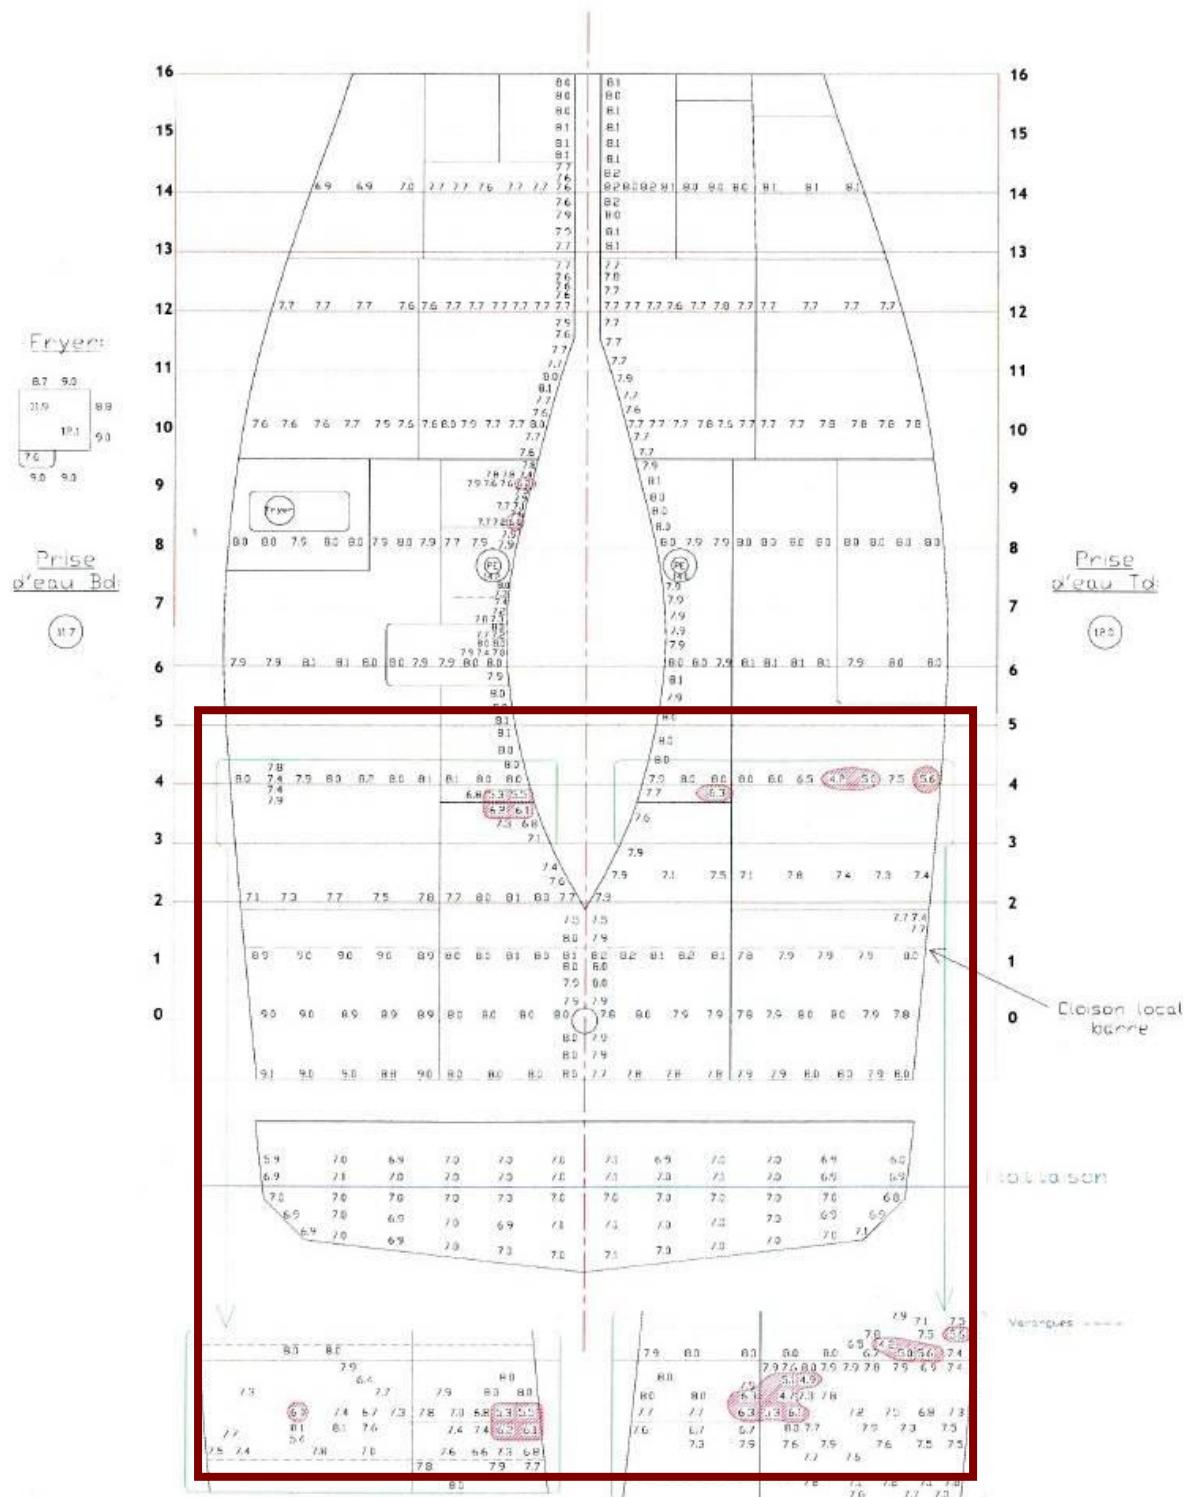
***Zoom on the area marked out on page 30,
displaying abnormal values of the hull thickness***
