# MARITIME SAFETY INVESTIGATION REPORT

MV WORLD VOYAGER  
IMO 9871529

**VERY SERIOUS MARITIME CASUALTY**  
**31/05/2025**  
**Occupational accident inside engine room**  
**With loss of one life**

**Final report homologated – 01/09/2025**

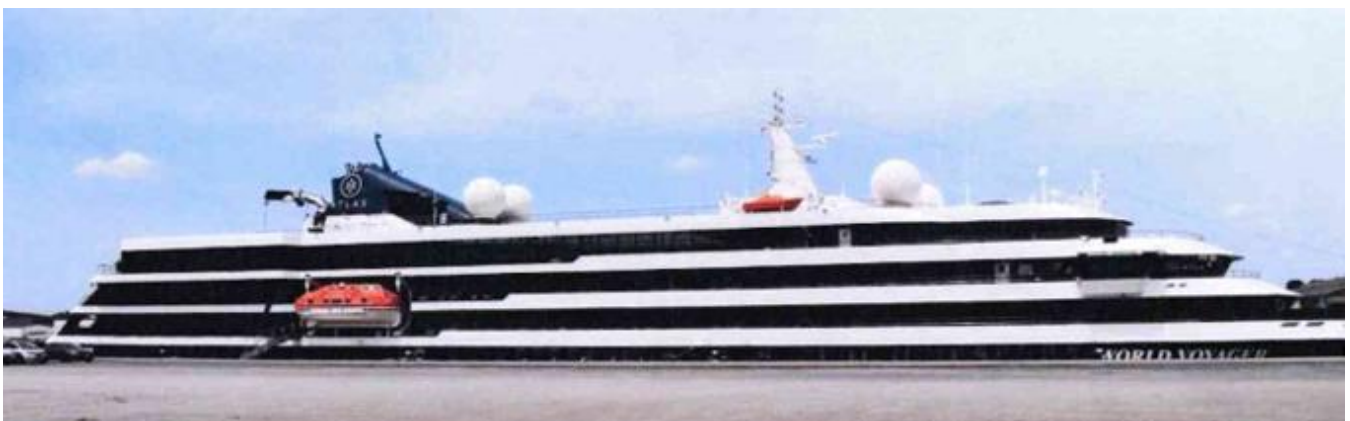
inspection and cleaning of the injector, the indicator cock was covered by the engine cadet using a metal bucket to avoid oil spillage around the engine room. When the engine was blown, the pressure released launched the metal bucket onto the cadet's head at a high speed. The cadet fell from the top of the engine where he was seated and was immediately assisted by the engine room team. Code Mike sounded on the public announcement system (PA) and medical assistance was called, onboard medic and medical shore team. The shore medical team pronounced the cadet deceased on arrival on board. Figure 2 below, shows the position of motor vessel WORLD VOYAGER (WV) made fast and starboard side alongside at Nantes and on the top left the interior of the engine room – view from the starboard side engine where the maintenance was performed (figure 1).

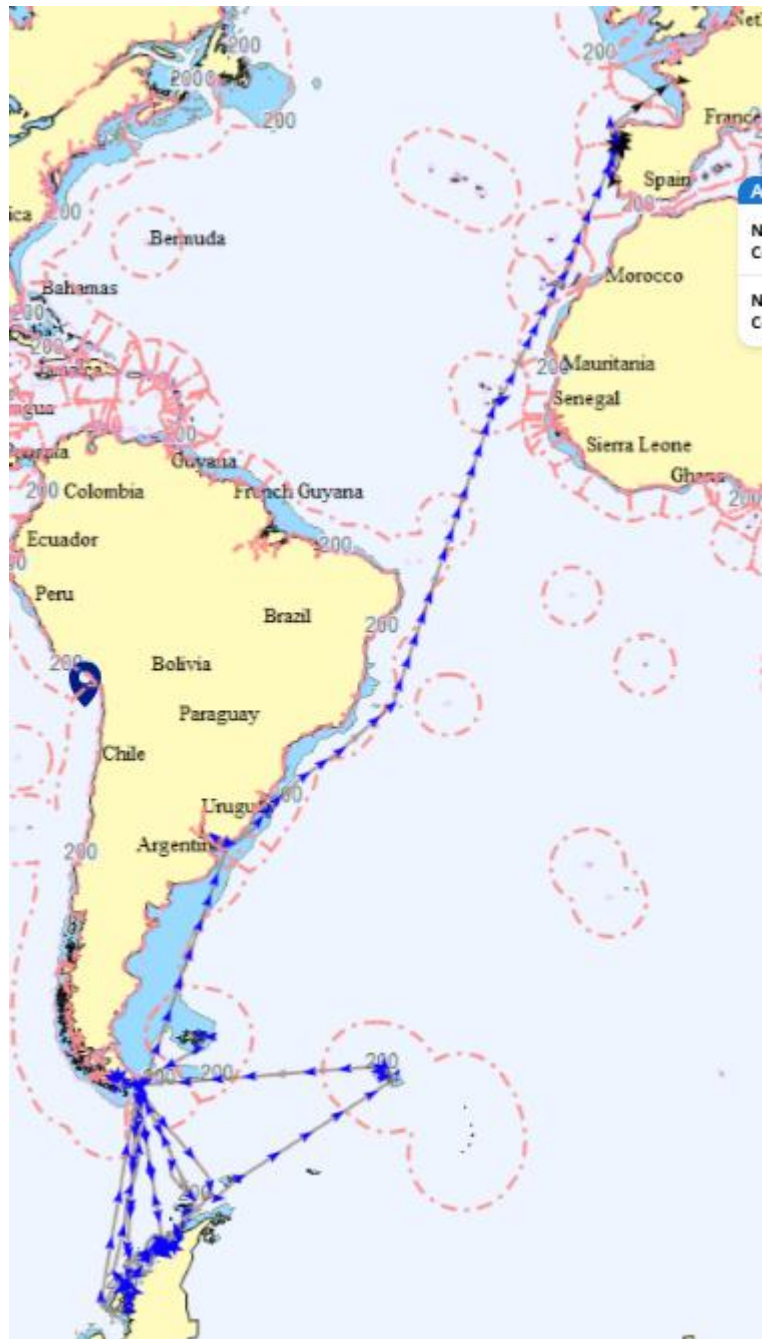
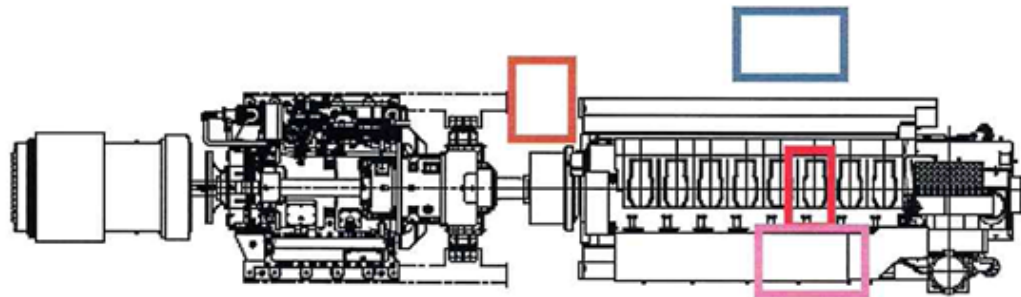
**Picture 2 – Location of the accident.**

The cadet, acting on informal instruction, held the bucket manually over the injector opening. When compressed air was applied, the bucket was expelled upward at high speed and struck the cadet. He collapsed and was pronounced dead after failed resuscitation. The figure below indicates the location of the casualty.

Injector number 3 - *Marked in red.*

Engine cadet position – *marked in purple.* Sitting on top of the engine exhaust.

Motorman position – *marked in blue.* On the lower platform.

First engineer position – *marked in brown.*

- No object should be left unsecured near open injector holes during turning with air.
- Compressed air operations require strict controls and clear zone establishment.
- Cadets must be treated according to their formal training stage, not their apparent familiarity.
- Informal practices must be challenged and replaced with standardised methods.
- Every maintenance step must be risk-assessed, particularly involving stored energy (compressed air).

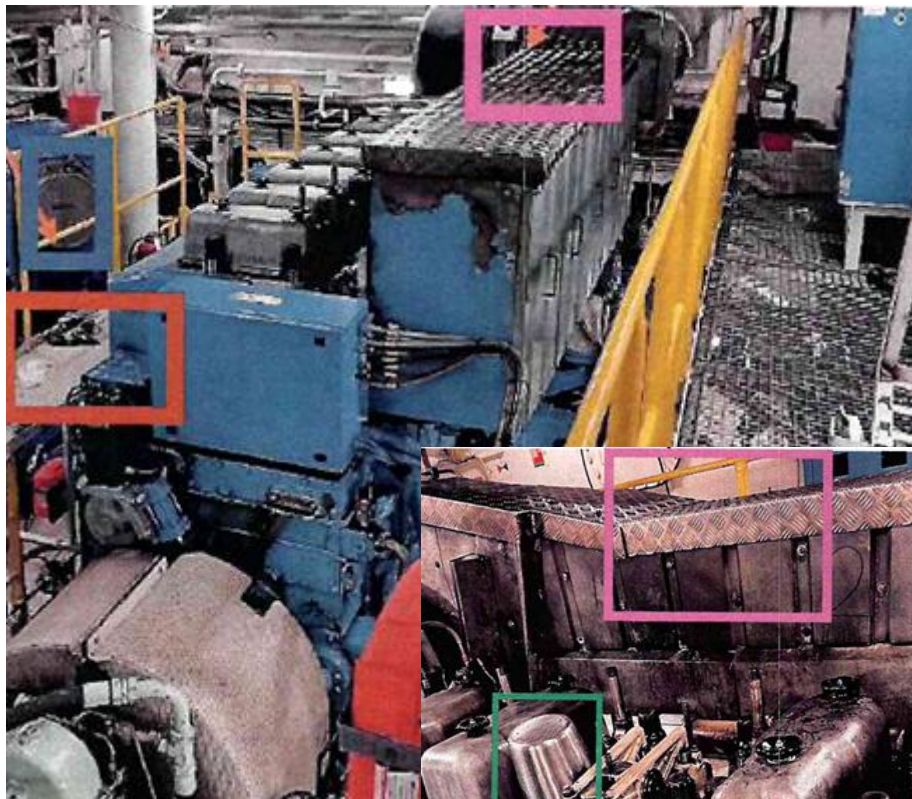
The engine cadet was sitting on top of the engine exhaust, holding the metal bucket with both hands, between his legs. In the engine room there was also the chief engineer, working in his office, the 1<sup>st</sup> engineer, who at 1120 hours started the engine, the 2<sup>nd</sup> engineer who called the bridge from engine control room (ECR) at 1121, requesting medical assistance and the motorman, in the position indicated in the above and below figures.
