# **Annual report 2015**

Bureau d'enquêtes sur les événements de mer

# Annual Report 2015

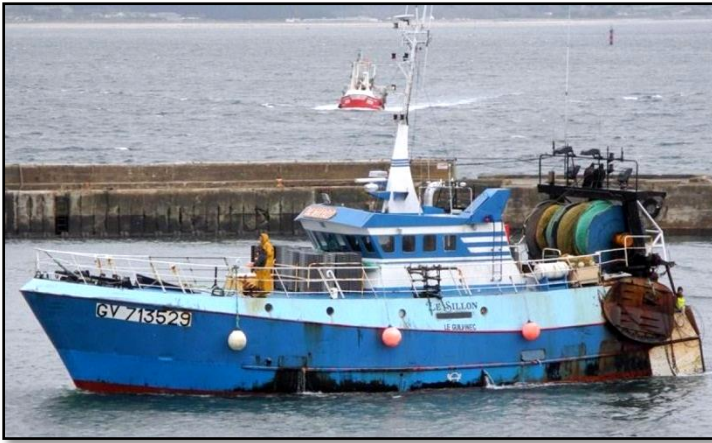
**Loss of control and stranding of the trawler *LE SILLON*, on 2 February 2014 on Totty Cove rocks (Cornwall, UK).**

On 1st February 2014 around 4.30 pm, off the north-west coast of Cornwall (UK), the trawler *LE SILLON* was heaving to in very poor weather conditions. She faced a succession of exceptional waves, one of which broke several windows and devastated the bridge. The water flooded inside the vessel through a left open hatch. Short-circuits occurred on the bridge. As heavy vibrations were experienced, the skipper shut the engine down. It had been impossible to restart it.

The investigation shows the harmful effect of shutting down the engine in very severe sea state conditions.

**1 - 2015-R-001:** To make the regulation evolve concerning the location or the protection of the portable VHF's battery charger on the bridge of fishing vessels so that it remains reachable in case of major damage on the bridge.

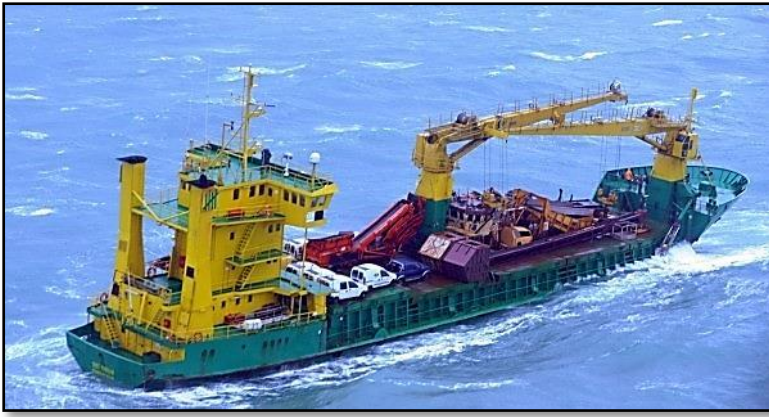
**Blackout followed by a loss of propulsion on board the cargo vessel *JUST MARIAM* on 10 February 2014 off *Belle-Île* (France).**

The investigation concludes that the cause was a failure of the automatic electric power management system and points out the delay to inform the MRCC.

- the electric power management system which should be made more reliable or supplemented (possibility to be started and coupled independently from PMS for one of the generators, or shaft generator driven by the main engine for example) in order to comply with the requirements of the ISM code article 10.3;
- the necessary measures to enhance the crew familiarization of vessel equipment knowledge ("understudy", keeping an engineer officer on the crew list despite the UMS certification) in order to comply with the requirements of the ISM code article 6.3.

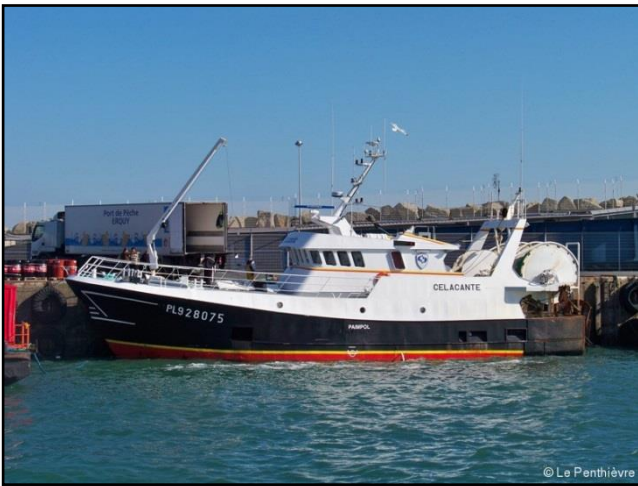
**Stranding of the trawler *CÉLACANTE*, on 22 May 2014 in the vicinity of *Les Pierres Noires* lighthouse in the framework of an assistance operation to the sailing boat *NÉNETTE*.**

When she arrived in the vicinity of *Les Pierres Noires*, the heaving line of the tow-line, made fast aboard *NÉNETTE*, broke at a dozen of meters from the sailing boat. The skipper of the sailing boat started then the engine in order to prevent from drifting. The engine stalled, as the propeller was fouled by the tow-line. *NÉNETTE* was drifting rapidly towards the reefs because of her sail still partly hoisted. The crew of the sailing boat did not try to cast anchor. The crew of the trawler recovered the broken tow-line and succeeded in passing another one. After several attempts, the sailboat's hand managed to make it fast on a cleat. As she got too close from *Les Pierres Noires* rocks, the trawler stranded around 11.30 pm.

**1 - 2015-R-009:** to study a regulatory amendment designed to fit the 12 to 24 meter long fishing vessels with a mooring line ready to be used (cf. Division 226).

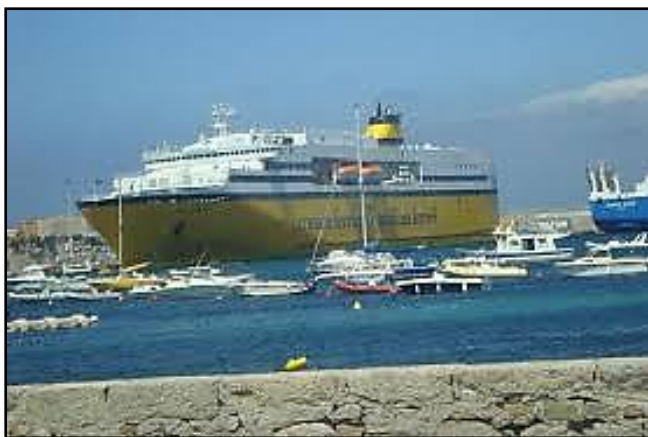
## Grounding of the passenger ferry *MEGA EXPRESS FIVE* on 31 May 2014 on departure from the port of *L'Île-Rousse* (Corsica)

Upon arrival, the divers intervened, observed the damages and made a temporary repair. The classification society required repairs before resuming the commercial activity. During the night the vessel sailed bound to the Italian port of *La Spezia*.

The investigation found a lack of vigilance in the handling of the vessel in the vicinity of a danger, outside the port.

**1 - 2015-R-008 :** to set up, in its Quality Management System, a procedure aiming at the fact that the ship leaves the compulsory pilotage area of the port *L'Île-Rousse* by having cleared any danger.

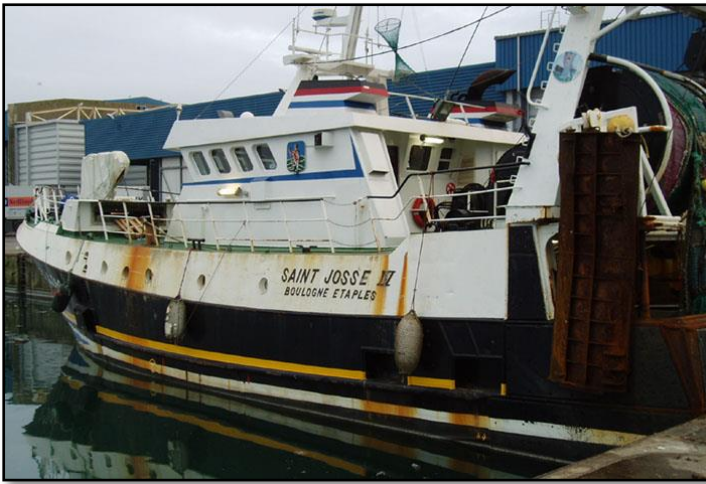
**Maritime work accident on board the trawler *SAINT JOSSE IV*, on 7 November 2014 at *Boulogne-sur-mer* (one fatality).**

On 7 November 2014, the skipper of the trawler *SAINT JOSSE IV* was fatally injured while he was conducting a trial of the rope guide of the port warp reel, after a cut-out sensor had been replaced. At the time of the trial, the chief engineer was on the bridge to actuate the control of the guide on gear trolley. The accident occurred alongside at *Boulogne-sur-Mer*, without any eyewitness.

**1 - 2015-R-007:** to add to the risk assessment plan (*document unique d'évaluation des risques professionnels - DUP*) risks induced by high power gear moving in a limited space and the subsequent precaution to be taken.

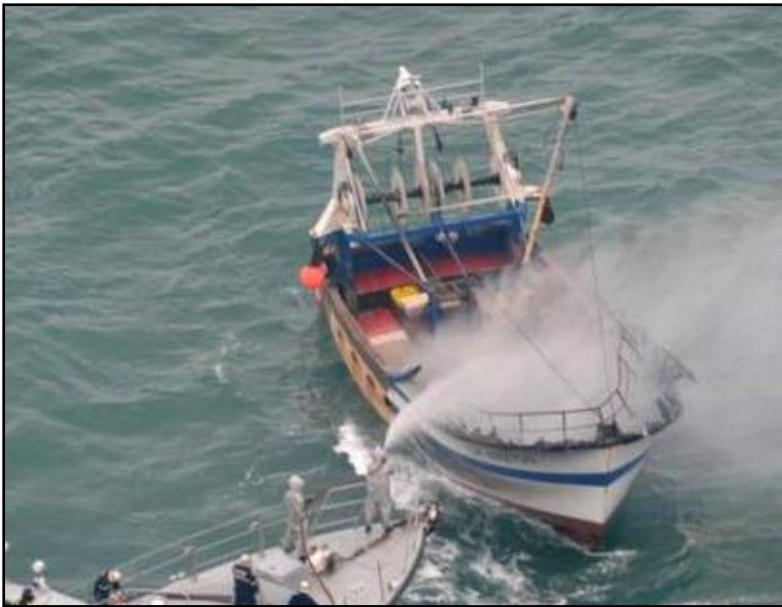
## Fire and subsequent foundering of the dredger *LUCKY*, on 6 January 2015 off *Ouistreham*.

On 6 January 2015, in the late morning, the dredger *LUCKY* was on her fishing route off *Courseulles-sur-Mer* at a speed of about 3 knots, for a scallop fishing haul. The skipper was on his own in the wheelhouse when an unusual noise, coming from the engine room, arose without any warnings or alarm. When the skipper opened the engine room hatch cover, for a rapid investigation, he was surprised by an already severe fire which burnt his face.

Despite the intervention of the marine fire-fighters winched down in the area on board *PSP CORMORAN*, *LUCKY* broke up and foundered in 21 meters of water in the late afternoon. The wreck has been removed on 10 March 2015. The date on which the skipper resumed his activity on board a new vessel is unknown.

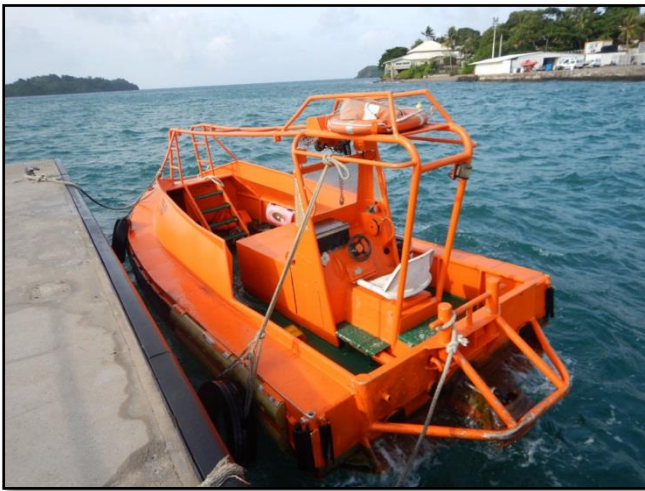
**Maritime accident at work occurred on 16 January 2015 on board the service ship *POUDJOU*, during a mooring manoeuvre at a buoy of a tanker on roads at Mayotte (one fatality).**

While *POUDJOU* was approaching to get the two lines hanging off, with severe weather conditions, the wind and a sudden « water movement » pressed her against the aft hull of the tanker, causing the launch to list heavily and four out of five boatmen, all equipped with a PFD, to fall overboard.

**4 - 2015-R-013**: To supplement the document on ships accommodation and on safety at the *Longoni* oil and gas terminal with the rules to be planned for the site of *Les Badamiers* including the weather conditions for mooring at a buoy. It should be included into Mayotte harbour specific police regulations.

**5 - 2015-R-014**: The towing and mooring company Boluda Mayotte should seek approval from *Conseil général de Mayotte* (local administration), port authority, for its operations. For this purpose Mayotte Channel Gateway Company, as the public service concession holder which has subcontracted this activity to Boluda Mayotte, should call upon the port council to be convened and request the inclusion of this application for approval to the agenda of the meeting.

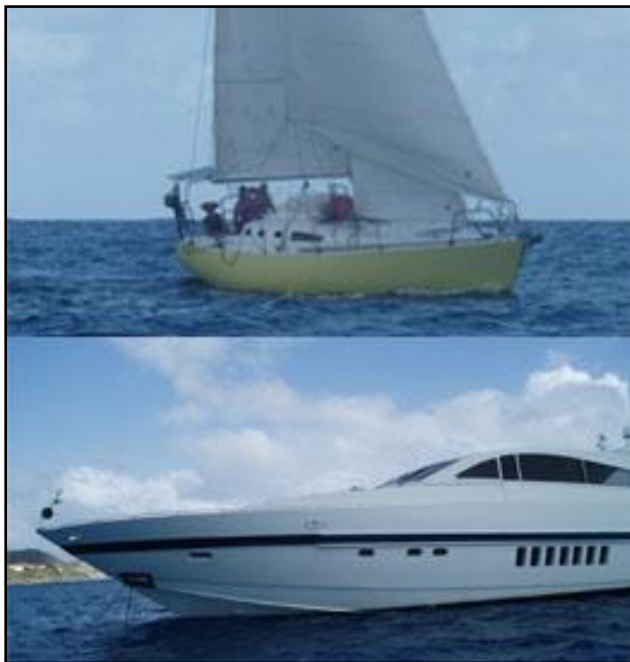
**Collision between the motor yacht *WHAT ELSE* and the cutter *PASTAGA* at 1 mile in the north-west of *Pointe à Colombier* (*Saint-Barthélemy* Island) on 25 May 2015 (1 casualty, 2 severely injured).**

On 25 May 2015 in fair weather conditions (east south-easterly wind force 3 to 4, moderate sea state with swell) the motor yacht *WHAT ELSE* sailed from *Baie de Saint-Jean* anchorage (*Saint-Barthélemy* Island) with two crewmembers and nine American passengers, for a short crossing to *Saint-Martin* Island where they were expected on board a private aircraft. After she rounded *Pointe à Colombier*, the speed was set to 18 knots and, as the master assessed that the sailing area was clear on the bow, the autopilot was set on, heading 290°.
