**MINISTRY FOR INFRASTRUCTURES AND TRANSPORTS**

## **M/V GRANDE AMERICA**

**Fire on board and subsequent sinking off Cape Finisterre**

**Final Report**

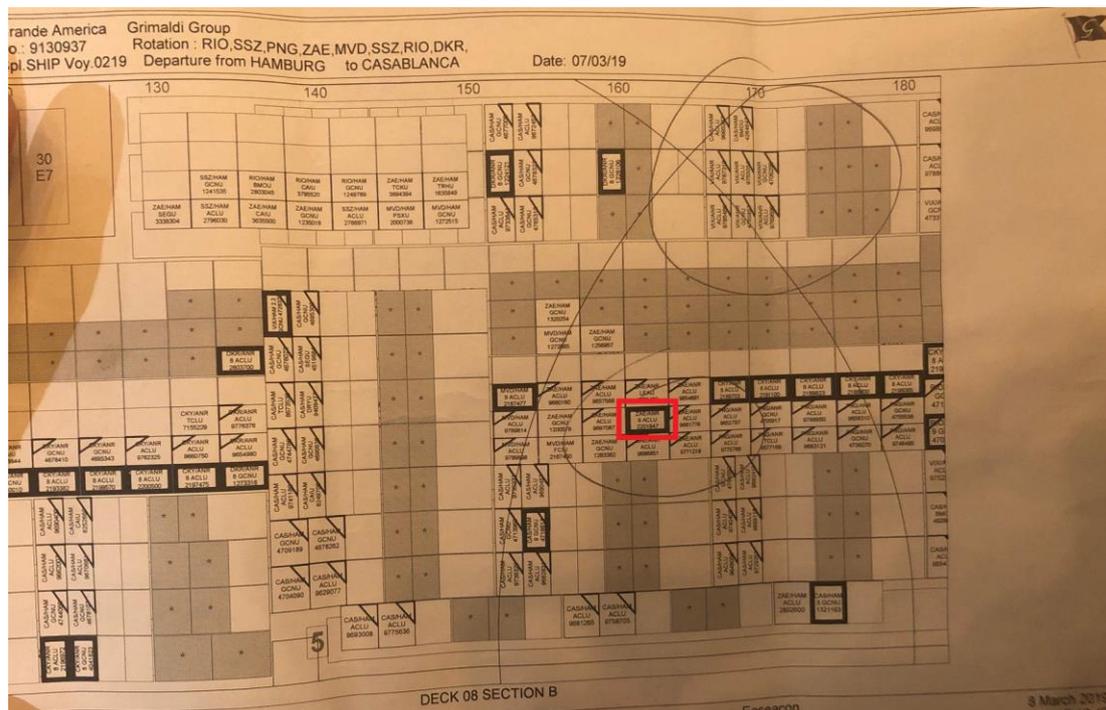
However, at around 5.30 pm the 2<sup>nd</sup> Deck Officer informed the Captain of the presence of white smoke between the containers positioned on the "weather deck" and the presence of

flames between two containers located on the second tier, one of which identified contained dangerous goods classified IMO9.

Picture 2: Excerpt of the cargo plan (Weather deck) showing the container with IMO9

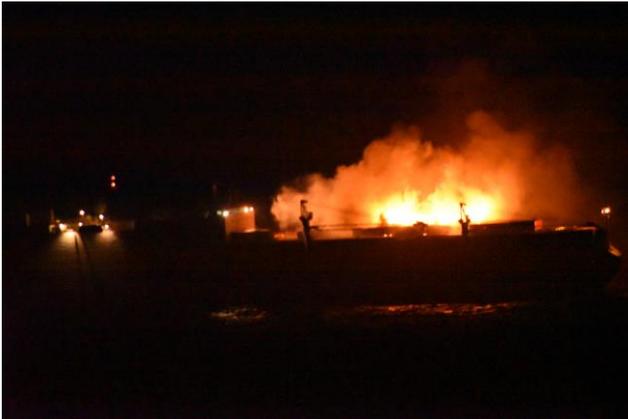
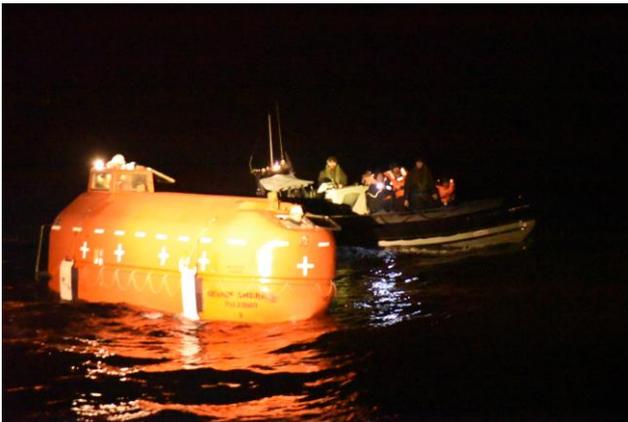
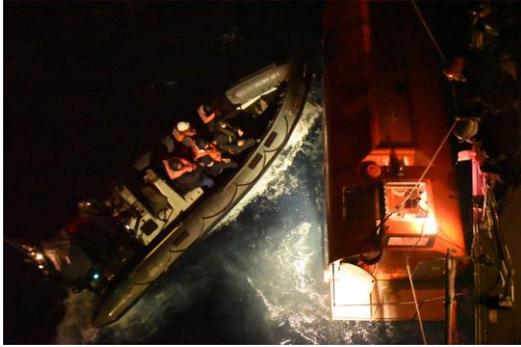
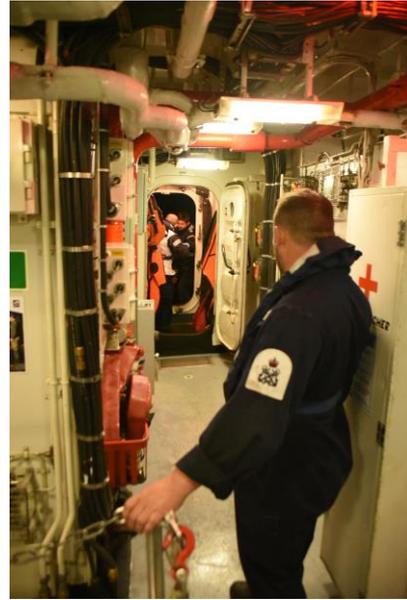
Picture 4: phases of the crew rescue ops (courtesy HMS Argyll/MAIB)

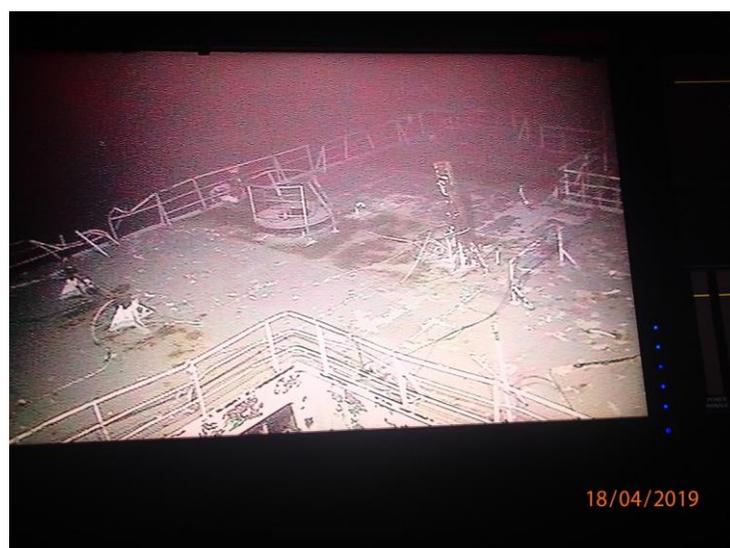
The activity carried out by the ROV, among other things, ascertained the absence of the VDR capsule from the wreck.

Picture 4: M/V GRANDE AMERICA ROV picture taken on 18/04/2019 (no VDR capsule on Deck 9)

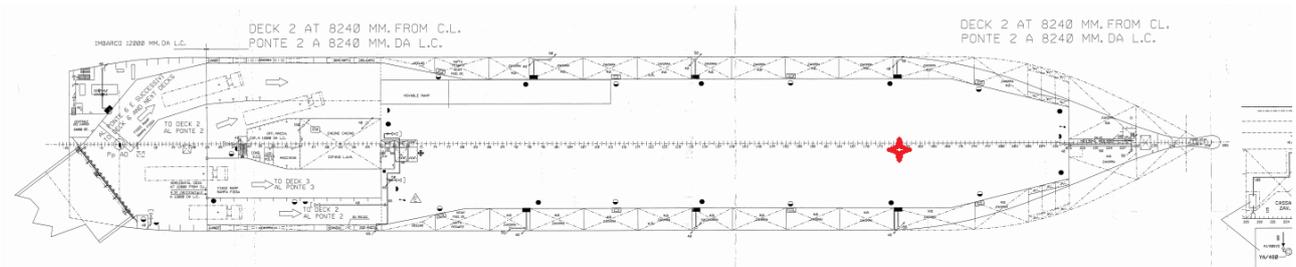
According the declarations released by the crew there were two fires within a short time distance (around one hour and half). Having analysed also the ventilation system of the ship, it does not appear to be a clear correlation between the two fires.

Picture 5: Excerpt Ship plan, Deck 2

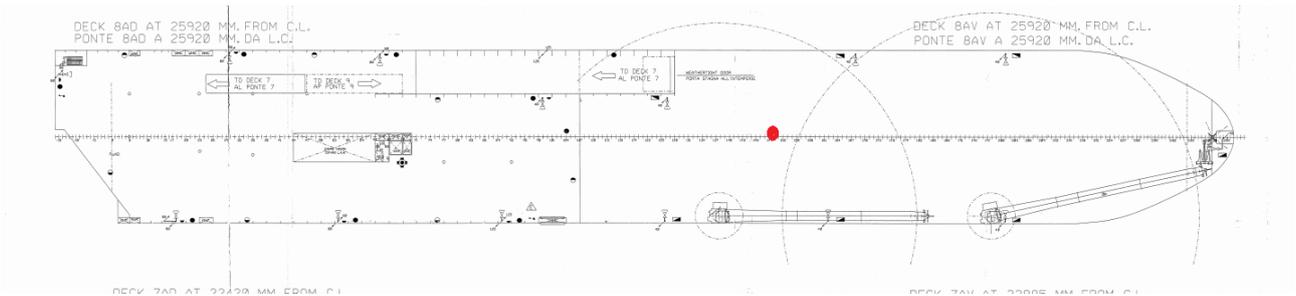
Picture 5: Excerpt of ship plan, deck 8

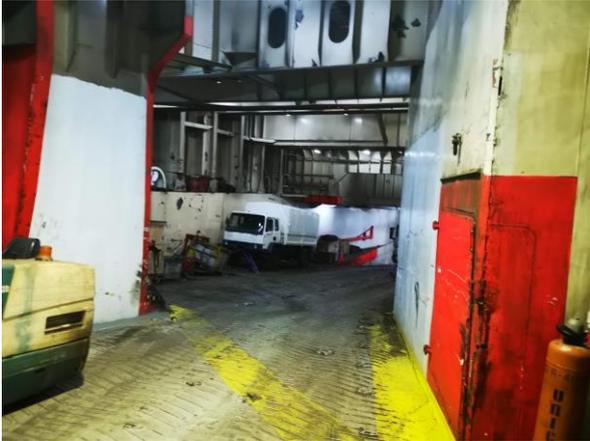
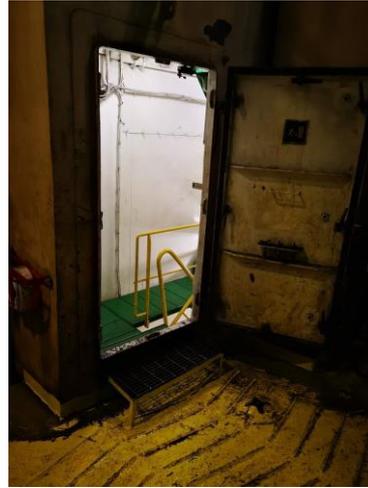
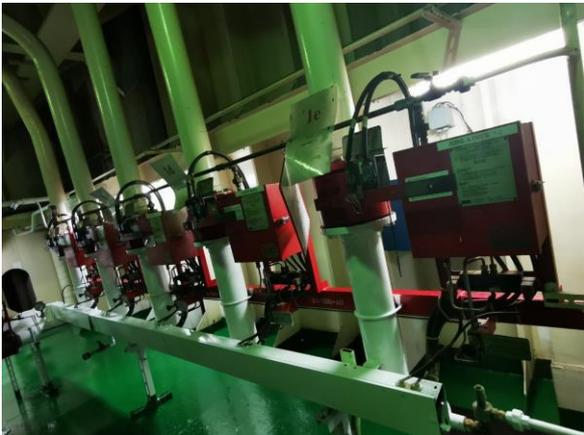
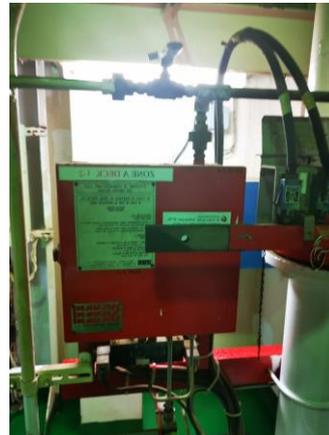
Picture 7: deck 2 and CO2 room (controls for CO2 release) pictures

The inspection of deck 2 (Garage 2) made it possible to ascertain the actual arrangement of the places and in particular excluded that in the event of CO2 opening, this could in some way affect the Engine Room, affecting the operation of the on-board generators, since the latter was completely separated and closed by an entrance fire door located in garage 2.

As regards the CO2 room, it was possible to verify that the CO2 release command station for deck 1 and 2 is located in the immediate vicinity of the one dedicated to the Engine room, therefore this suggests that the blackout was caused from the incorrect activation in the initial phase of the planned command station.

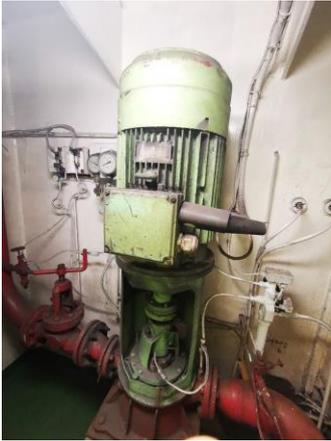
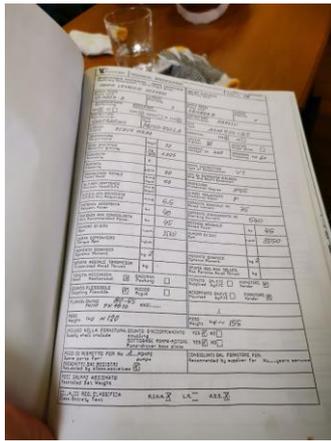
Picture 8: Emergency fire pump

Furthermore, the arrangement of the EFP and its characteristics were examined (capacity 90 m3 per hour)

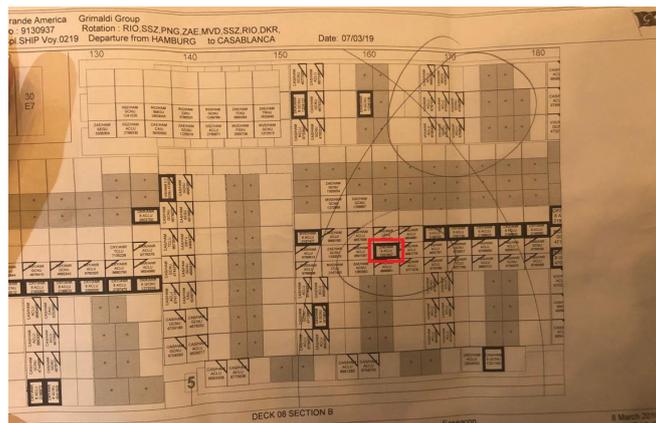
The cargo of containers on deck had been loaded entirely in Hamburg, in particular the container from which, according to the declarations made by the ship's Command and from the communications received by the Company, would have been located on the second draft as more precisely identified in the image below

Picture 9a: Container alleged to be the possible the source of fire

This substance, classified IMO 9 according to IMDG code, as per the safety data sheet and CLH report <sup>1</sup>, is not explosive and has a low degree of flammability, therefore it is difficult to state that the point of origin of the fire may have been exactly that container but rather another container placed nearby containing products with higher flammability characteristics.
