BUGALED BREIZH

Bureau d'enquêtes sur les événements de mer

Technical report
on the investigation
of the

Capsize and foundering
of the trawler
BUGALED BREIZH
on 15th January
South of Lizard Point
(with the loss of 5 lives)

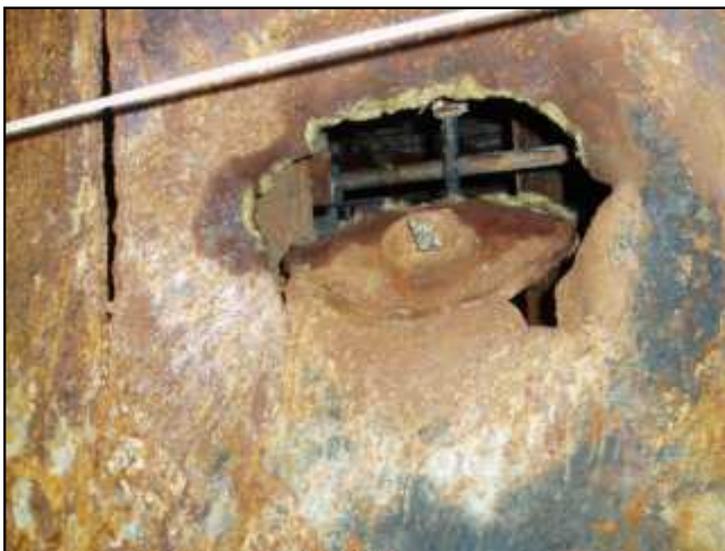
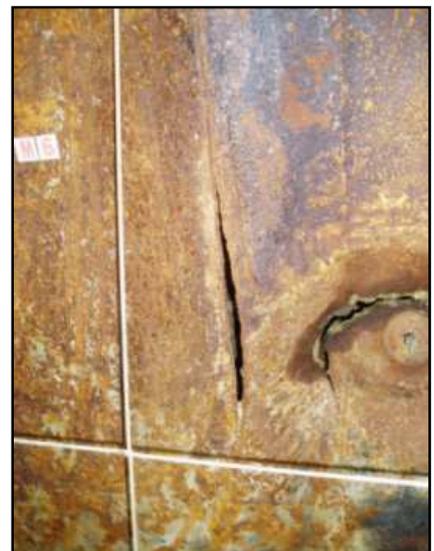
6.2.1 Damage to the port side of the engine room (see appendix E.1 and photographs in appendix F.1)

A visual inspection of the hull established that the side shell was damaged in three places on the port side forward of the engine spaces around the echo sounder mounting :

- ✓ The plating had been torn open and pushed inwards; this breach corresponded to the position of the port echo sounder;
- ✓ There was a vertical crack in the shell plating in way of frame 18 forward of the torn sounder location, together with a secondary vertical crack parallel to it a few centimetres further forward and a horizontal crack above it;
- ✓ There was a further vertical crack with perforation of the shell plating over a few millimetres in way of frame 19.

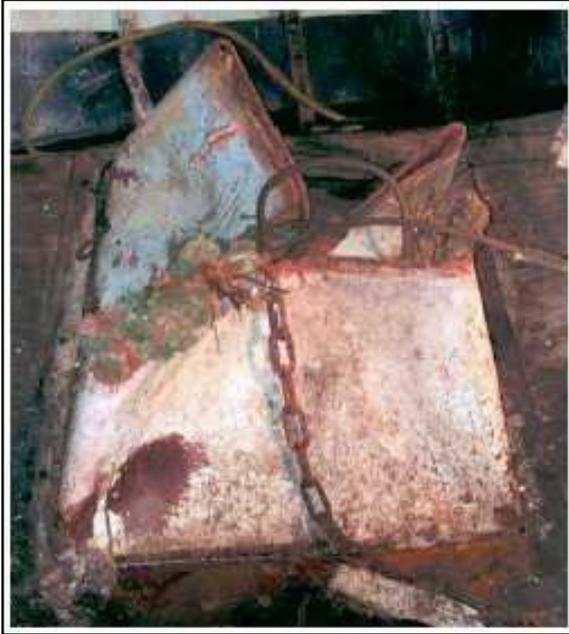
Deformation of the starboard fish hold hatchway

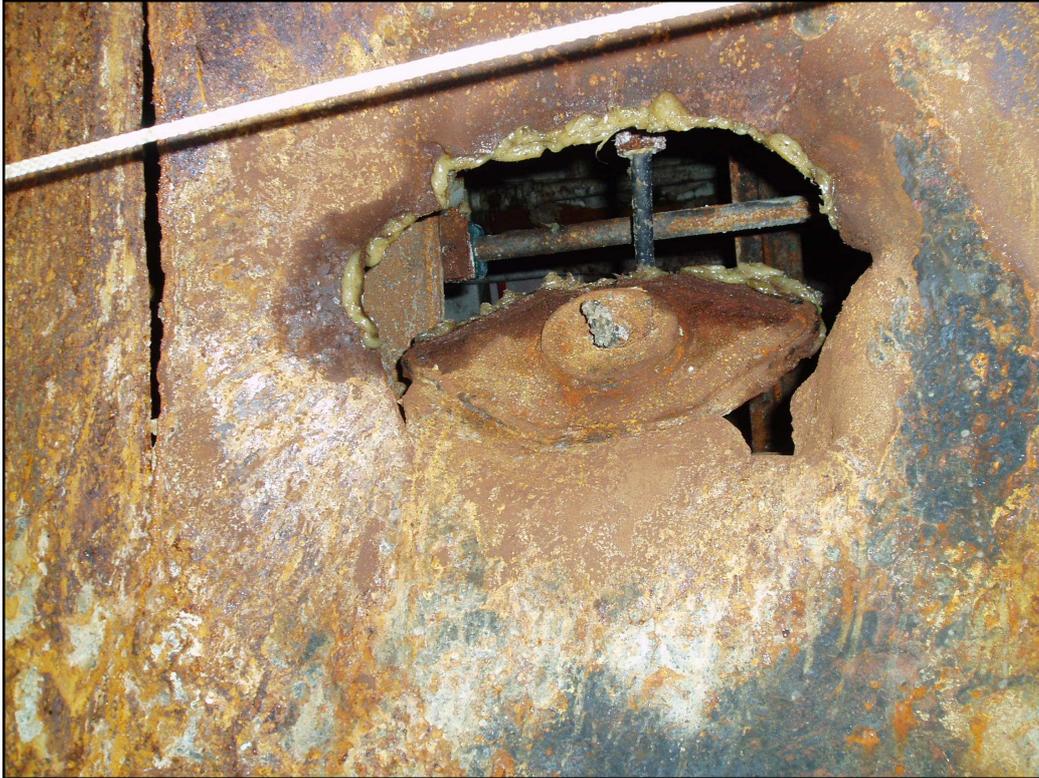
Breach at the port echo sounder

View of the breach at the port echo sounder seen from outside the vessel. The flap-like plate has pivoted into the engine room. The vertical crack in way of frame 18 can also be seen.

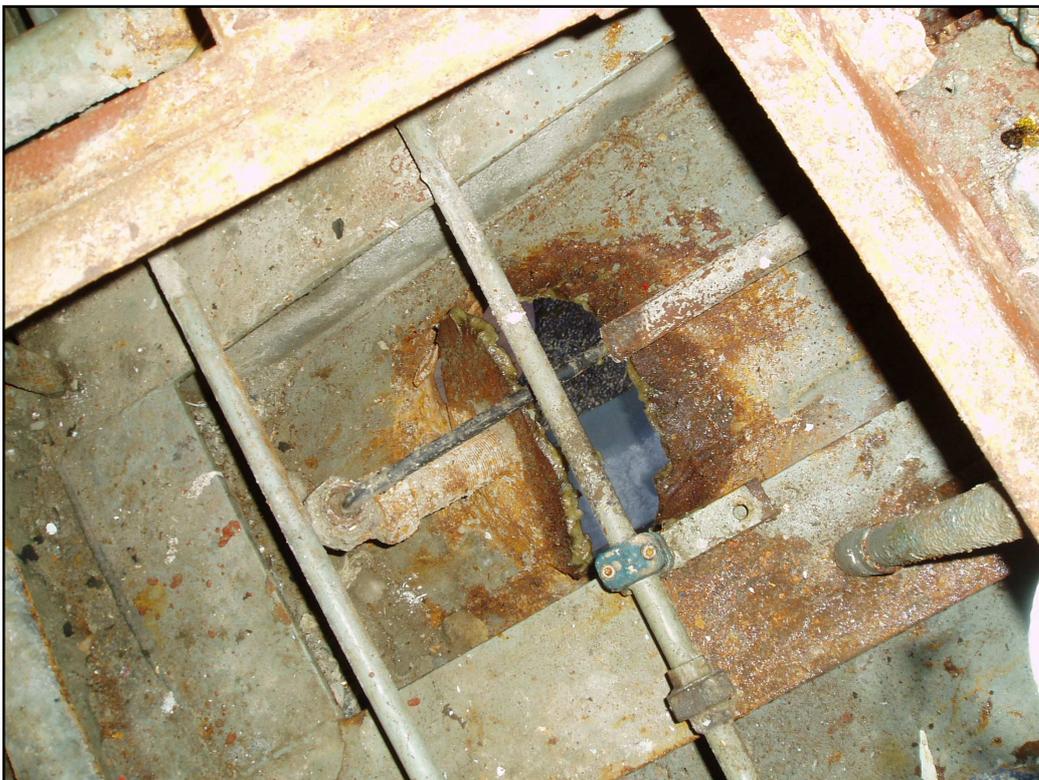
View of the breach at the port echo sounder seen from inside the vessel. On the left of the photograph the broken cable conduit coupling can be seen. The part of the conduit rising towards the upper part of the engine room is visible on the right of the photograph.

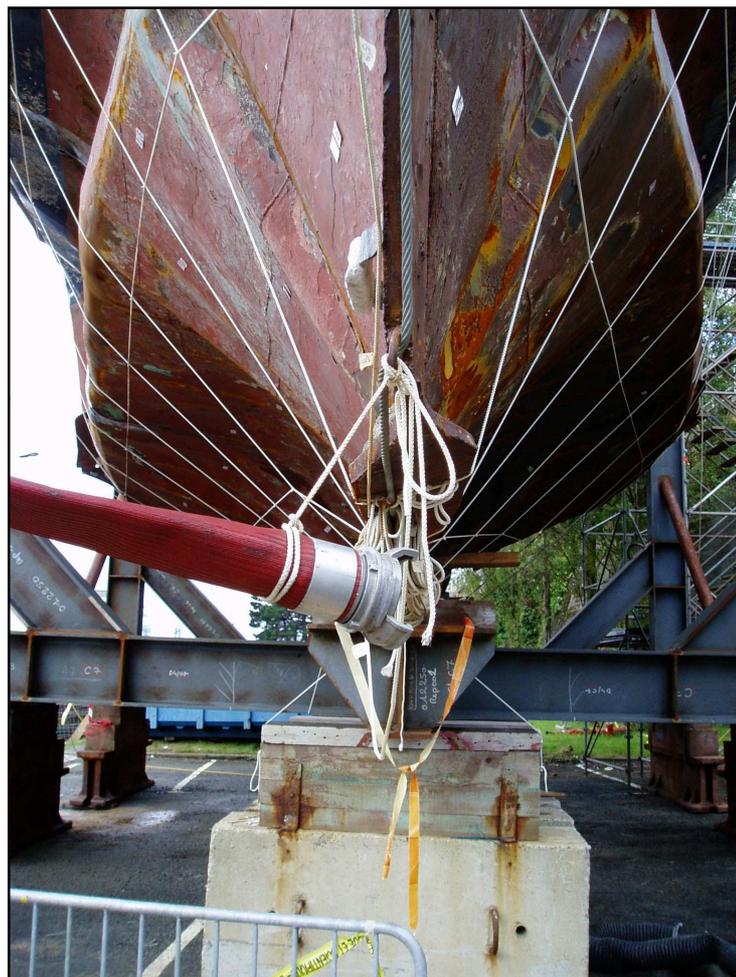
Photograph looking aft showing the symmetry of the deformations.

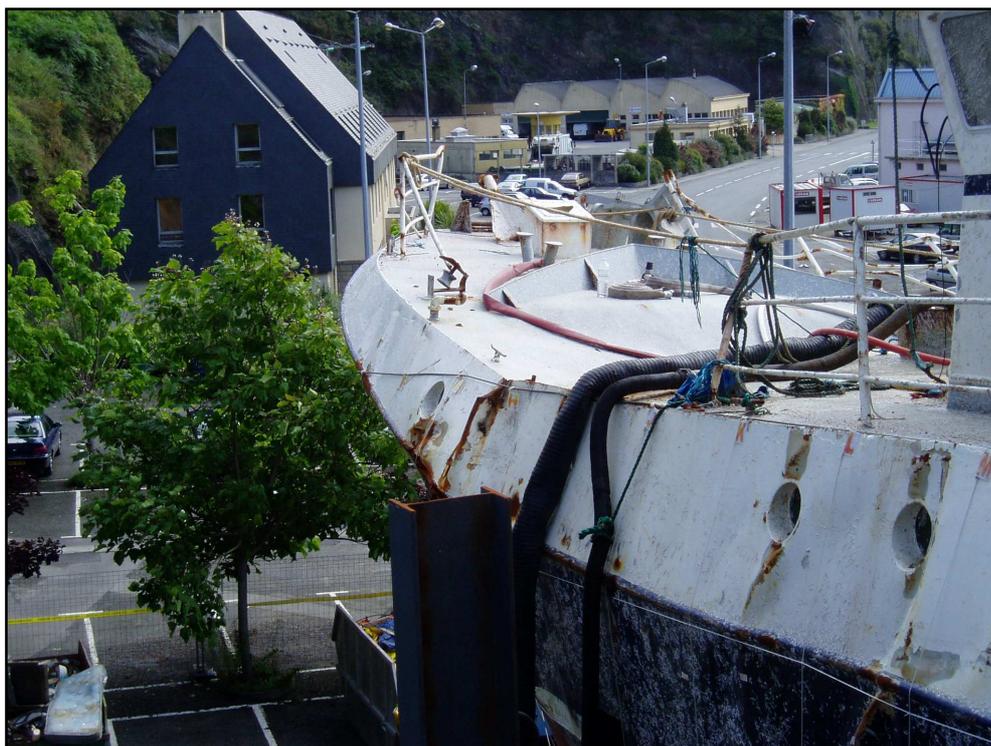
View of the deformations of the forward part of the upper deck. The wheelhouse is located to right of the photograph.

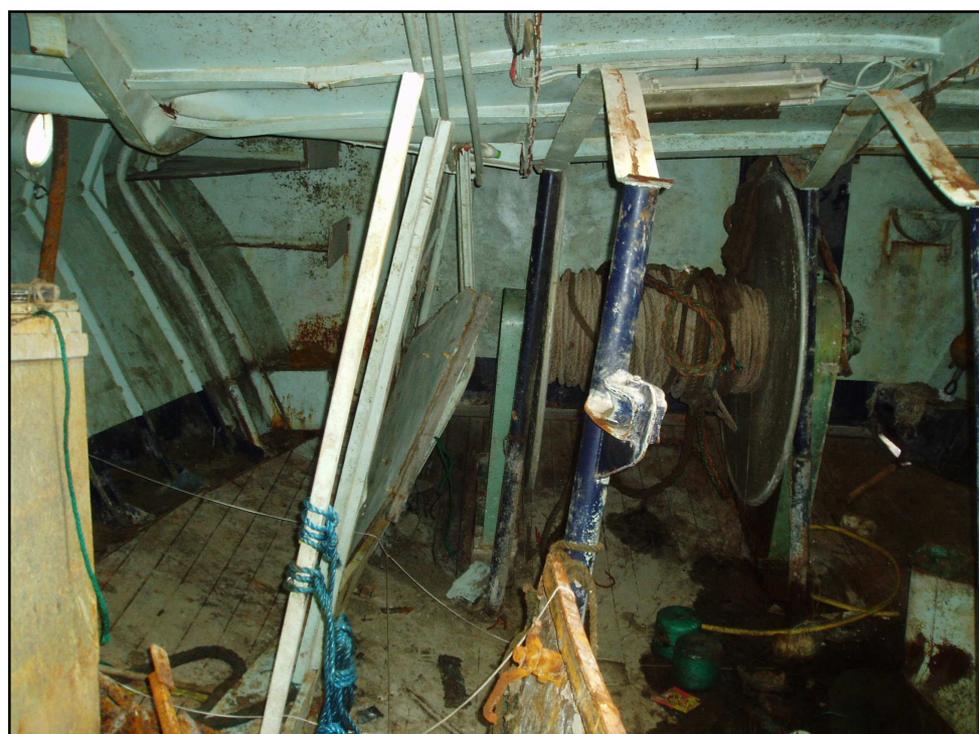
View of the deformation of the main deck. The photograph was taken from the after end of the work room.

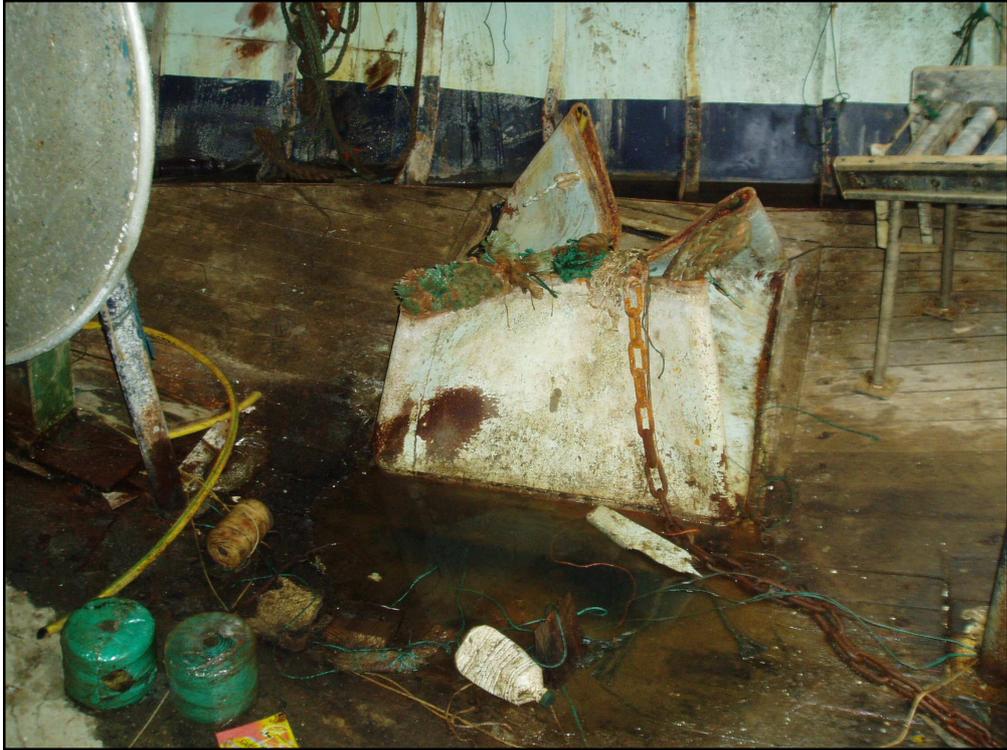
Deformation of the fish loading hatch on the the starboard side of the forward part of the work room.

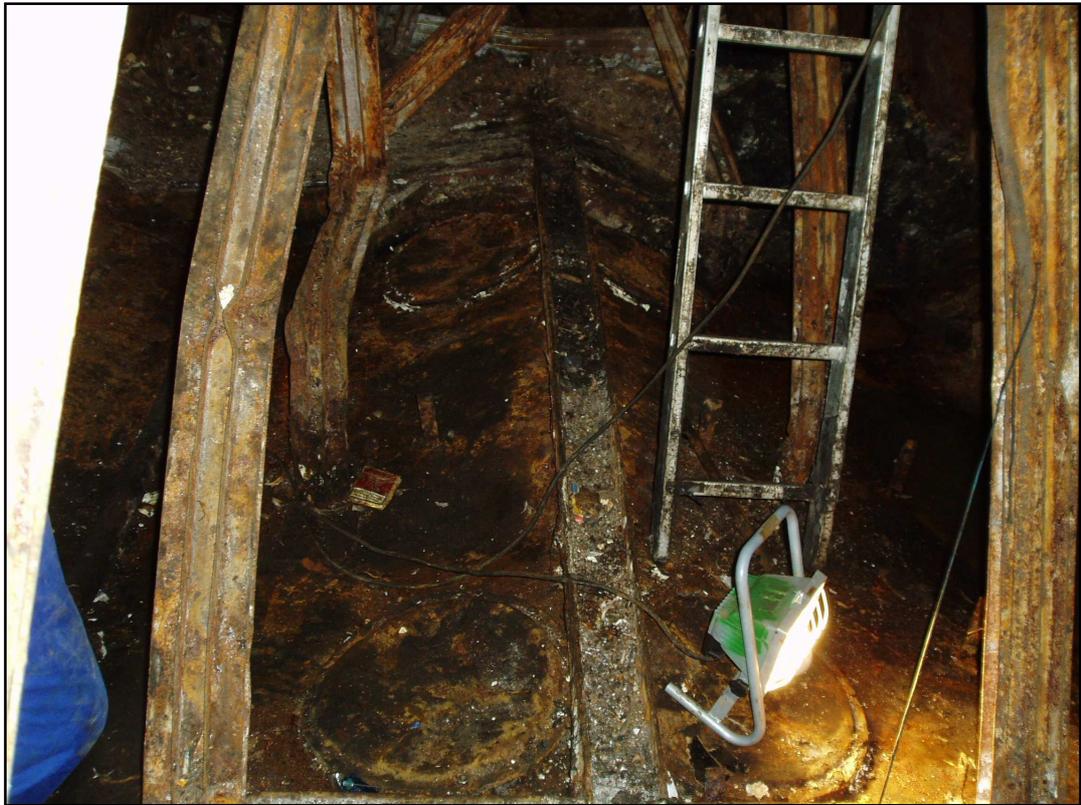
Deformation of the double bottom tank top below the fish hold. The photograph was taken from the middle of the fish hold, looking forward.

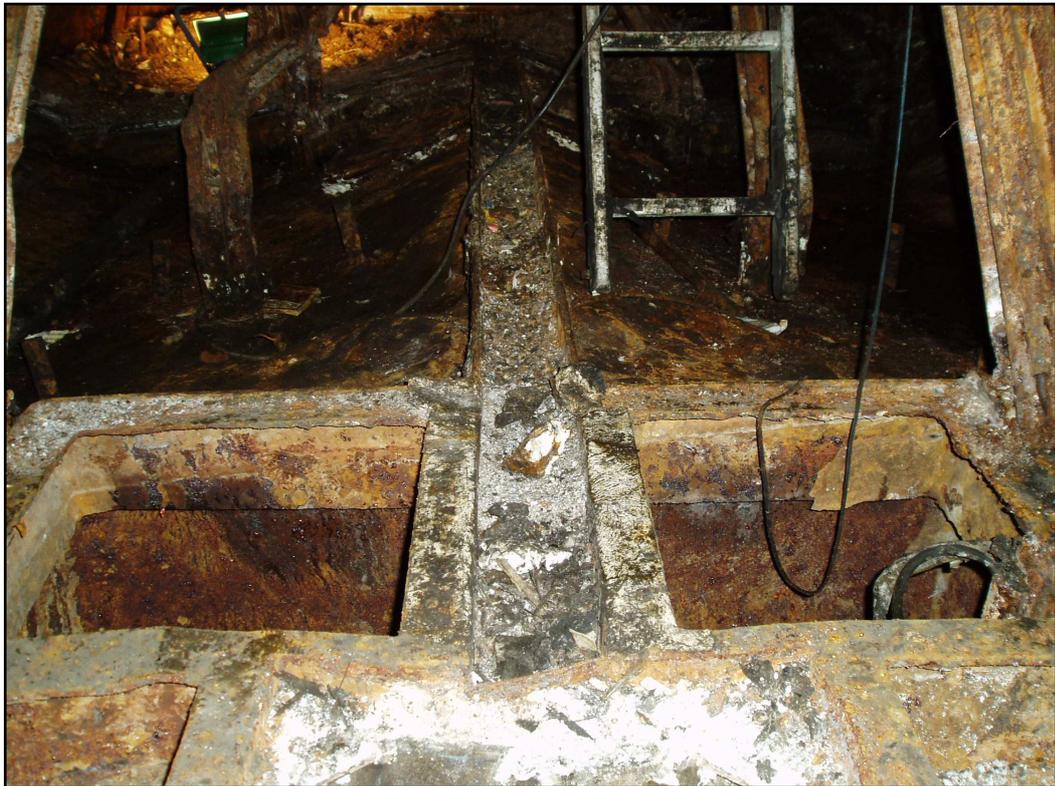
Deformation of the double bottom below the fish hold. Photograph taken in way of the bilge well.

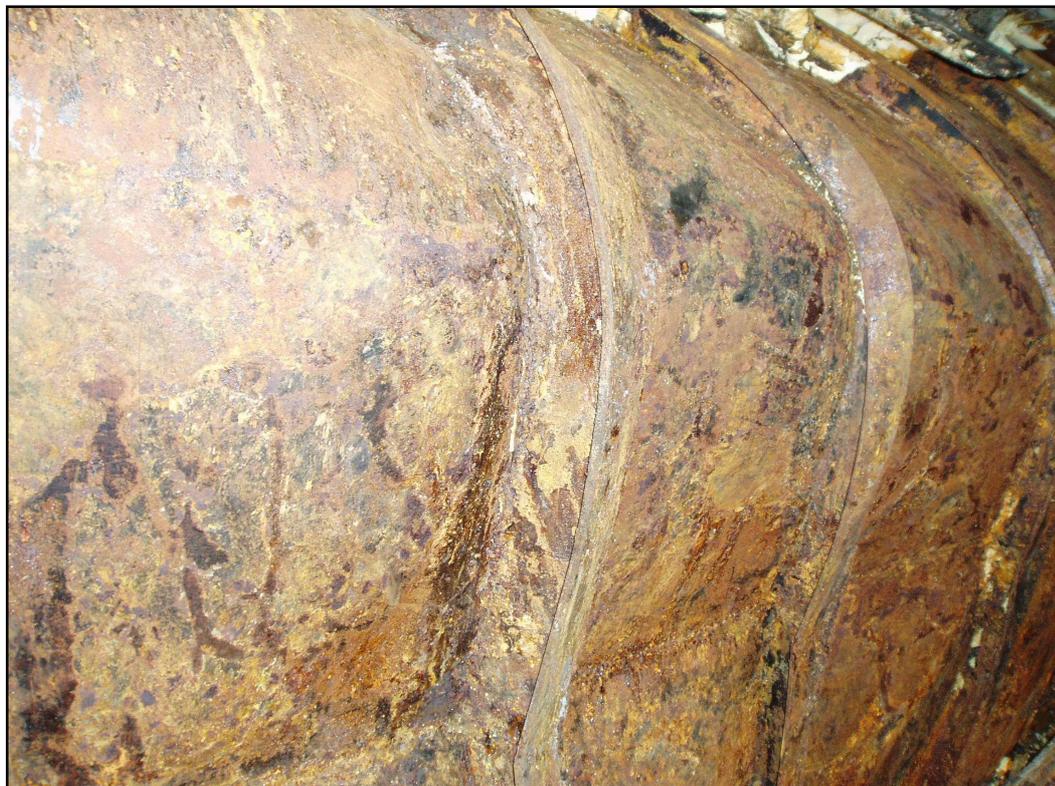
Photograph showing the deformation of the side shell and frames of the starboard side of the fish hold.

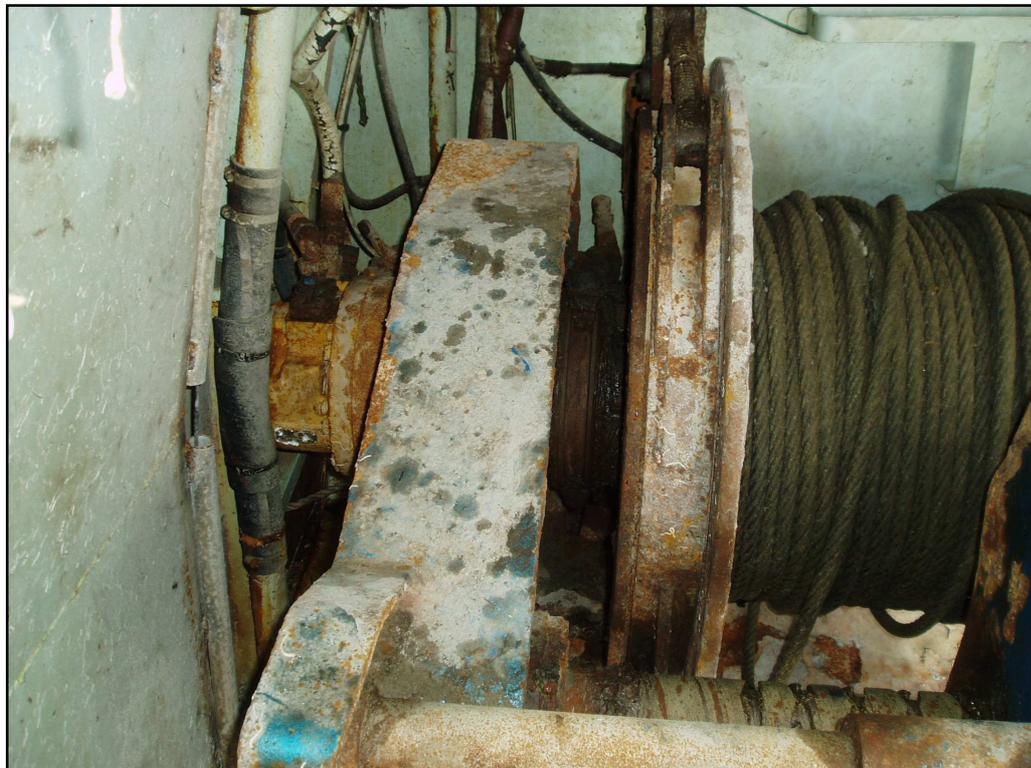
View of the port warping winch showing that the warping head is declutched.

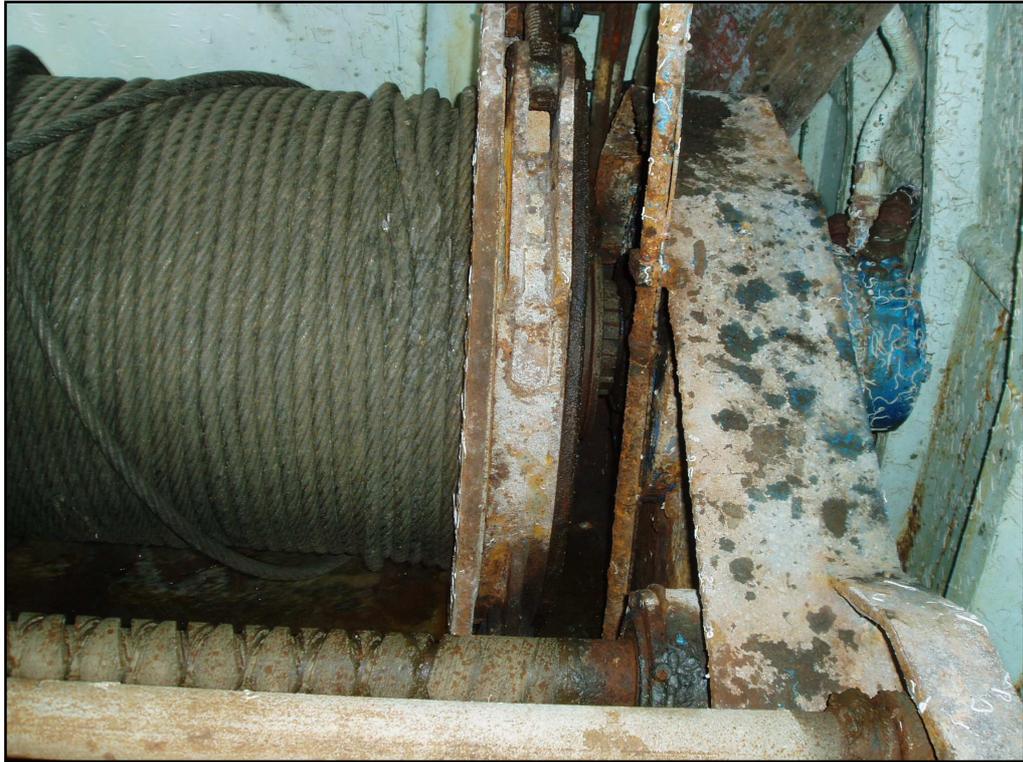
View of the starboard winch showing that the warping head is declutched.

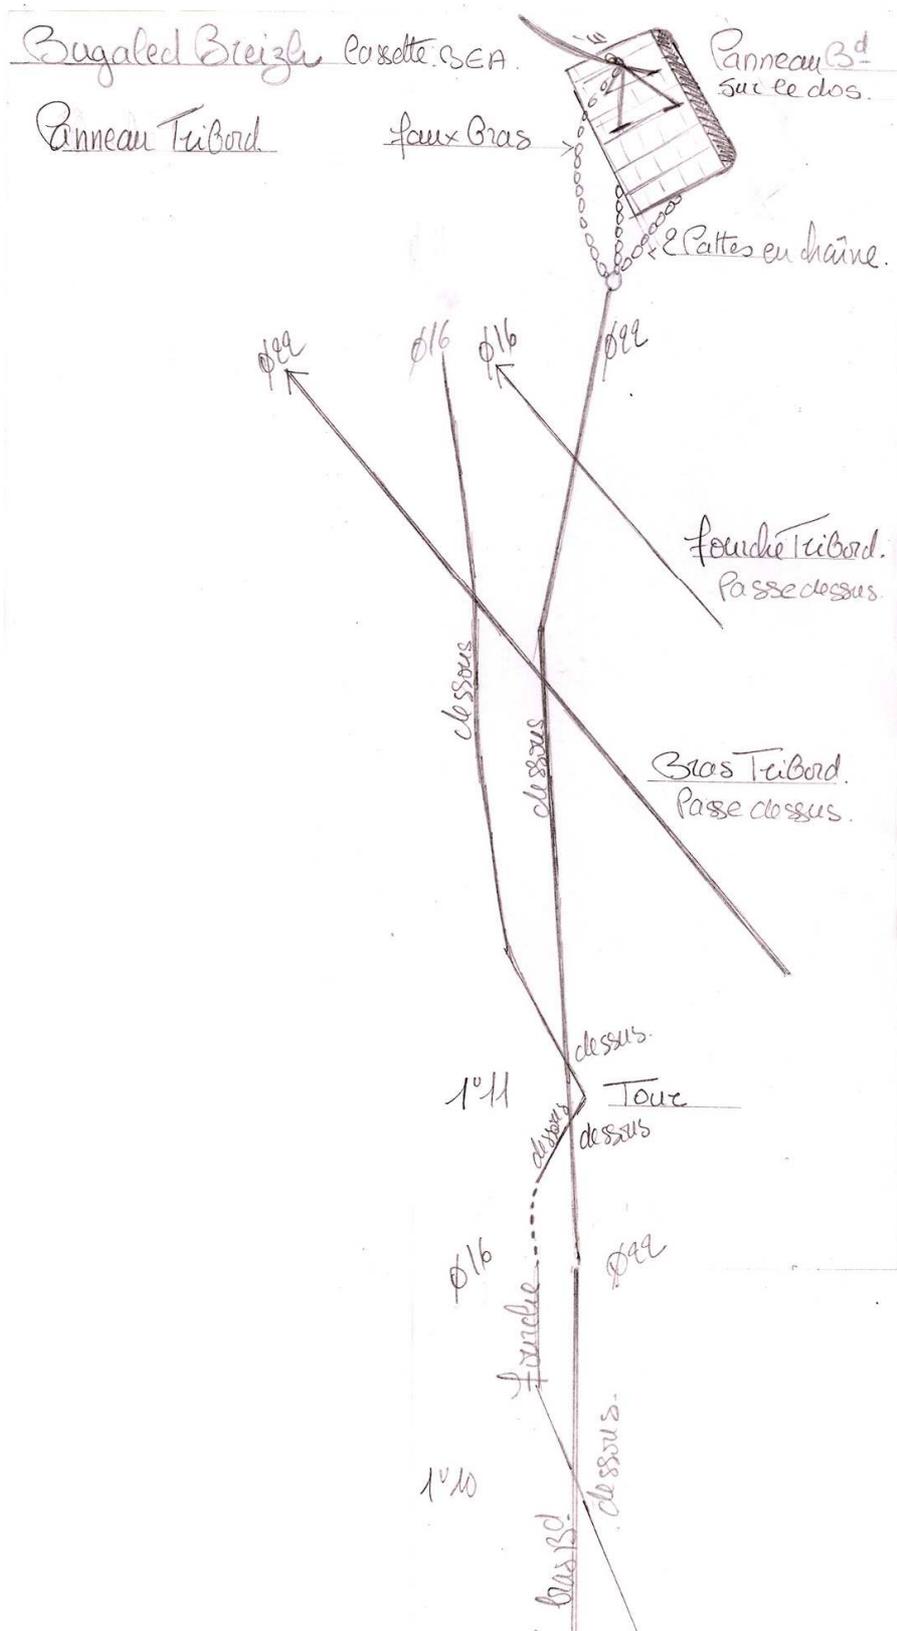
Summary diagram made from the video footage taken by the ANDROMÈDE showing the respective positions of the port and starboard bridles and fork legs.

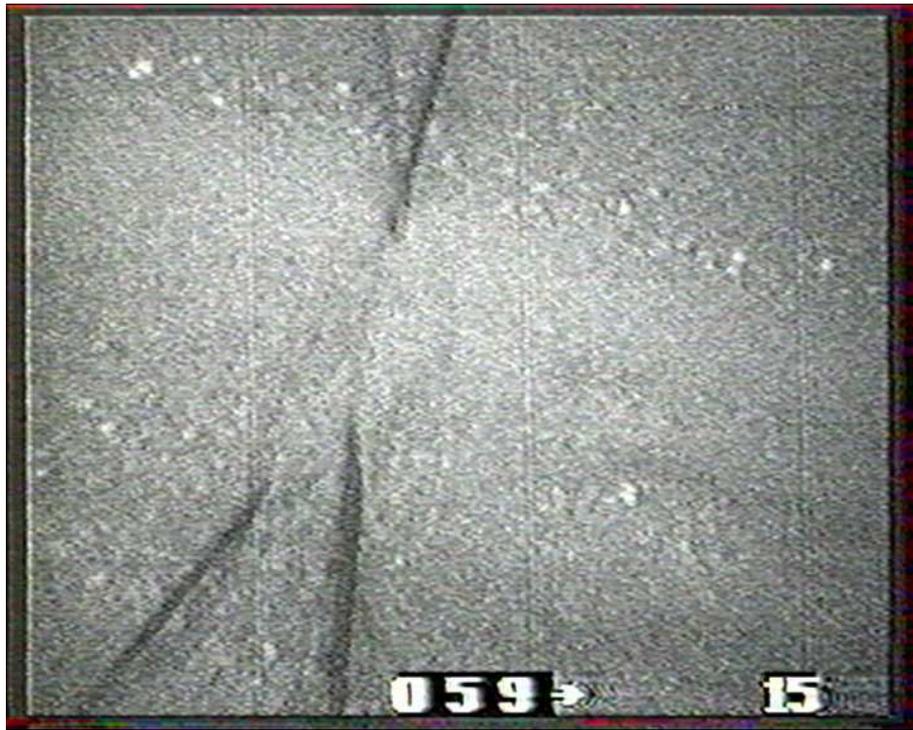
A photograph of this area can be seen in appendix F4; on it, the port fork leg can be seen as it passes under the port bridle towards the right, it then immediately turns back under the bridle and runs parallel to it. The video film shows that the fork leg passed over the bridle 1 or 2 metres before this, looking towards the trawl net; no images were captured of this sequence. The way the port fork leg and bridle are positioned shows that the port otter board flipped over before coming to rest on the bottom with the shackling arms uppermost.

View of the port fork leg passing under the lower port bridle in two places then running roughly parallel to it towards the trawl door (area 1 described in paragraph 6.4 of the main body of the report).

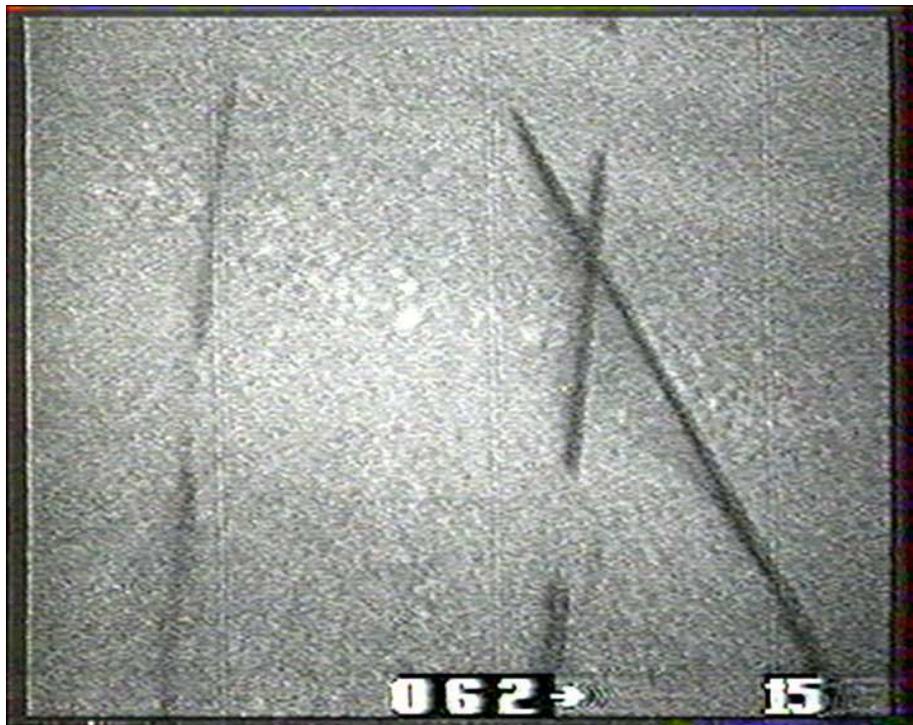
View of the starboard bridle passing over the port bridle. The shadow to the left of the starboard bridle shows the respective positions of the two cables and the presence of a concavity on the seabed (area 2 described in 6.4 of the main body of the report). The cable on the left of the photograph is the port fork leg.

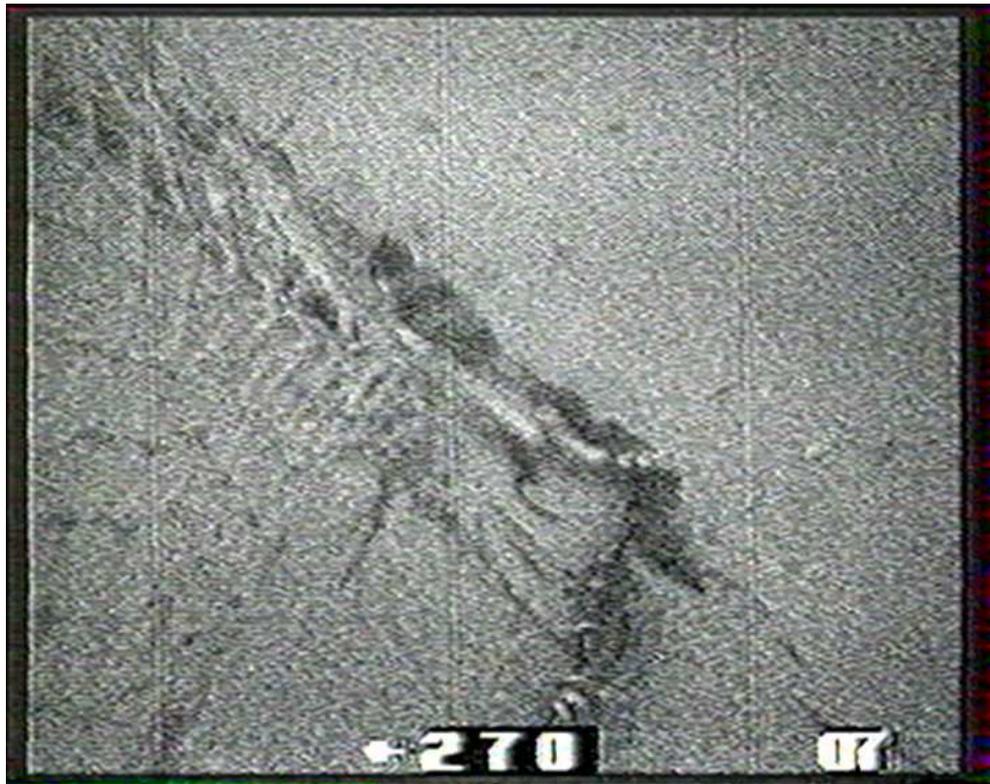
View of the portside three way connection. It can be seen that the webbing on the wing line is torn. The line of rock-hoppers is also visible.

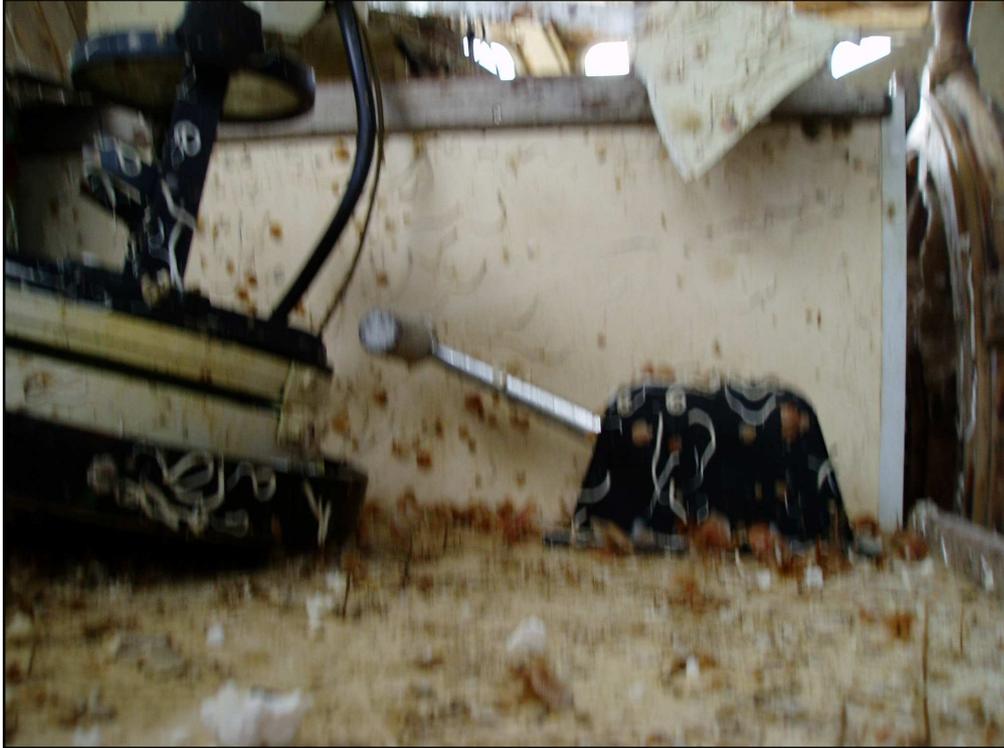
View of the engine control lever showing that it was engaged.
