Supplementary report to the inquiry into

The collision between the car carrier
TRICOLOR
and the container vessel *KARIBA*

**ON 14TH DECEMBER 2002
NEAR WESTHINDER**

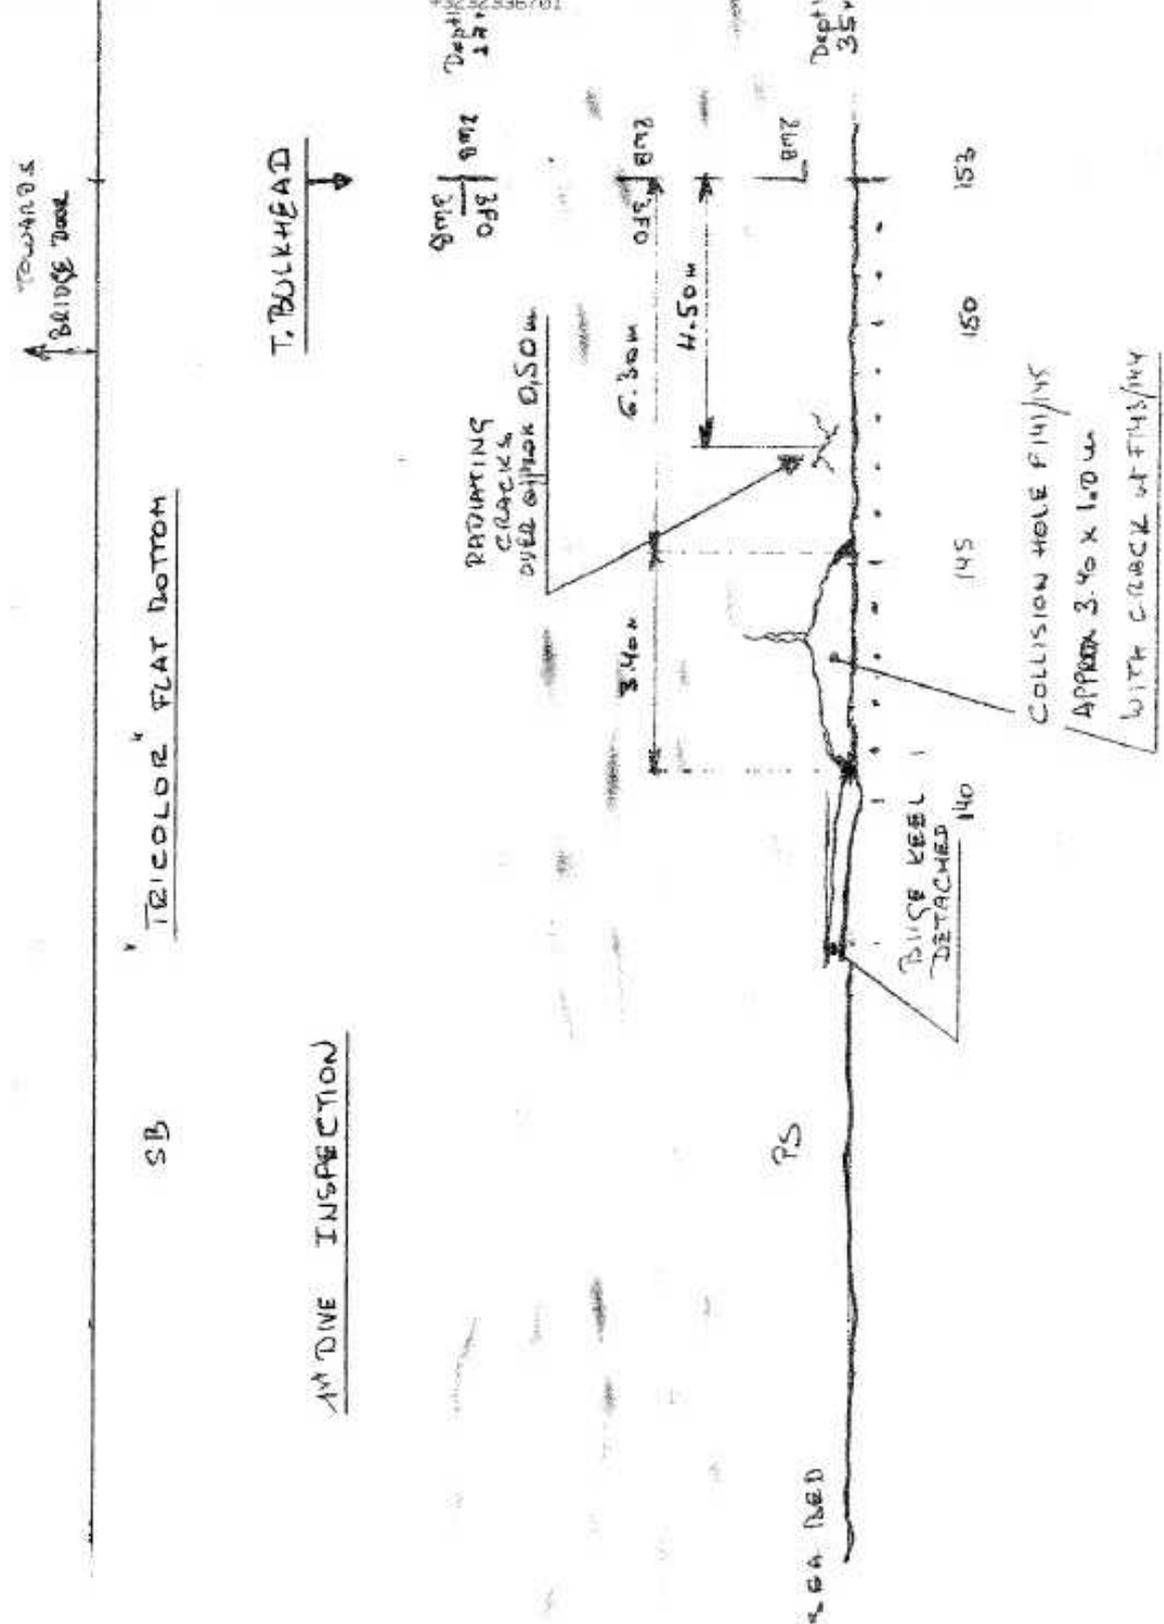
**Sketch showing hull damage sustained by the
TRICOLOR in the collision with the *KARIBA***

The damage sustained by the *TRICOLOR* in the collision with the *KARIBA* was observed by the divers to be on the port side abaft the watertight bulkhead situated at frame 153 : there was a gash about 3.4 metres long and 1 metre wide in way of frames 141 to 145, with a 1 metre long vertical crack in way of frame 143; there were also cracks about 50 cms long in way of frames 147/148 (see sketch in Annex B). From these observations it was possible to deduce that the No.3 port FO tank had been pushed in by the bulbous bow of the *KARIBA*.

The new elements supplied to the BEAmer investigators by the Norwegian administration and the owners of the *TRICOLOR* at the end of 2004 made it possible for them to establish that the *KARIBA* had holed the *TRICOLOR* abaft the watertight bulkhead of the garage in way of the No.3 port FO2 tank.

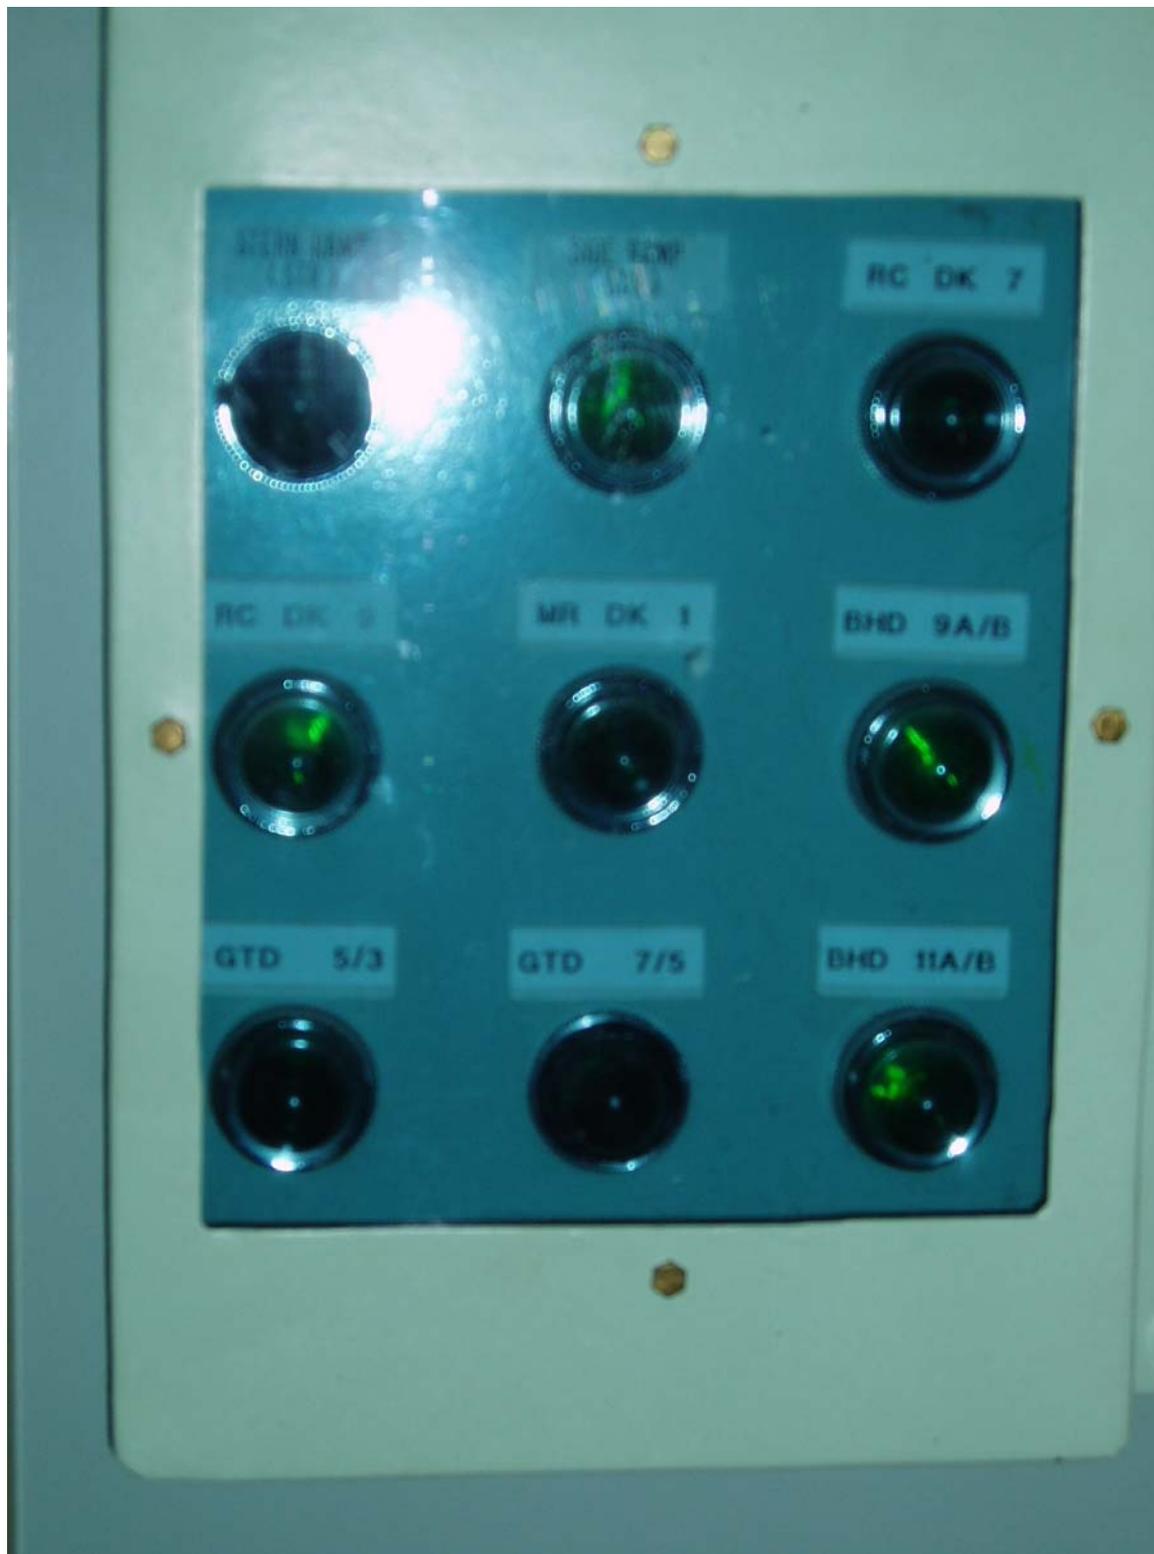
Photo 1 : Status panel on the bridge for doors and ramps.

The status of the doors could be checked on the bridge by means of a mimic panel which also indicated the status of the vessel's other watertight doors and ramps. As regards the garage doors, a light came on when the door was closed and locked (see photo 1 in Annex C).

During their investigations the BEAmer investigators had difficulty in ascertaining precisely what the bridge mimic lights indicated. It has now been established that the lights come on when the doors are closed and locked.

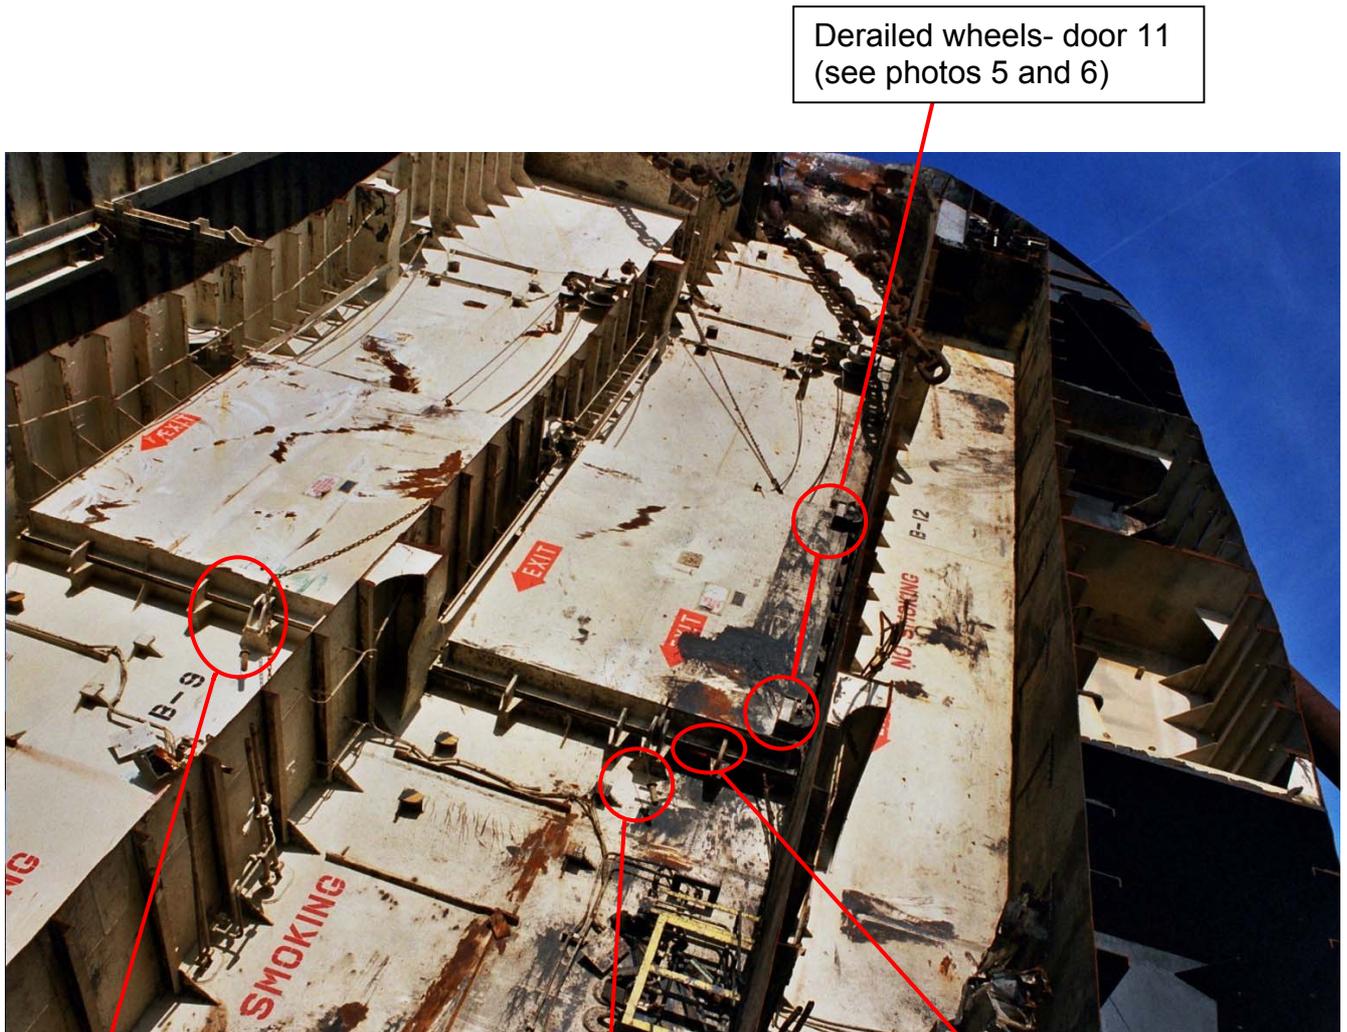
Photo 1 : Starboard after side of garage watertight bulkhead – decks 9, 11 and 12

The photographs taken on shore of the watertight bulkhead at frame 153, corresponding to the after part of section 3 of the wreck, show that the doors on decks 9 and 11 were closed (see photograph 1 in Annex D). The question remains as to whether they were really closed and locked at the time of the accident. The following points were checked : the status panel showing the position/condition of the door; the position of the hydraulic operating cylinder; the position of the safety locking pins; and whether the doors were free to move.

On the *TRICOLOR* the locking pins were found hanging outside their hinge pads (see photographs 1, 4 and 5 in Annex D).

A securing strap is jammed between the door jamb and the door (see photographs 1, 5 and 8 in Annex D).

Notice that :

- the safety locking pins on doors 9 and 11 are not engaged in their sockets ;
- there is a securing strap between the door on deck 11 and the door jamb.

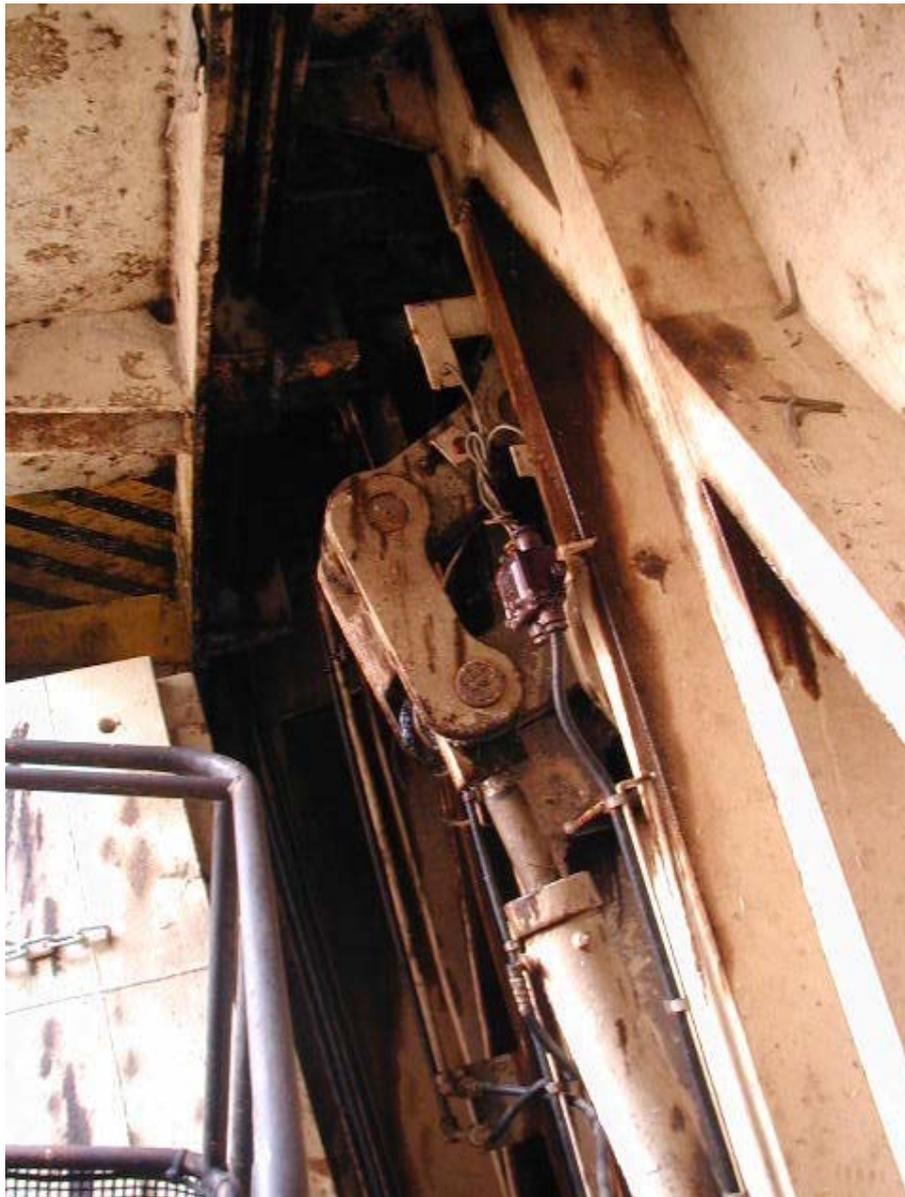
Photo 2 : Hydraulic locking rod – door on deck 9.

When the operating cylinders of doors 9 and 11 were examined after section 3 of the wreck of the *TRICOLOR* had been brought to the surface, it was observed that the rod on the door of deck 9 was partially retracted while that on the door of deck 11 was completely retracted (see photographs 2 and 3 in Annex D).

As the vessel was lying on her side, at right angles to her normal upright position, if there was no hydraulic pressure, or indeed any other force, the force of gravity may have pushed the rod back into its cylinder. This movement may have been impeded as long as the unlocking lever was held in position behind the stop on the door jamb. This could explain why, on deck 9, the rod was not completely retracted, even though it might have been fully extended, in the locked position, when the accident happened.

After examining the facts, the BEAmer investigators are convinced that the door on deck 9 was closed, but are not sure whether it was locked as the operating cylinder rod was partially retracted and the safety locking pins were not in position.

Notice that it is partially retracted.

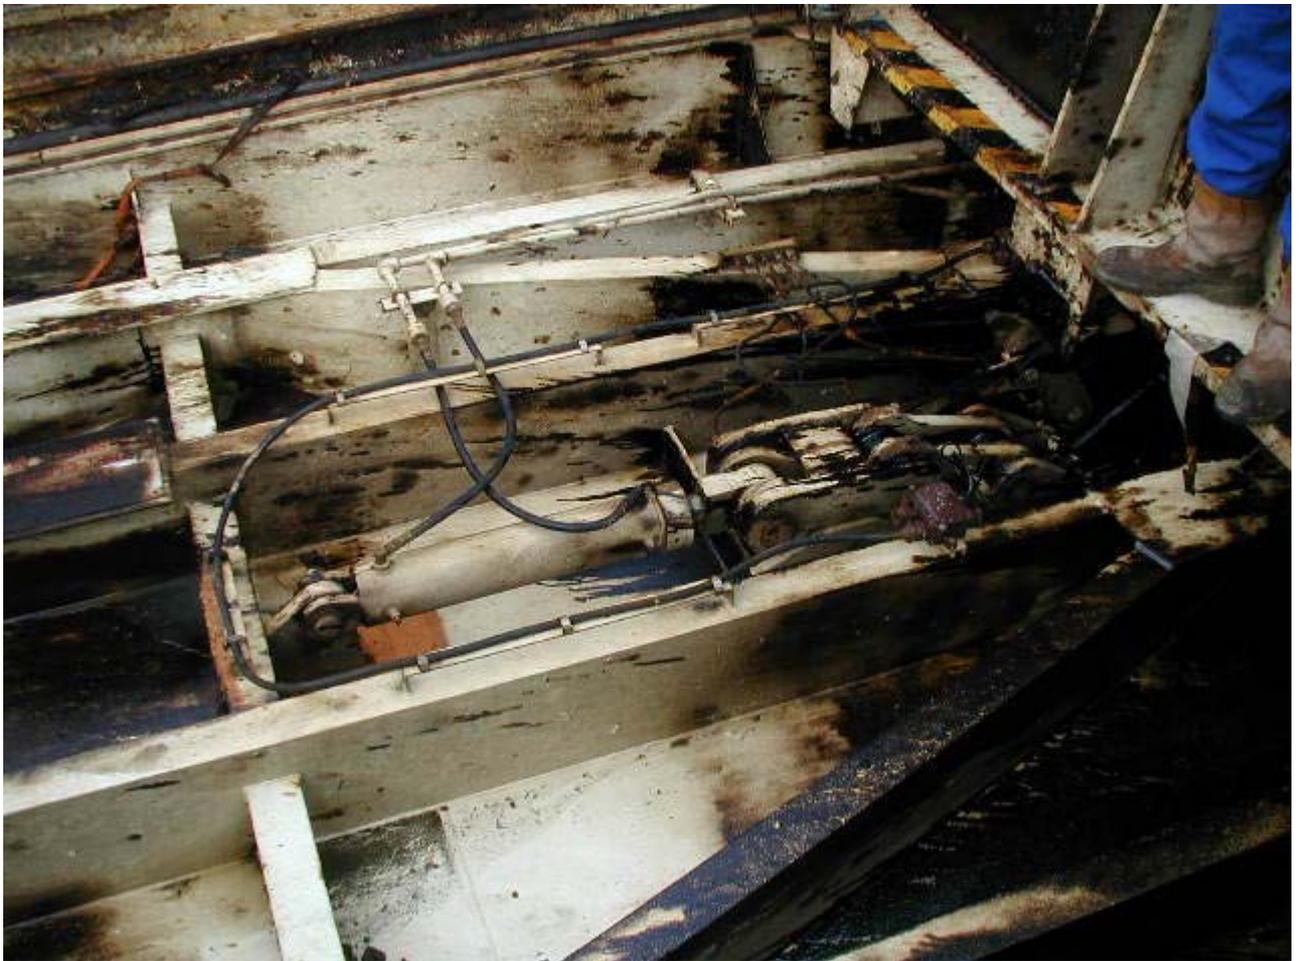
Photo 3 Hydraulic locking rod – door on deck 11.

As regards the door of deck 11, the fact that the rod was completely retracted could be explained either because the door was not locked or because the unlocking lever did not fulfil its function. The *BEAmer* investigators on board the *TRIANON* noticed that the point on which this lever bore on the door on deck 11 was damaged but did not prevent locking and unlocking operations from being carried out.

Notice that it is totally retracted.

Nota : This photograph was taken with the door laid flat after it had been removed from the wreck.

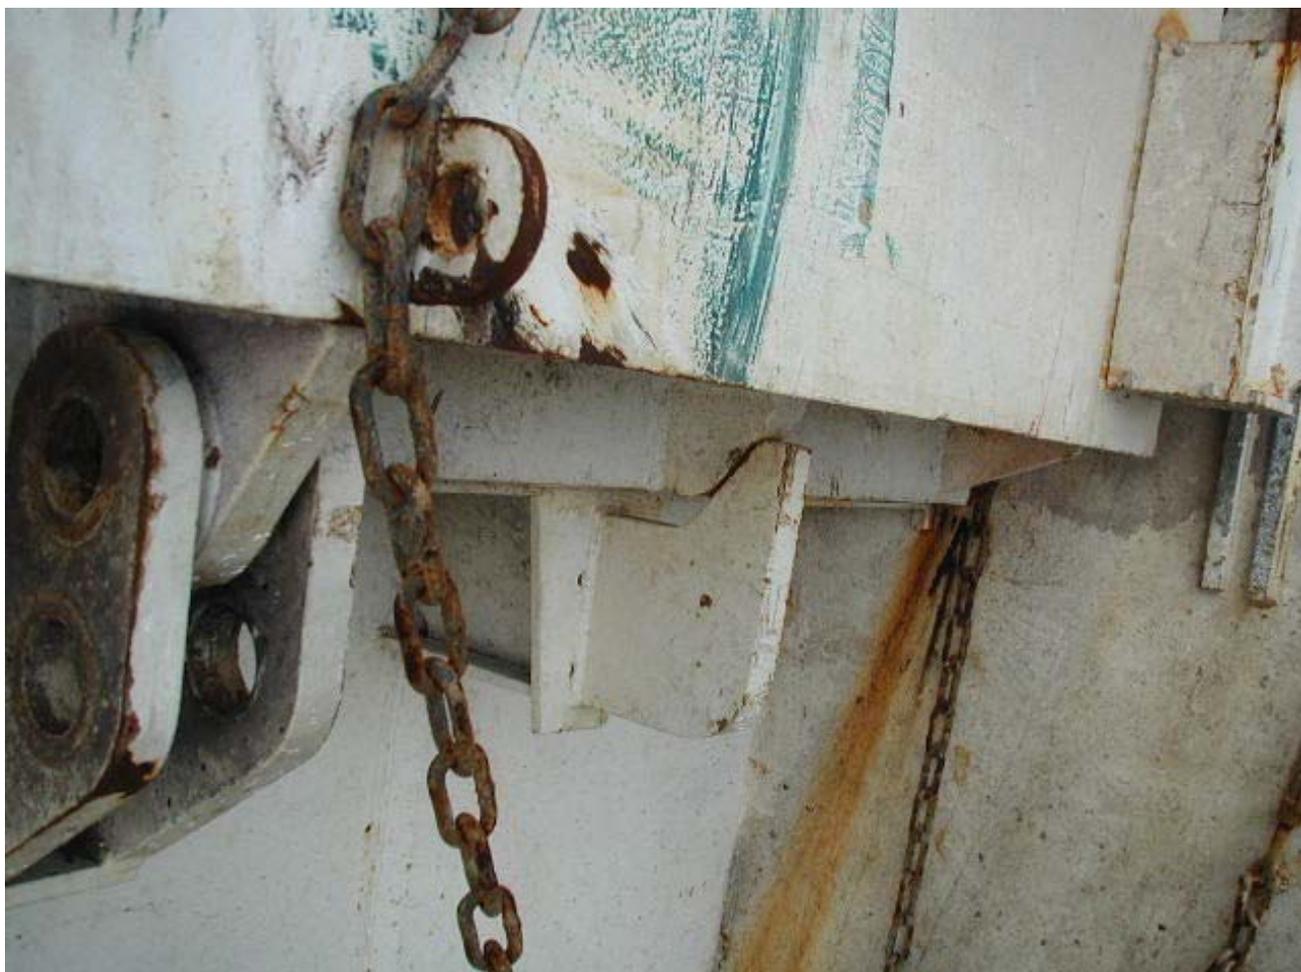
Photo 4 : Safety locking pin socket – door on deck 9.

In view of the play between pins and holes as measured on the *TRIANON*, it is possible that they fell out of the hinge pads when the vessel capsized or while the vessel was lying on her port side or again during the cutting and lifting operations.

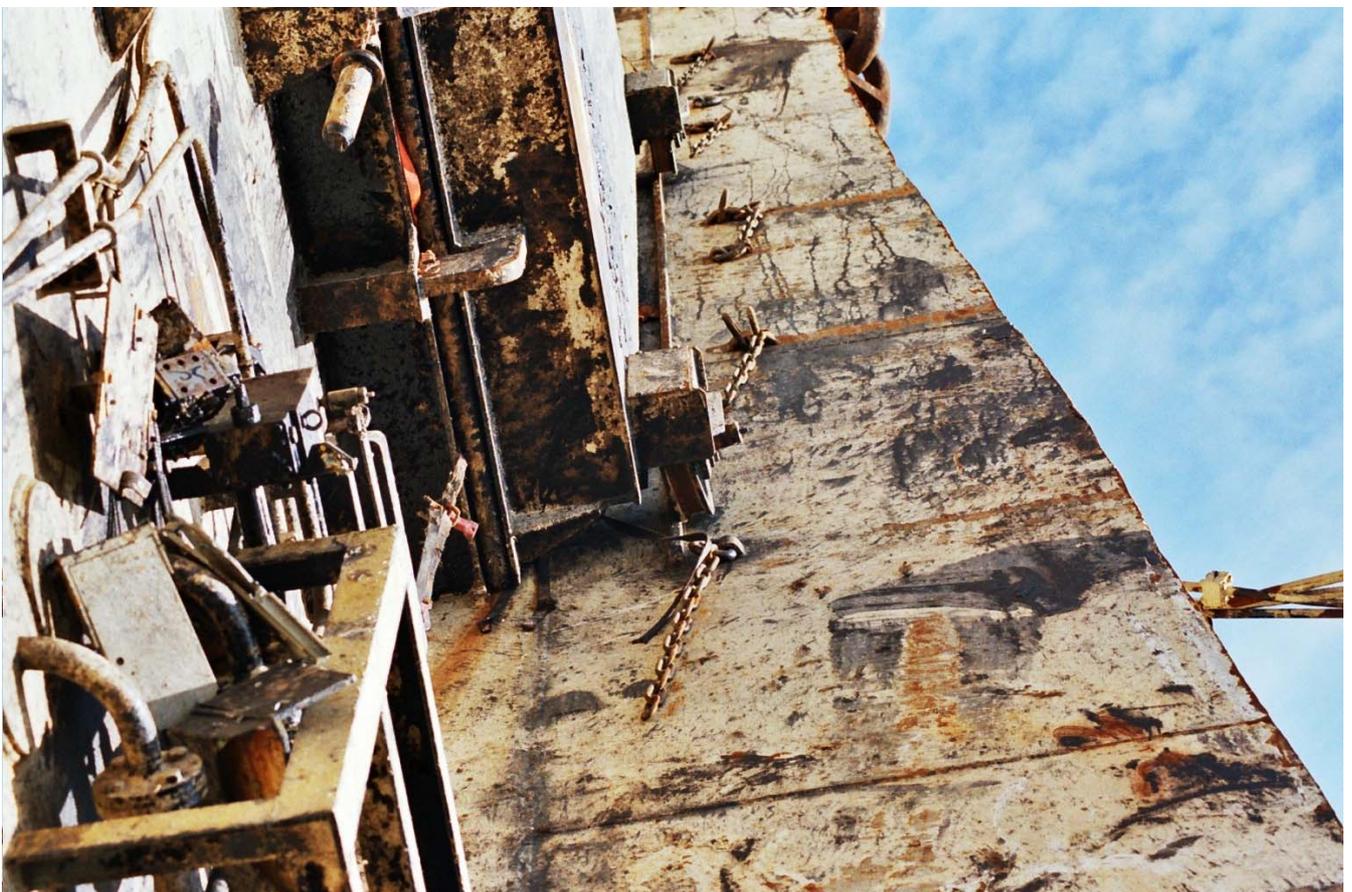
Photo 5 : Door on deck 11.

The door on deck 11, on the other hand, is closed but has come off its track, both wheels having slipped off the after edge of the track (see photo 5 in Annex D). The bottom edge of the inner wheel, that is, the one closer to the ship's centre line, shows a horizontal mark on the bottom edge of its forward side, showing that it slid along the track without turning after leaving the track (see photo 6 in Annex D). It is bent vertically showing that it was subjected to excessive stress after coming off the track. Furthermore, its axle pin has come out of its housing; one of its two vertical locking plates which are normally held in place by two bolts has disappeared and the other one is only held by one bolt (see photo 7 in Annex D).

Notice that :

- both wheels have come off the track, the inner wheel is bent and the axle pin is half-way out its bush;
- the safety locking pin is outside its socket and there is a securing strap between the door and the jamb.

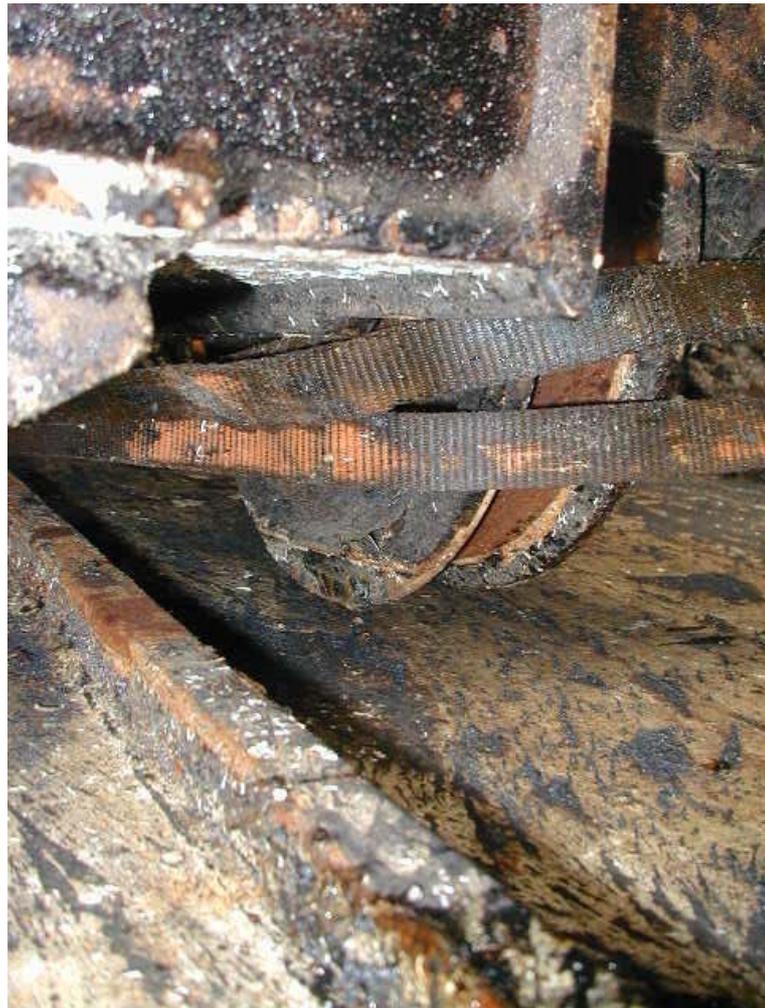
Photo 6 : Inner wheel of the door on deck 11.

Notice the mark on the lower part of the wheel, showing that it slid along the rail without turning after coming off the track.

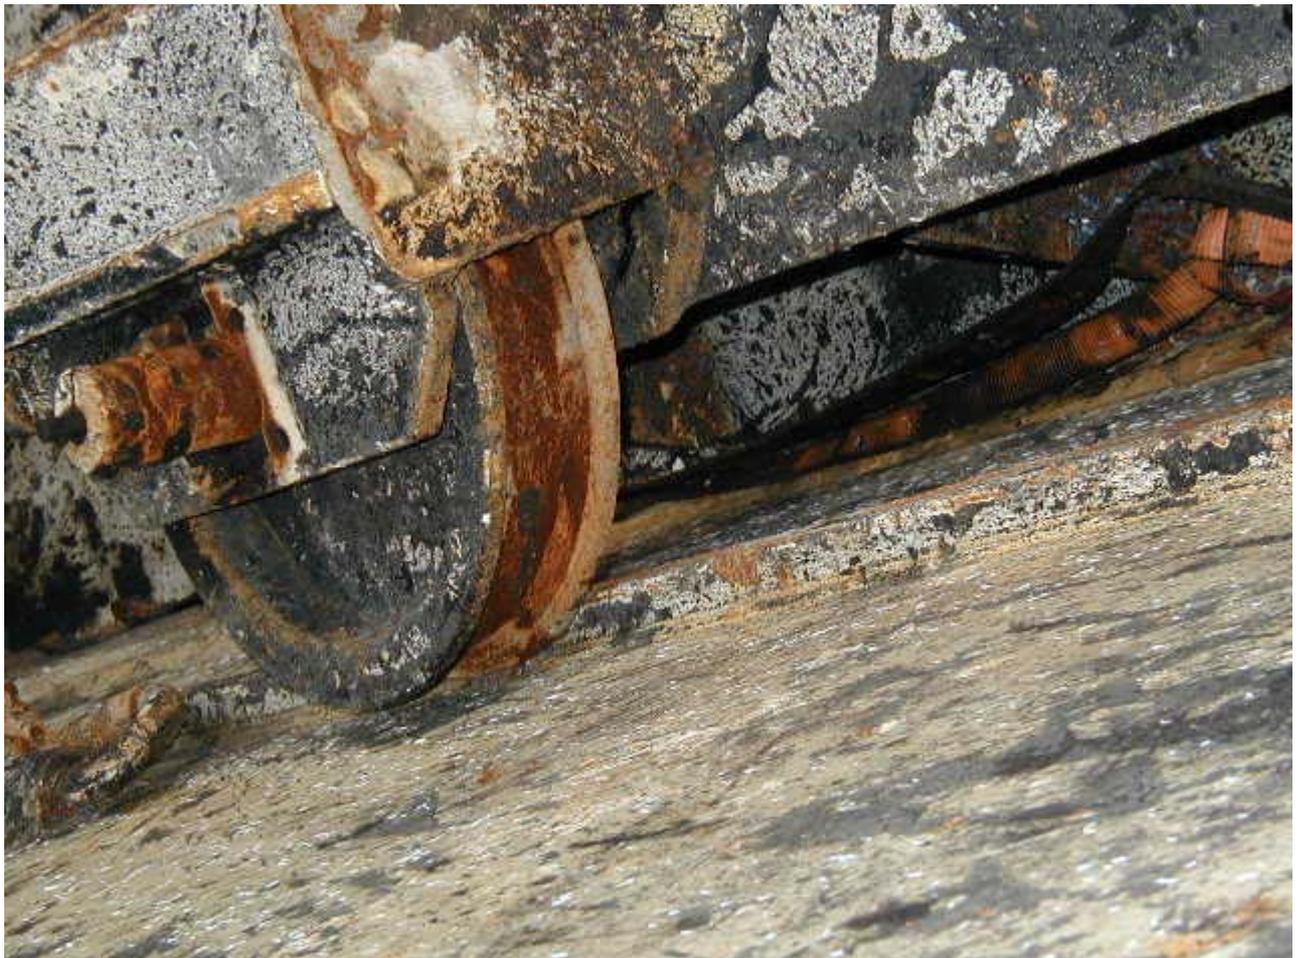
Photo 7 : Inner wheel of the door on deck 11.

Notice that the starboard blocking plate, as well as its retaining screws, has disappeared and that the axle has come partially out of its bush.

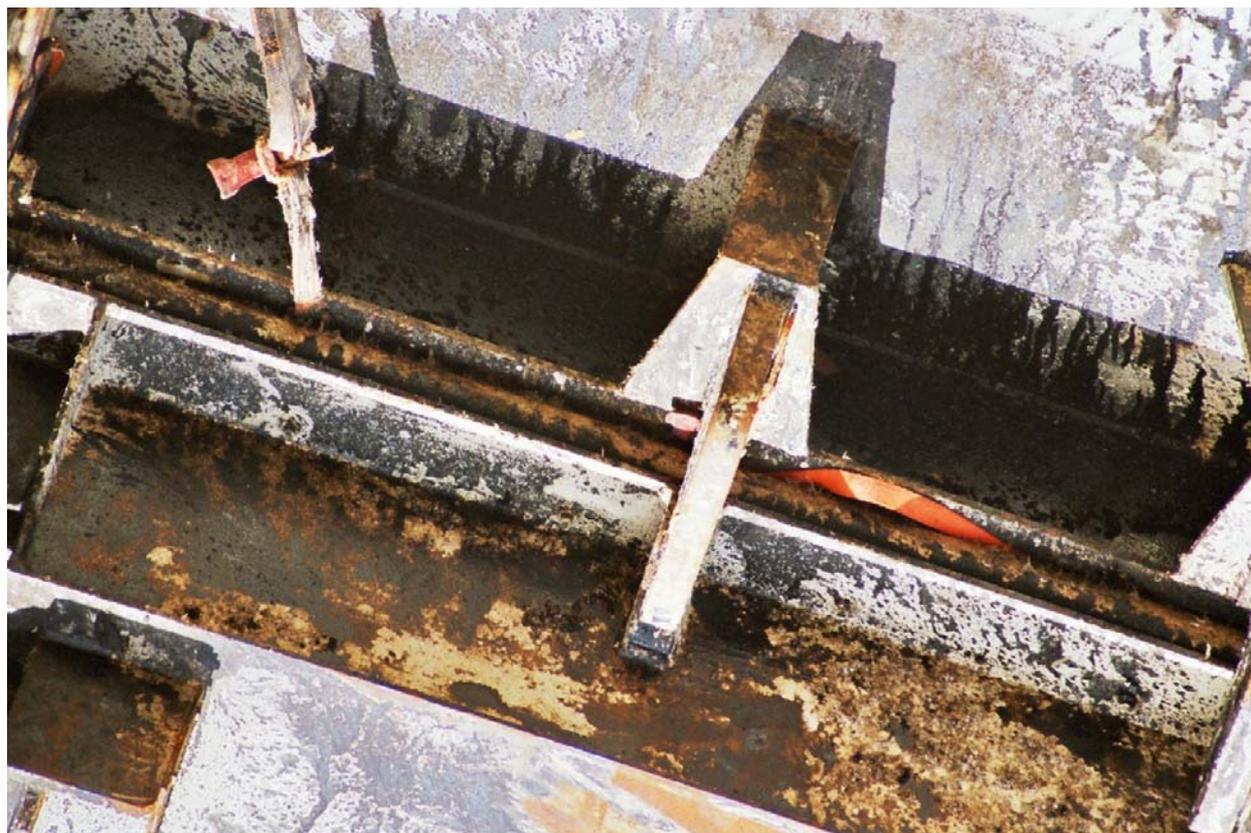
Photo 8 : Door on deck 11.

If the door on deck 11 was closed at the time of the accident, the possibility that it came off the track, took an abnormal position, at right angles to its normal upright position, and was subjected to considerable strain due to the capsizing, its prolonged stay underwater with the ship on her side and the cutting and lifting operations, cannot be totally ruled out; in this event, it is not possible to explain how the securing strap became jammed between the door and the jamb. Or the door was already off the track and impossible to lock.

Notice the securing strap jammed between the door and the door jamb.
