**Barfleur**

**Contact with chain of chain ferry *Bramble Bush Bay***

**Poole**

**16 July 2014**

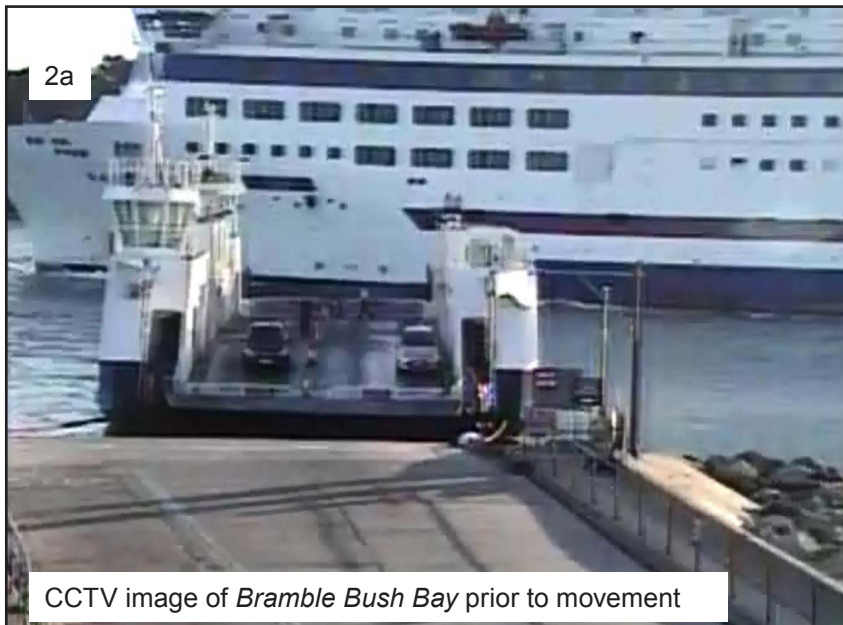
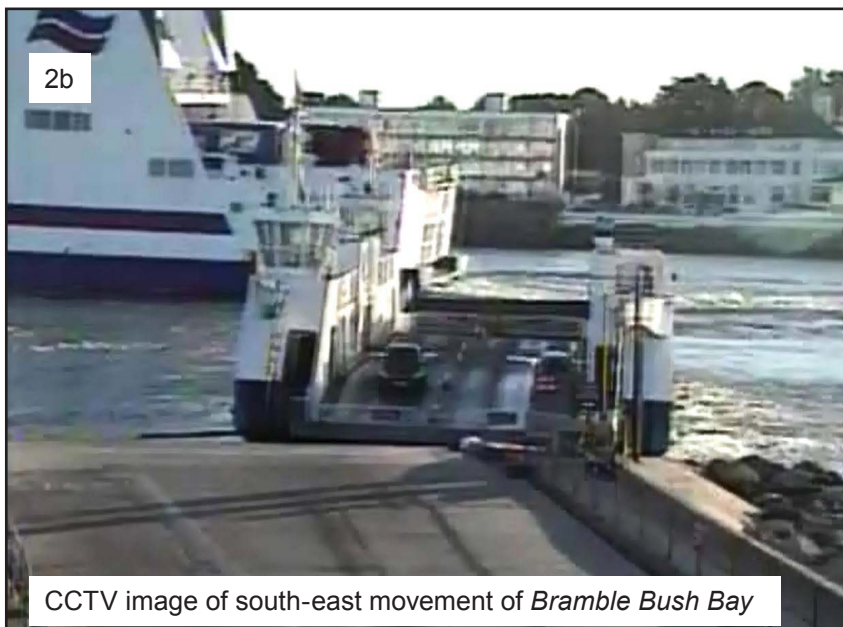
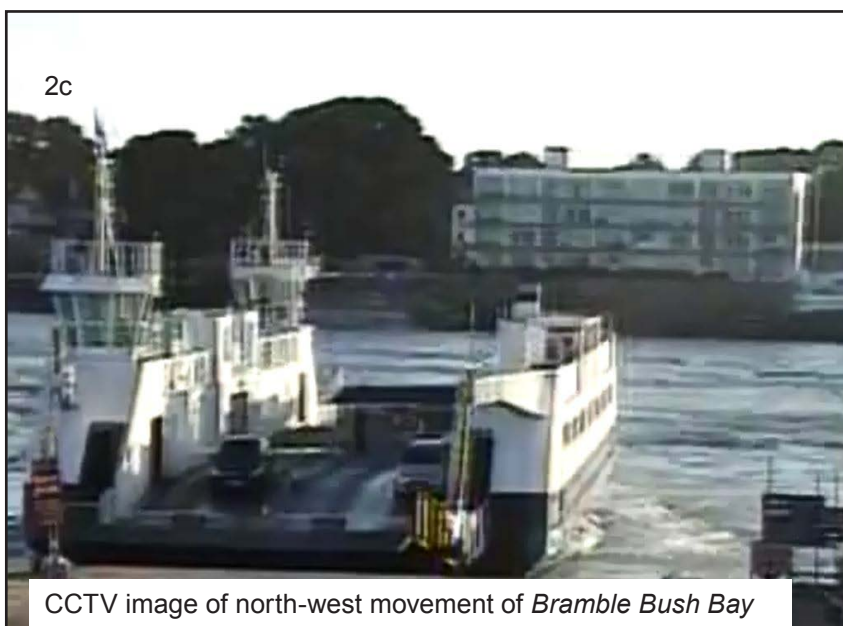
**Figure 2:** CCTV image sequence

At 0626, as *Barfleur* passed the chain ferry *Bramble Bush Bay*, which was moored in its normal 'out-of-service' position a few metres off South Haven slipway, the chain ferry started to move laterally south-east (**Figures 2a** and **2b**). *Barfleur*'s master then applied starboard helm to initiate a planned turn into Brownsea Road. As *Barfleur*'s stern passed over the chains of *Bramble Bush Bay*, the chain ferry stopped and then moved laterally north-west before eventually coming to rest (**Figure 2c**).

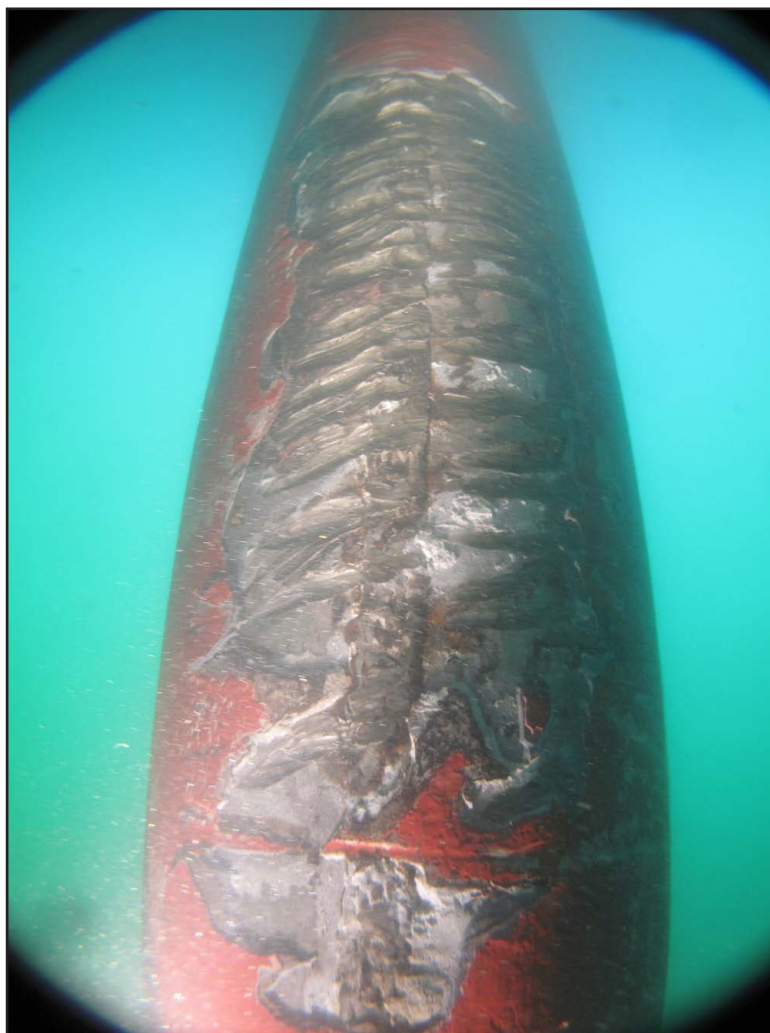
**Figure 3a:** Damage to Barfleur's port rudder

With no apparent damage to *Barfleur*, the ship departed Poole as scheduled and proceeded to Cherbourg, where a diver survey revealed some minor damage to both rudders (**Figure 3a**), one tip of the starboard propeller (**Figure 3b**), and the underside area of the skeg.

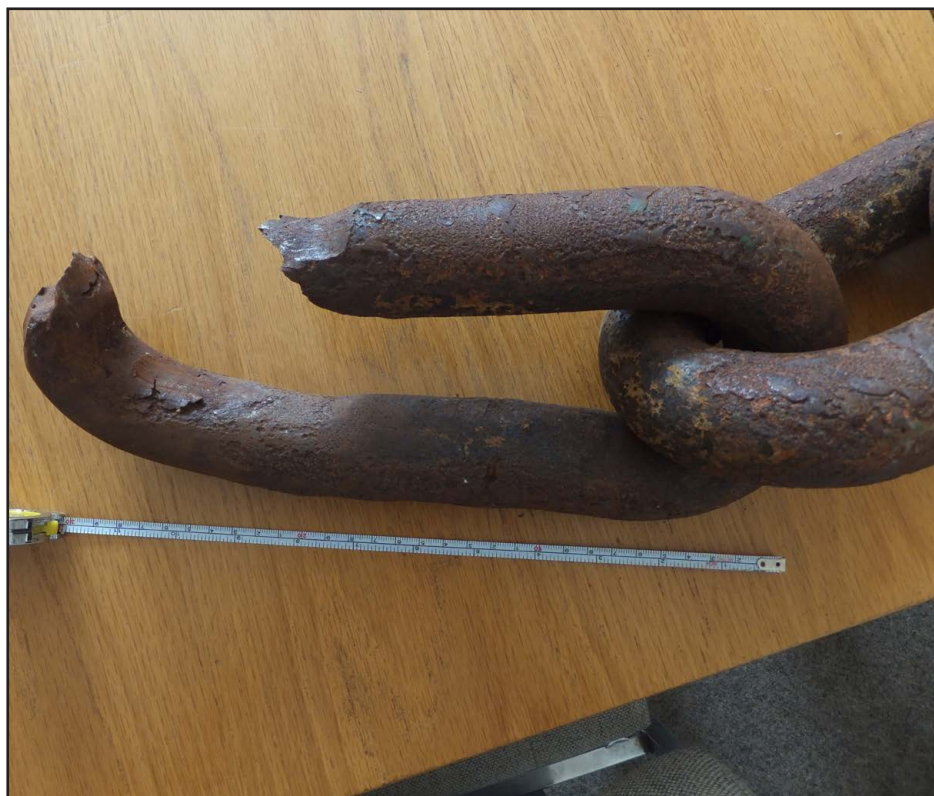
**Figure 4:** Parted 'out harbour' chain

The 'out harbour' chain of *Bramble Bush Bay* (**Figure 4**) parted as a result of the accident, and was replaced with a new chain on the same day. The parted chain had been scheduled for replacement at the beginning of August 2014. The hydraulic drive motor for that chain on *Bramble Bush Bay* was also damaged and required replacement, and the ferry returned to service on 18 July.

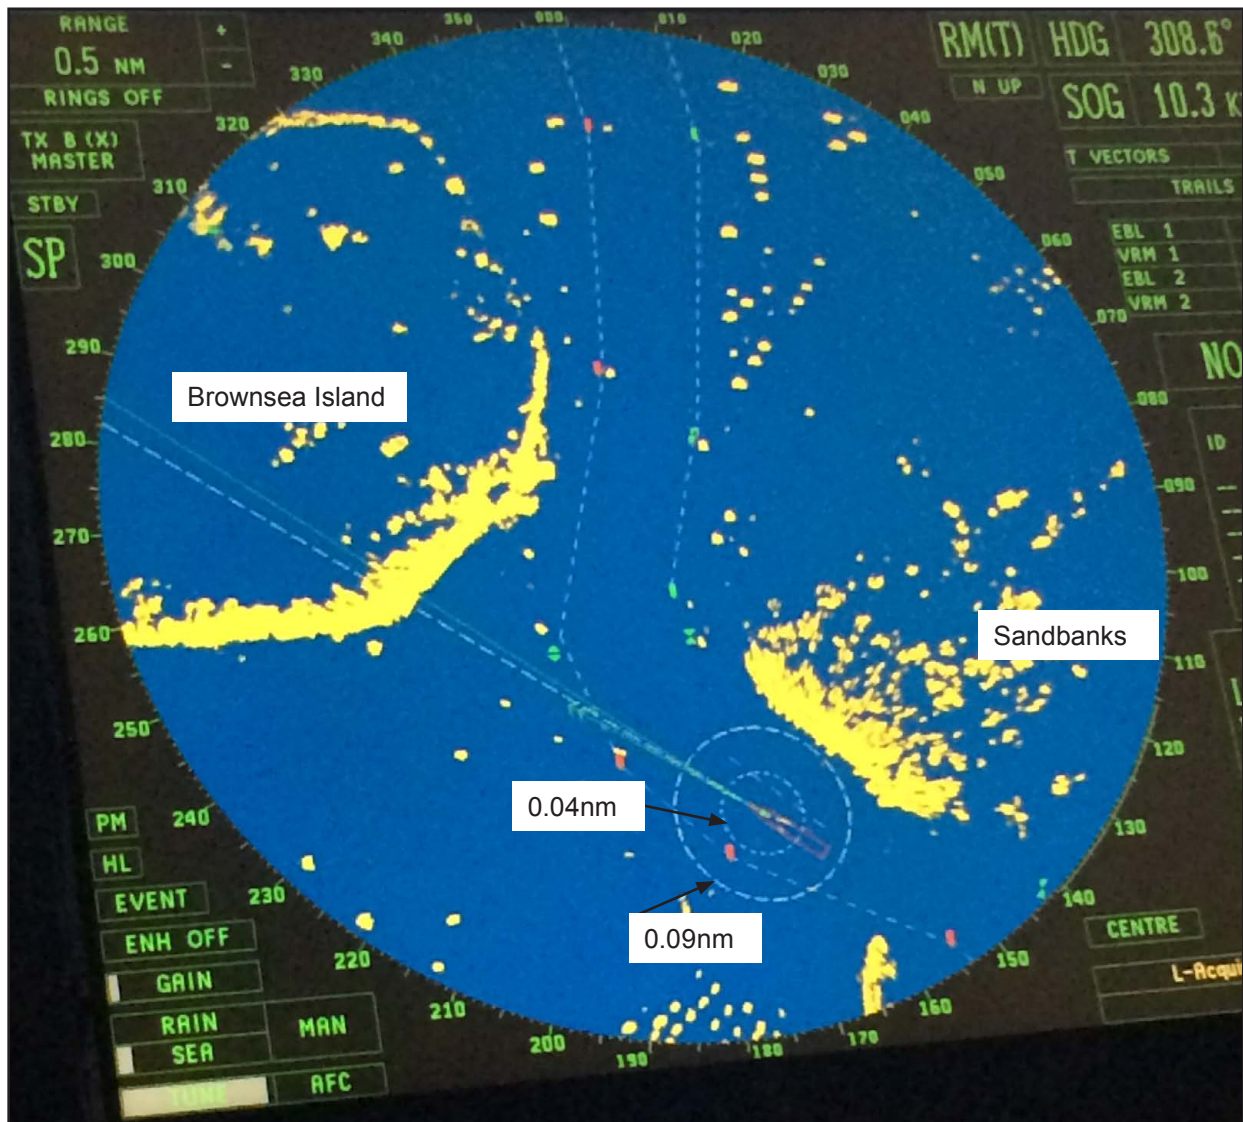
**Figure 5:** Radar with VRMs in use

In addition to visual cues, including the sectored light, the bridge team routinely used two radar variable range markers (VRM) to monitor *Barfleur's* track while entering Poole Harbour. One VRM was set at 0.04nm<sup>9</sup> to indicate the approximate distance at which to pass the Swash Channel buoys in order to maintain a mid-channel track; the other was set at 0.09nm to indicate the approximate distance at which to pass the Sandbanks peninsular in order to follow the fixed white leading light line and so clear Chapman's Peak (**Figure 5**).

*Barfleur*'s bridge team's familiarity with the track normally followed when entering Poole Harbour and the methods used to monitor the vessel's progress had led to an acceptance that the track and position monitoring methods were valid in all circumstances and conditions. With his focus on leaving Chapman's Peak clear to starboard, *Barfleur*'s master was encouraged to pass close to Buoy '10' when turning the ship onto a course of 299°(T) even though this placed the ship south of the fixed white leading light line. Then, with no means of readily identifying the point at which to safely initiate the turn to starboard into Brownsea Roads, his inclination was to alter course sooner rather than later to avoid the possibility of the ship overrunning the turn.

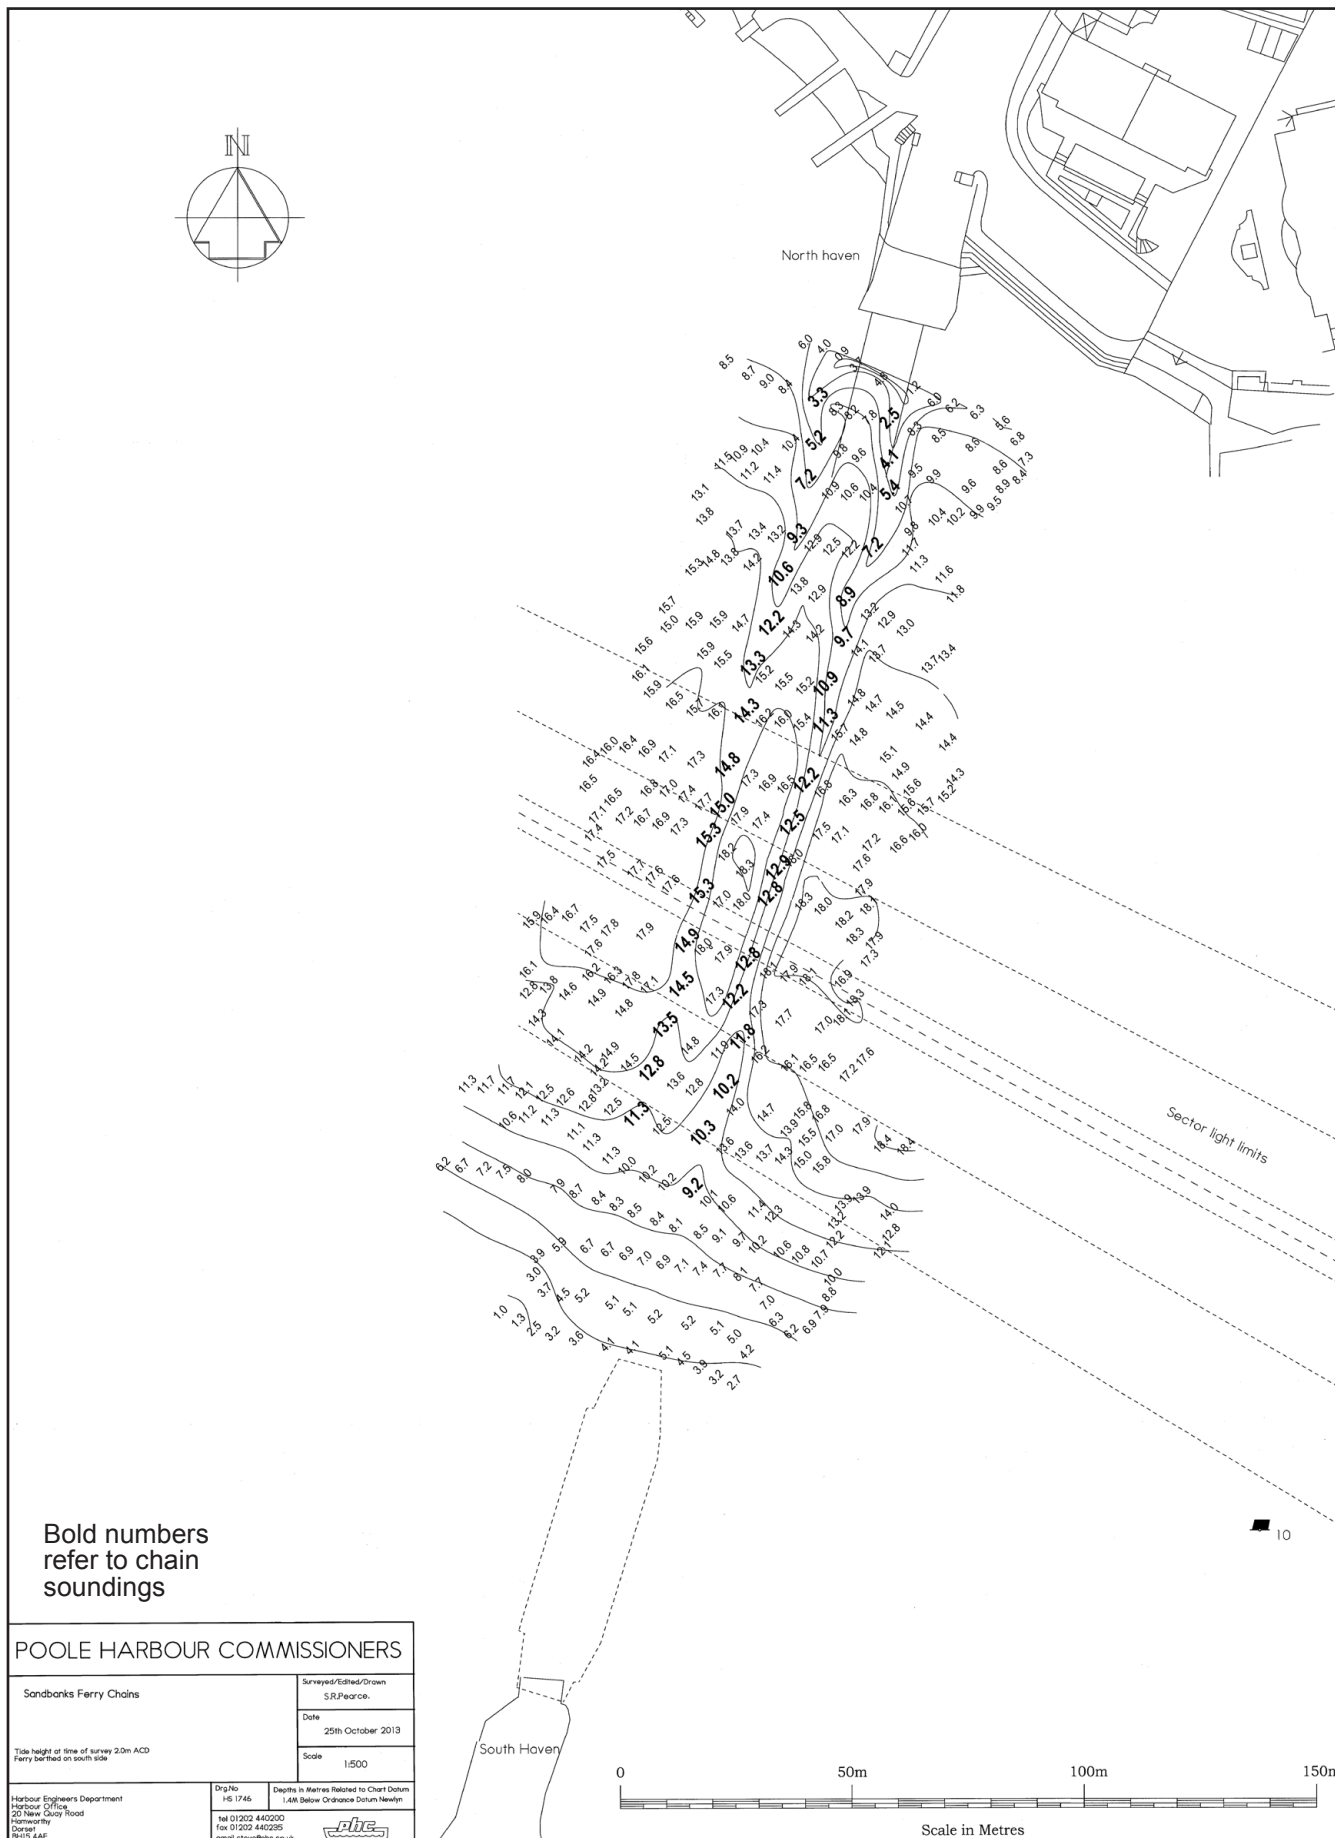
**Figure 6: Chain survey**

With *Bramble Bush Bay* moored at South Haven slipway, the annual chain survey carried out in October 2013 indicated maximum 'in harbour' and 'out harbour' chain depths below chart datum of 15.3m and 12.9m respectively. In view of their catenary, the chains were liable to move laterally in a strong ebb tidal stream, effectively reducing their depth by up to 1m.

Although the October 2013 survey showed the 'out harbour' chain to have a charted depth (CD) of 12.8m in the centre of the approach channel marked by the sector light, and at the time of the accident this was increased by a tidal height of 0.5m ( $12.8 + 0.5 = 13.3\text{m}$ ); the
