## MARINE SAFETY INVESTIGATION REPORT

Safety investigation into the fatality of a crew member on board the  
Maltese registered bulk carrier

***STARA PLANINA***

MARINE SAFETY INVESTIGATION REPORT NO. 21/2015

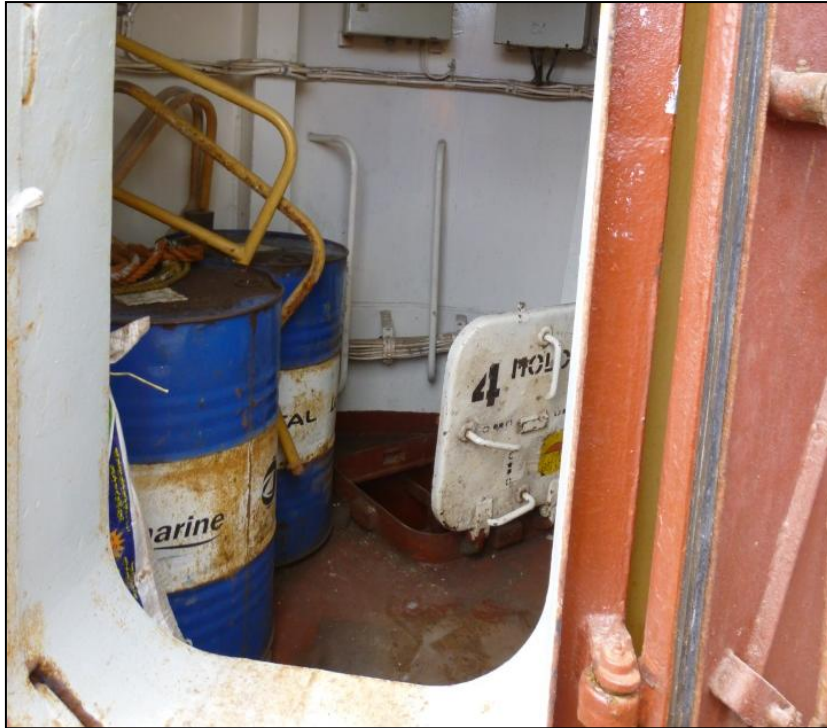
**Figure 3: Cargo hold no. 4 forward access hatches inside the crane housing**

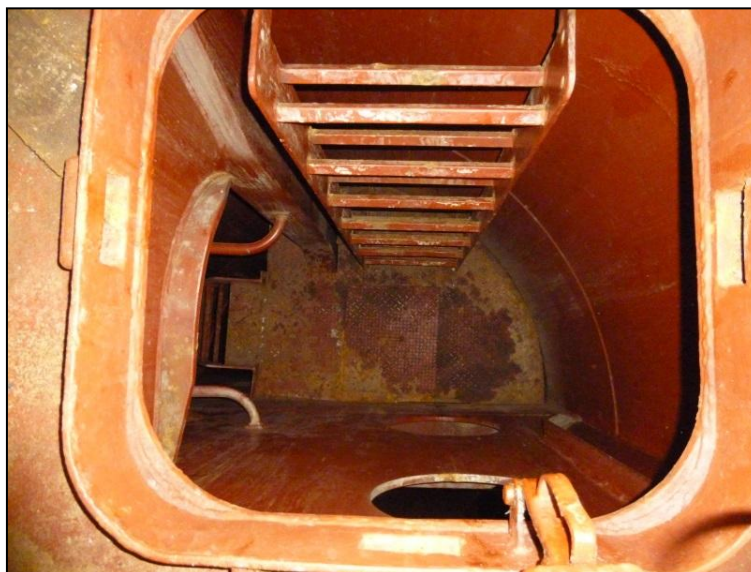
The chief mate and the bosun proceeded to test the atmosphere in the forward entrances to the cargo holds. They found that the gas analyser alarmed at a depth of between 1 m and 1.5 m from the top of the access hatch (Figure 4) on all cargo holds and indicated high concentrations of carbon monoxide. The readings, however, were not documented.

**Figure 4: Forward cargo hold access way viewed from the top void**

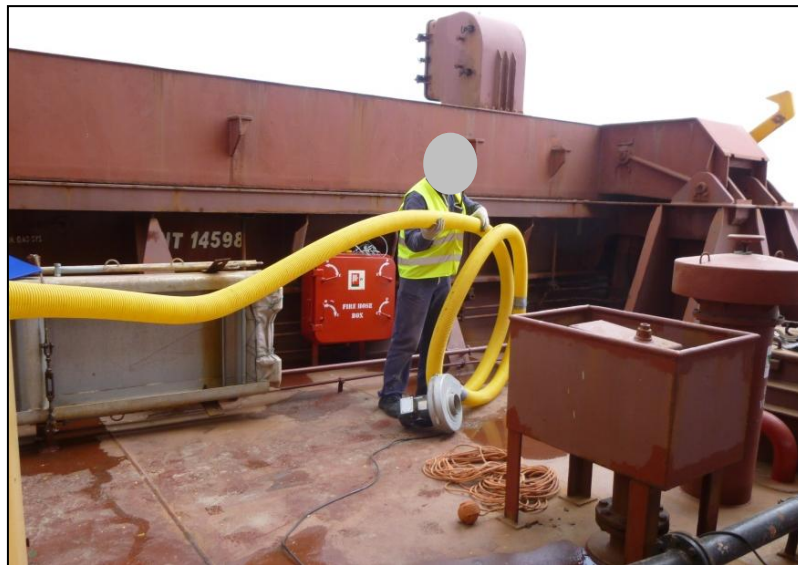
**Figure 5: Portable ventilator and hose**

The chief mate continued to search the main deck and then noticed that the portable ventilator hose had been led into the access way of cargo hold no. 4 via cargo deck crane no. 3 housing. Suspecting that the bosun may have entered the cargo hold, the chief mate advised the master to sound the 'General Alarm' and instructed the second mate to bring a breathing apparatus set to cargo deck crane no. 3.

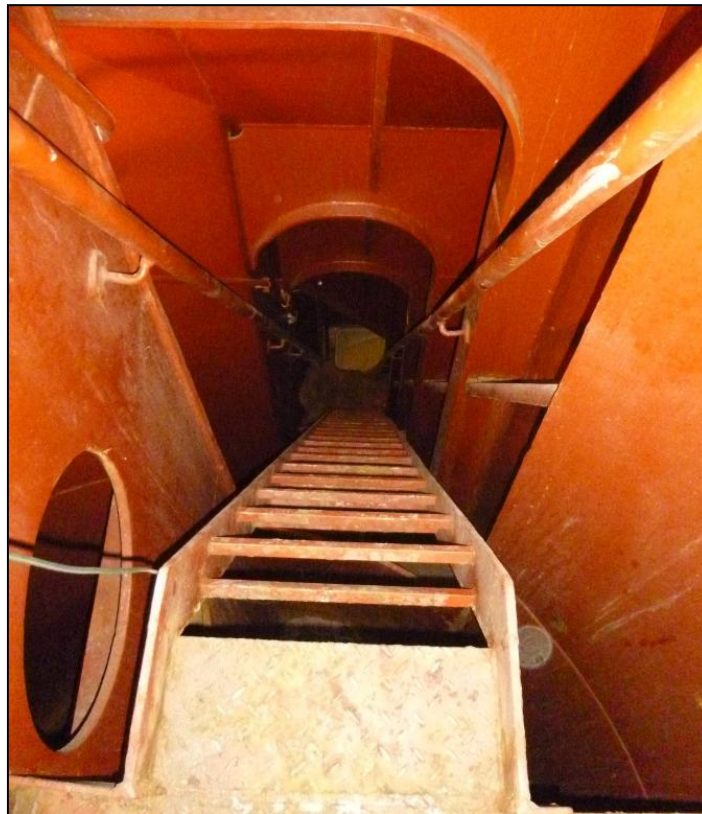
**Figure 6: Internal view of the 'Australian ladder' showing the bottom**

The bosun was found at the base of the 'Australian ladder' in the access to cargo hold no. 4 as indicated in Figures 6 and 7.

The post mortem report confirmed that the bosun had died of asphyxia. It also confirmed that the injuries noted to his head were compatible with a fall similar to that from the top of the lower platform (Figure 6) to the base of the ladder (Figure 7), where he was found. The cause of death was not compatible with carbon monoxide poisoning as initially suspected by the crew.

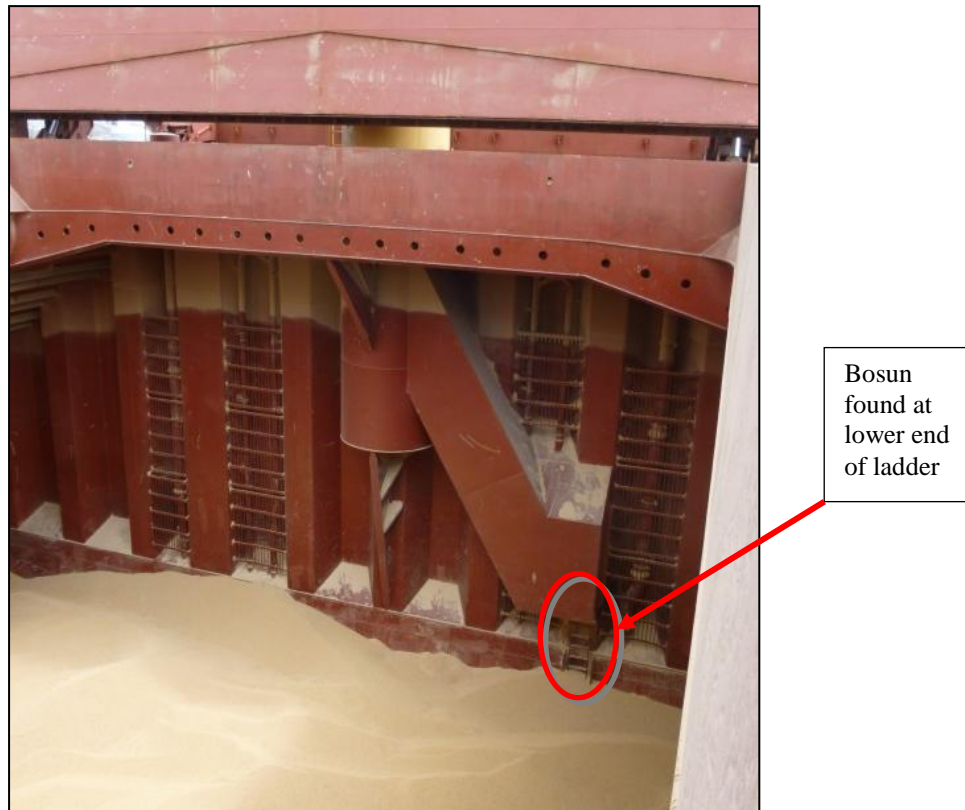
On finding the bosun at the bottom of the 'Australian ladder' (Figure 7), the fitter tried to wake the bosun but there was no response. The fitter then proceeded to turn

**Figure 7: External view of cargo hold no. 4's Australian ladder arrangement**

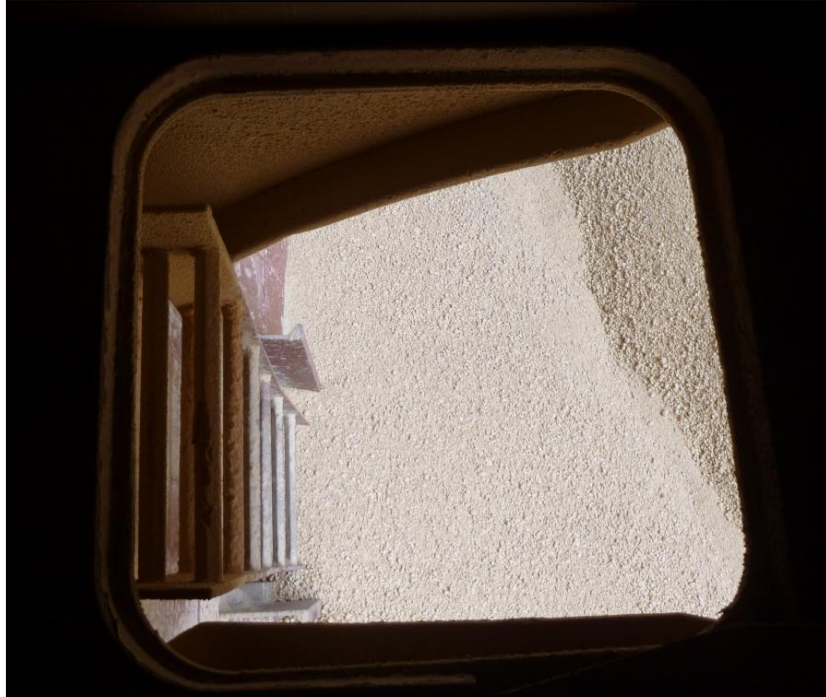
**Figure 8: Lower vertical ladder giving access to the cargo space**

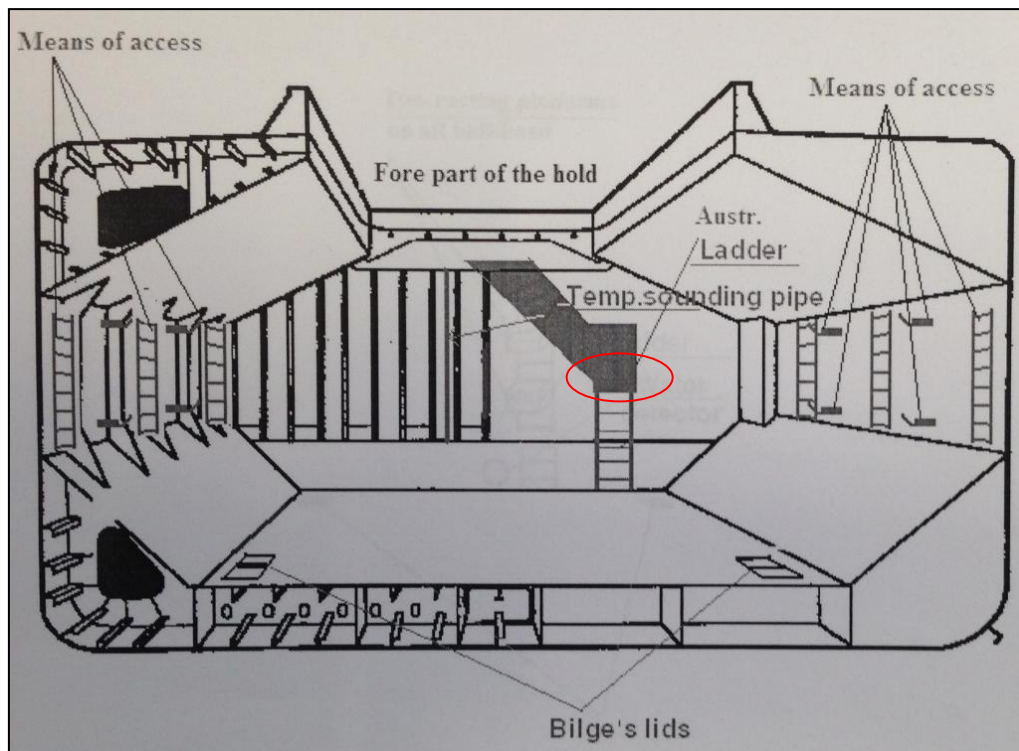
Figure 9 provides a schematic view of the forward part of cargo hold no. 4.

**Figure 9: Schematic view of the fore part of cargo hold no. 4**

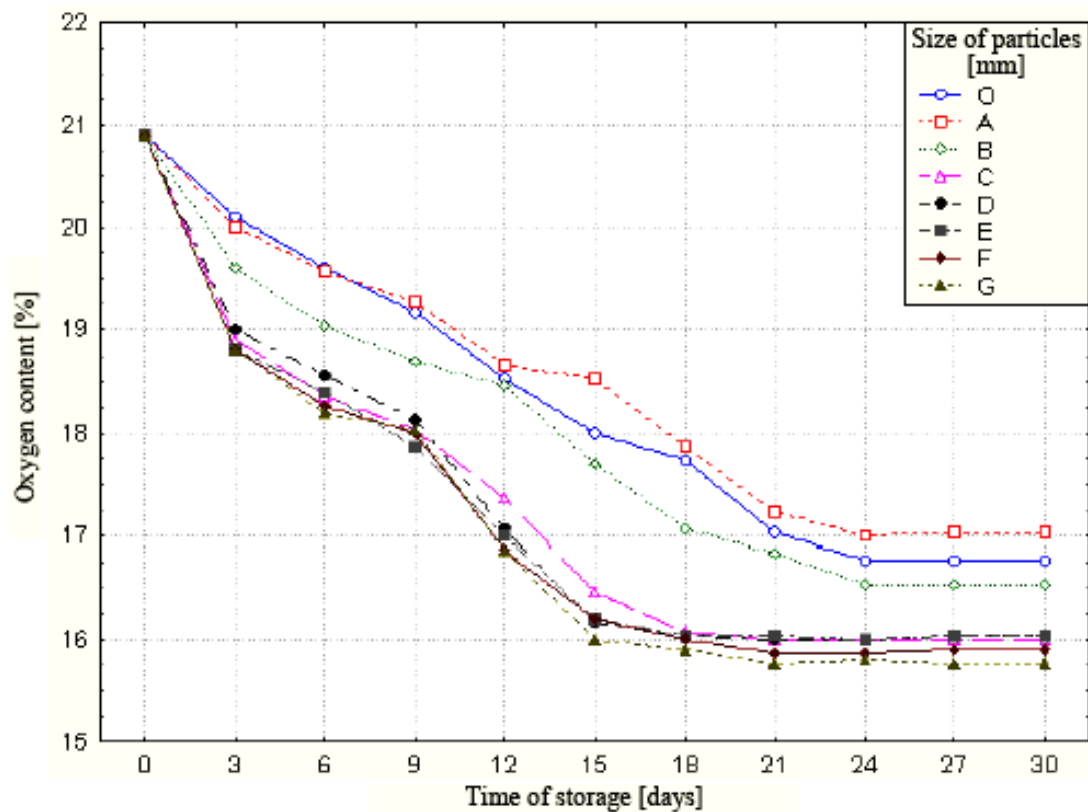
Soya bean seedcake is susceptible to oxidation. A study by Drzewieniecka (2012) concluded that over a period of 30 days, up to 5% of the oxygen in a space may be depleted (Figure 10).

**Figure 10: Relations of changes in oxygen content of soya bean seed cake over time in storage**

In the absence of detailed technical information such as that presented in Figure 10 and other negative cues, Company procedures were not followed and a dangerous space was entered after it had been closed for 39 days and before it was declared free of all hazards.

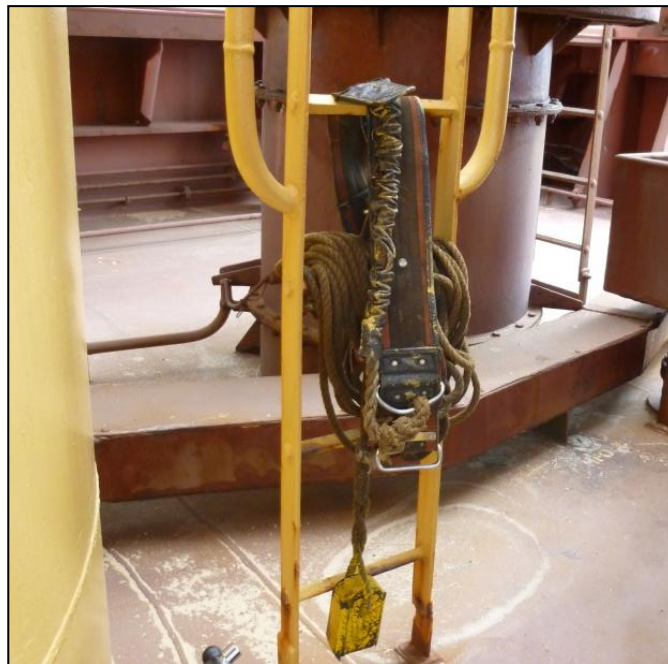
The response to the emergency was quick and within minutes the second mate and fitter had donned their BA set and entered the cargo hold access. However, additional equipment such as breathing sets, first aid kits and oxygen arrived in stages. The action of the chief mate in donning a BA set and entering the cargo hold meant that the on-scene command was temporarily lost. The crew used a safety harness (Figure 11) to extract the bosun. This harness, however, was not very effective to extract unconscious bosun from the space.

**Figure 11: Safety harness**
