# MÆRSK BATTLER

Marine accident report on MAERSK BATTLER's loss of tow and the foundering of MÆRSK SEARCHER and MÆRSK SHIPPER on 21 and 22 December 2016

The report is issued on 30 August 2017

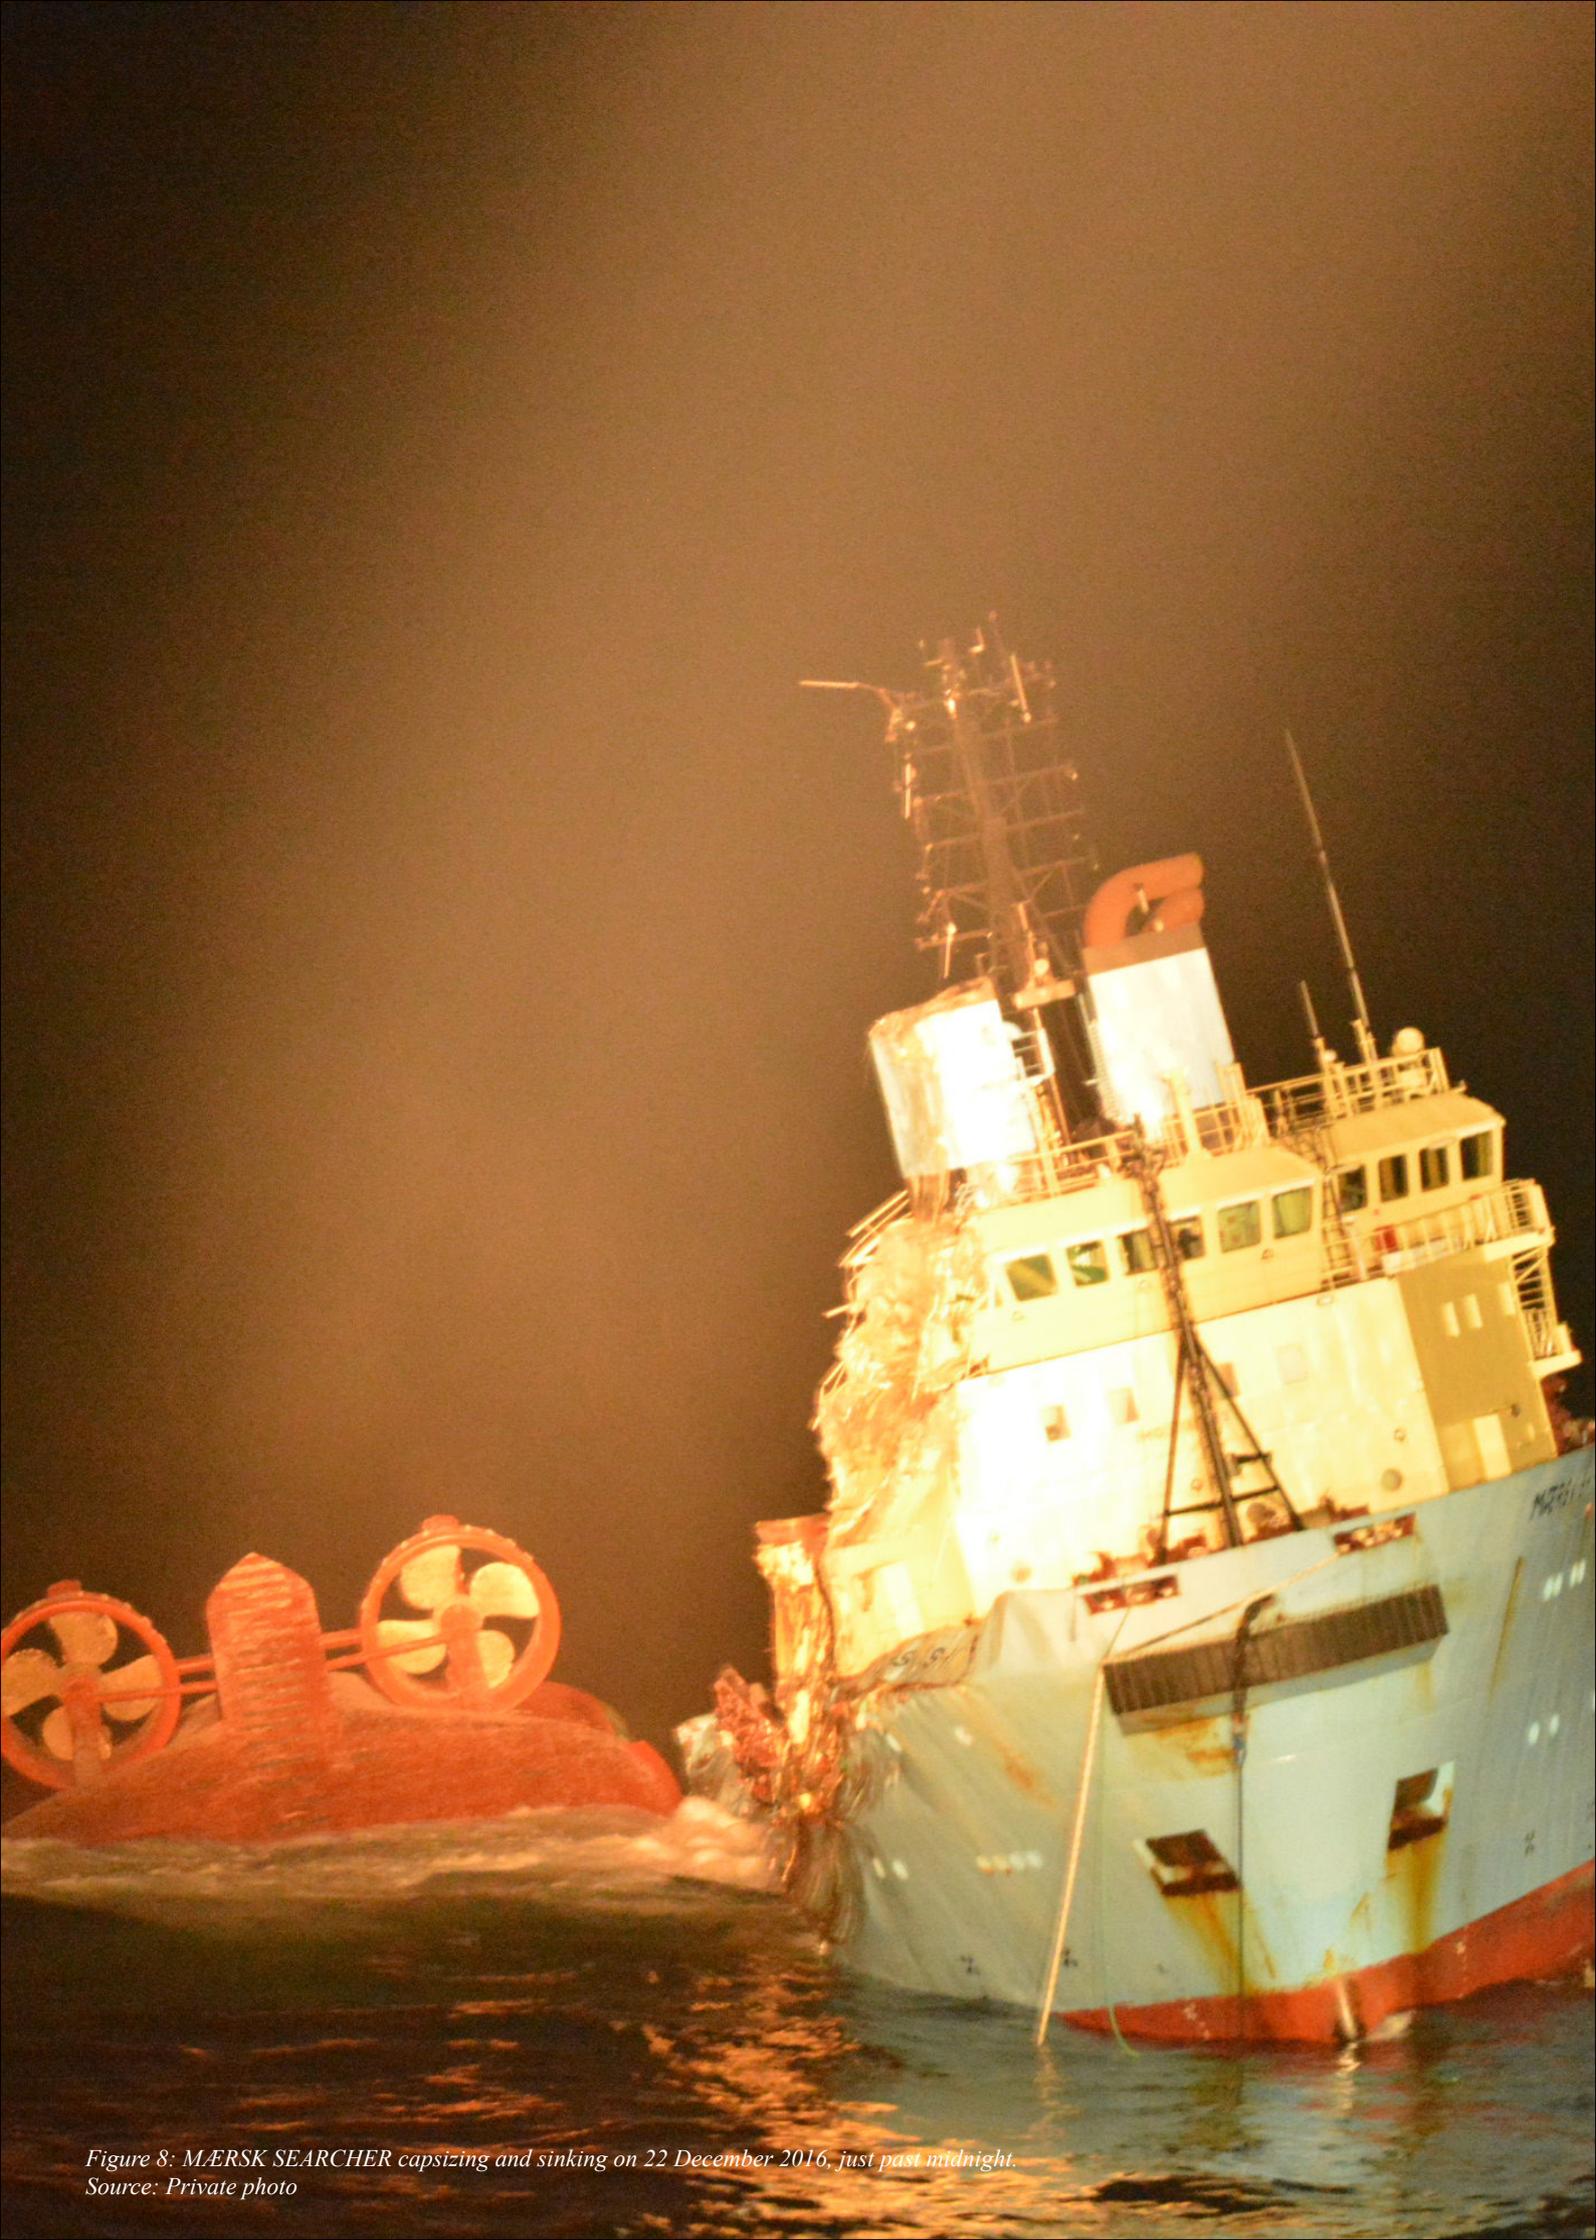
*Figure 8: MÆRSK SEARCHER capsizing and sinking on 22 December 2016, just past midnight.  
Source: Private photo*

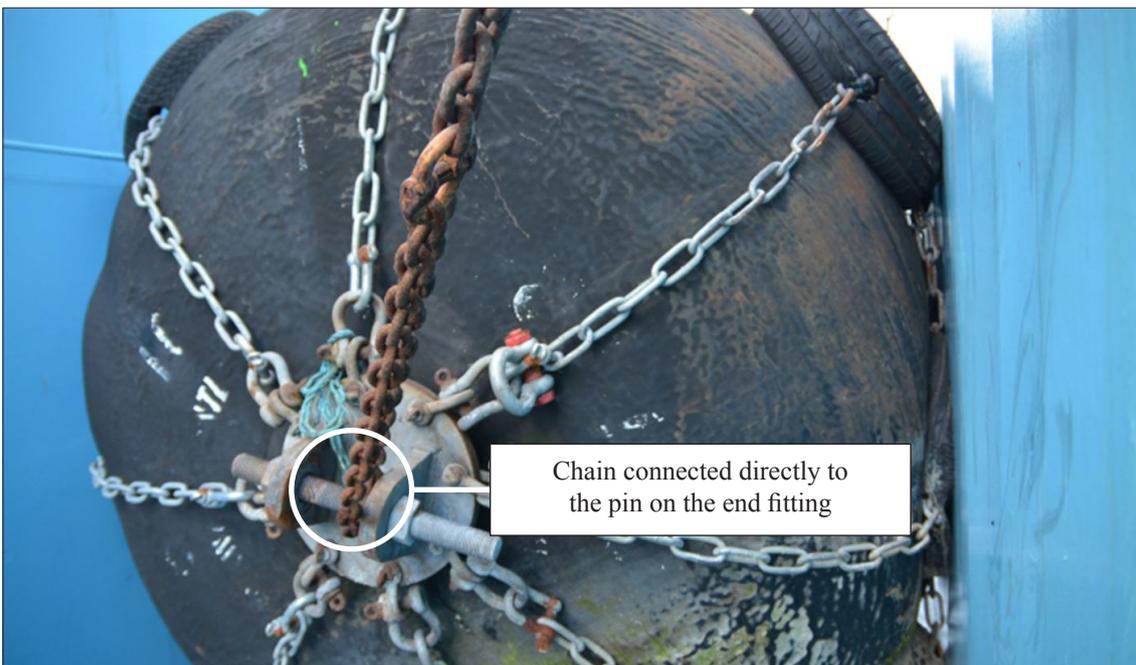
Figure 17: Fender from MÆRSK SEARCHER.  
Source: Private photo

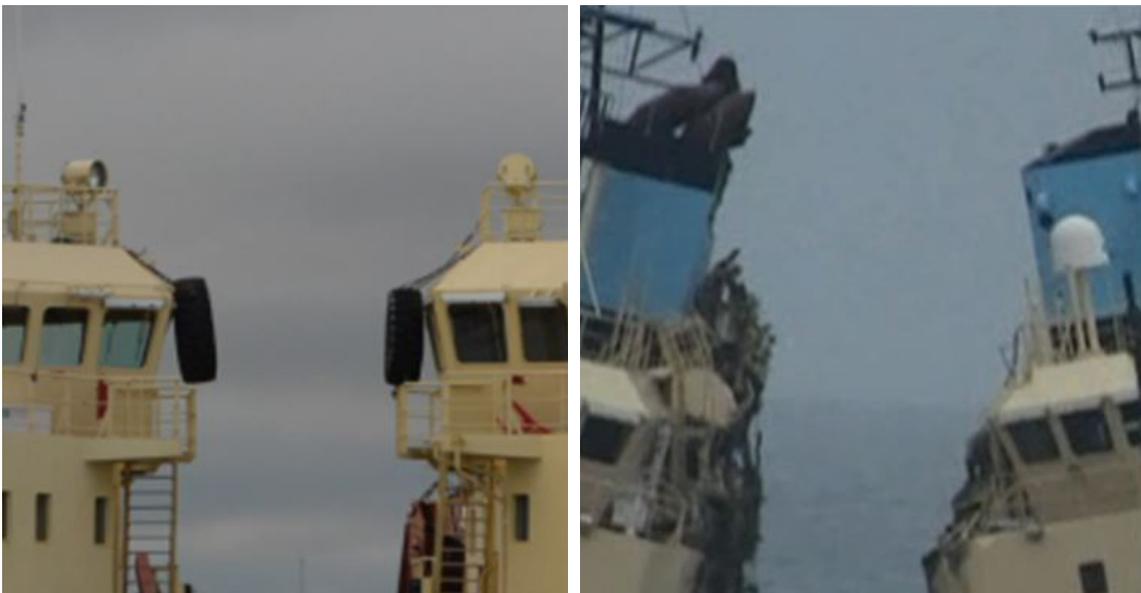
In addition to the fender setup discussed above, the planning process had identified a separate risk of the bridge wings colliding, causing structural damage to the superstructure. To counter this, it was decided to mount tyre fenders on the outer end of each bridge wing. When the towed ships started impacting, the bridge wings were crushed, and thus the tyre fenders did not have the desired effect (figure 20).

*Figure 20: Left: Tyre fenders on bridge wings Right: Bridge wings after impact.  
Source: Maersk Supply Service*

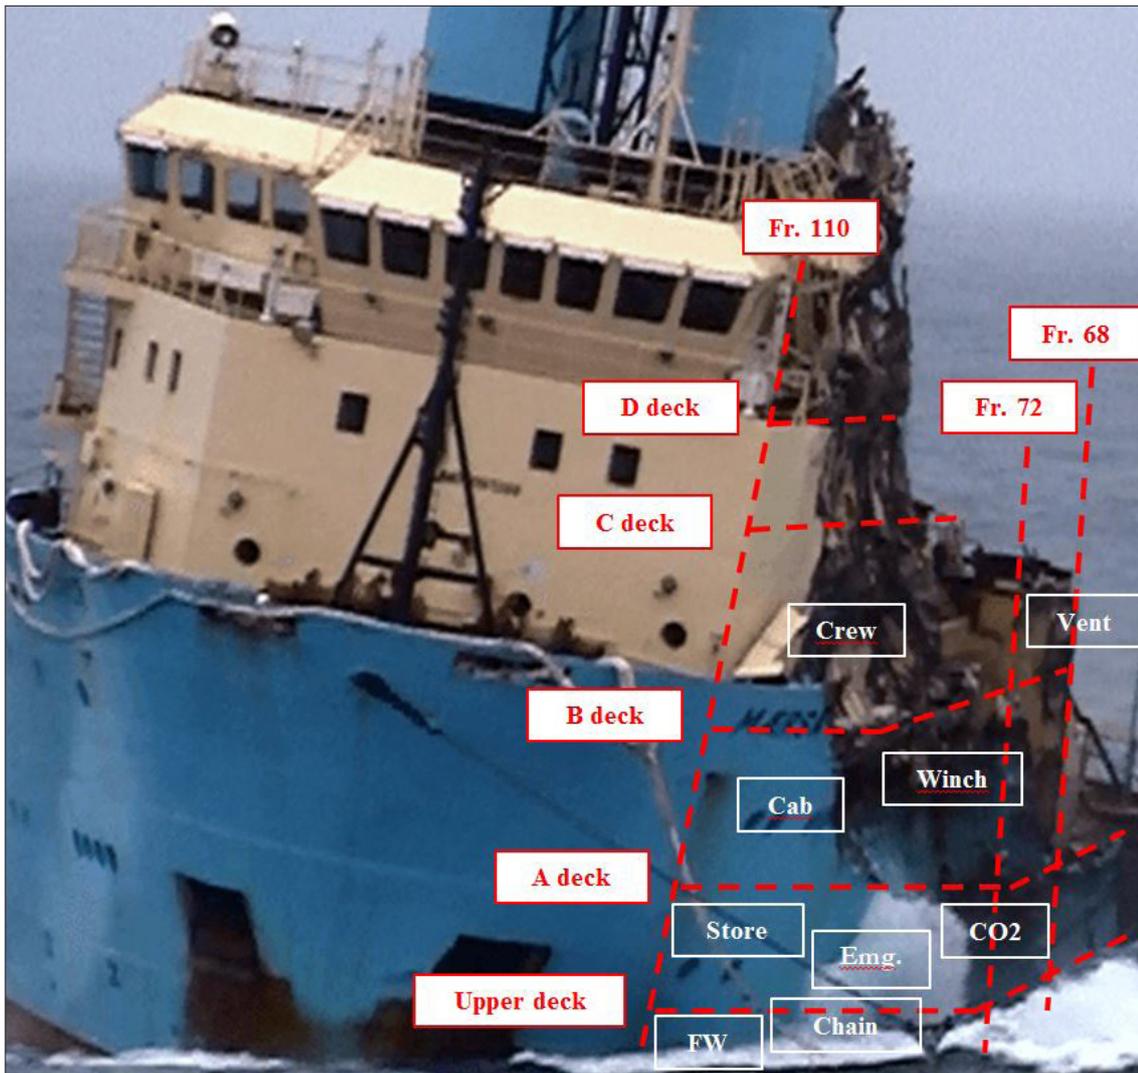
As the illustrations of MÆRSK SEARCHER show (figure 26, next page), the shell plating, superstructure, deck appendages and underlying structure had sustained significant damage in an area extending longitudinally from the front of the superstructure to aft of the engine room ventilation duct, just aft of the superstructure and winch garage.

Figure 26: Extent of the visible damage on MÆRSK SEARCHER.  
 Source: Maersk Supply Service/DMAIB

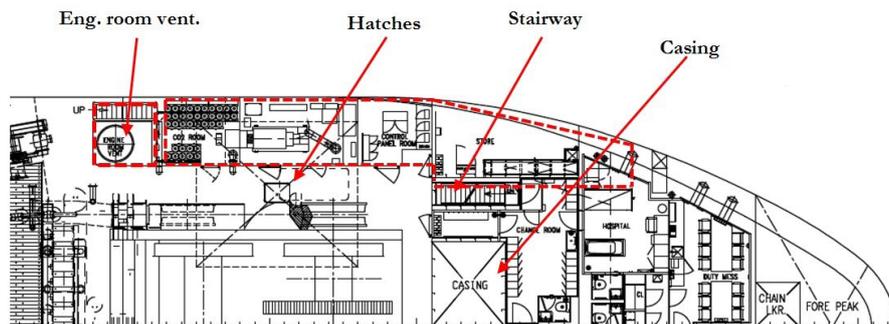
The significant damage to the ship's structure allowed a large ingress of sea water into the internal compartments of the ship. Because the ships had one large watertight compartment below the freeboard deck, any water ingress into the major part of the hull would enter into the same watertight compartment. Figure 29 on next page shows potential flooding points and areas.

Figure 29: Potential water ingress flooding points and areas.  
Source: Private photos/DMAIB
