MARINE SAFETY INVESTIGATION REPORT

Safety investigation into the serious injury on board the
Maltese registered general cargo

HOPA

MARINE SAFETY INVESTIGATION REPORT NO. 07/2014

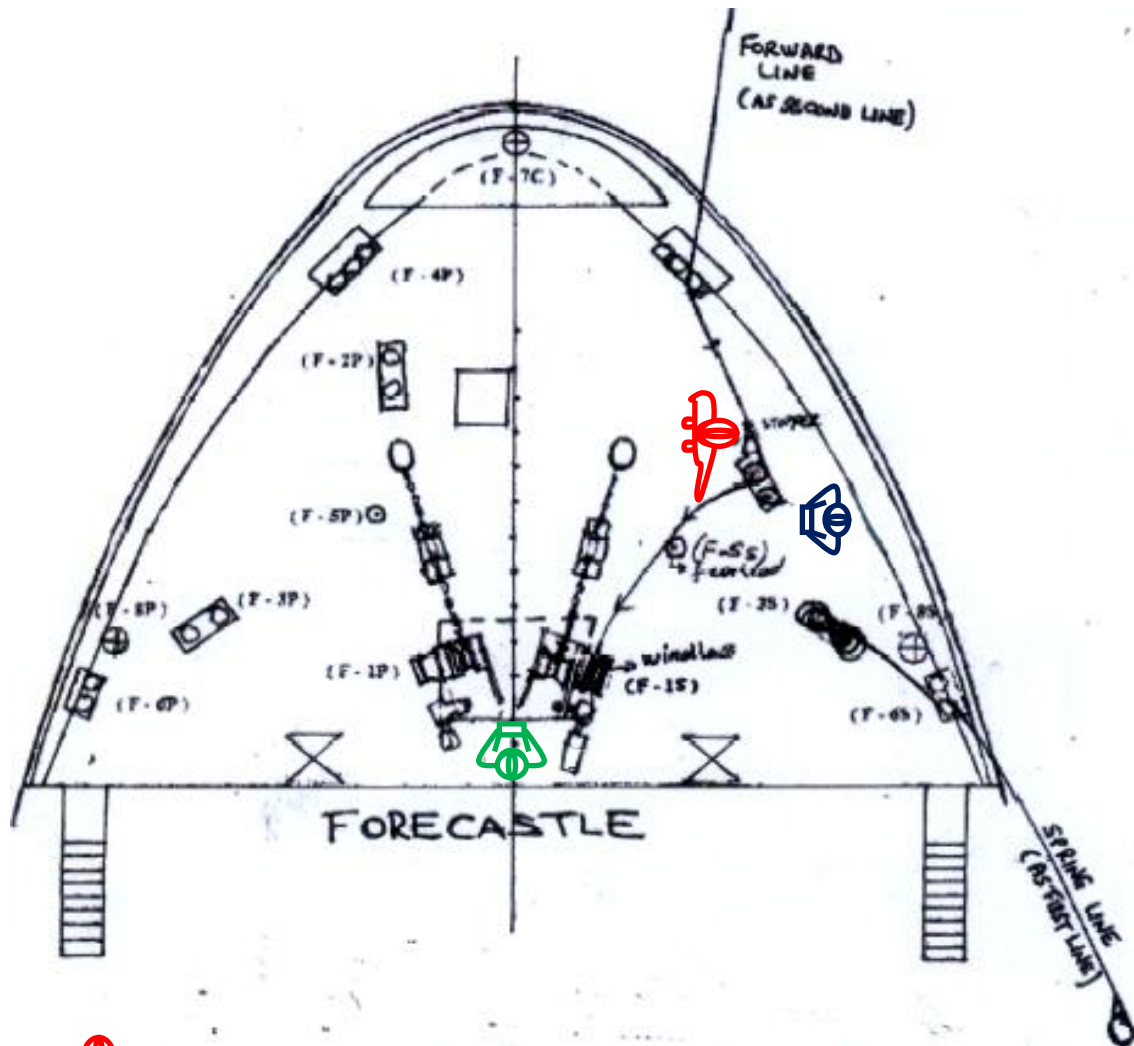
Figure 4: Crew members on forecastle deck at the time of the accident

Figure 4 is a sketch prepared by the master, showing the approximate positions of the crew members involved in the mooring operation at the time of the accident.

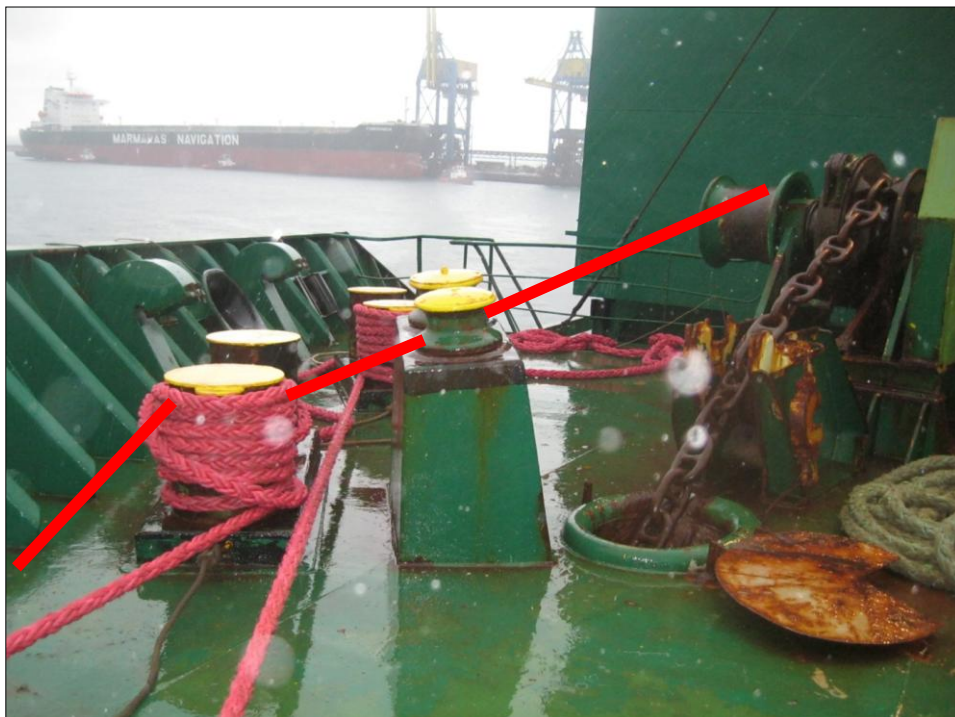
Figure 5: The head line arrangement at the bitts and the pedestal fairleads

fairlead, the head line was passed in between the two pillars of the starboard forward bollards, to the rollers and onto the windlass' capstan.

According to the chief mate's advice, as soon as the head line was under tension, the OS applied a stopper line so that he could shift the head line and fasten it on the vessel's bollard. At this point in time, the chief mate noticed that the OS was not using the stopper line correctly. Specifically, the OS had fixed the stopper line very close to the bitt and did not allocate enough length for the application of the stopper line to hold the head line effectively. The chief mate cautioned the OS to ensure that the stopper line is well aligned with the mooring rope. The OS changed the position of the stopper line and led it closer to the mooring rope.

During this second application of the stopper line, the OS noticed that the head line was making a creaking sound indicating that it was very much under tension. At this instance, at about 1230, the head line jumped off the bitt and hit the OS (Figure 5) who, as a result of the impact, fell to his knees on the forecastle deck.

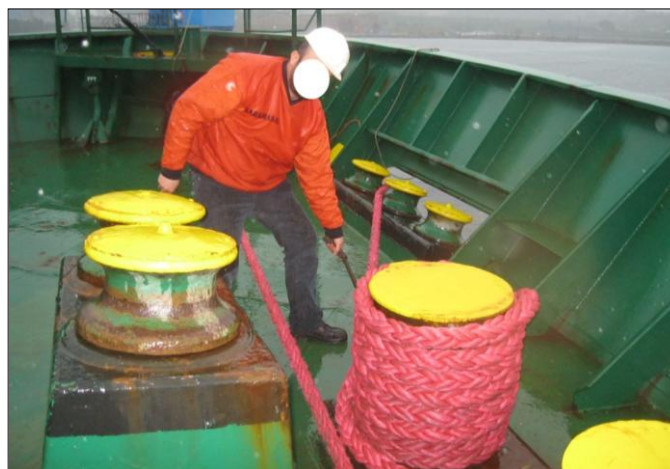
Figure 6: The chief mate demonstrating the approximate position of the OS, moments before the accident

Considering that the OS lacked experience, Figure 6 also suggested that the other crew members on the forecastle deck did not caution the OS of the dangers of staying in close proximity of a mooring rope under tension, in all probability because they were busy executing their tasks.

Team work is central to most settings, including shipboard operations. There was no evidence to suggest that the OS was directed to stand in a hazardous position. Therefore, positioning himself in close proximity of a mooring rope under tension was a decision, which was not influenced by any other crew member. However, informational support *i.e.* advice from other crew members on the potential hazards of stressed mooring ropes, was not provided by any of the other crew members.

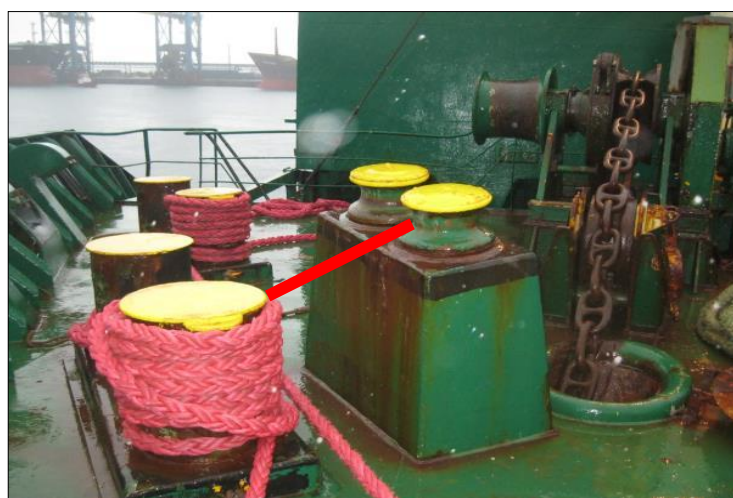
Figure 7: Different heights of mooring equipment on the forecastle deck (red line indicates the resulting angle of the mooring rope)

It is normal on board ships to have the pedestal fairleads and the bitts of different heights. Moreover, the rollers on board *Hopa* were closely fitted to the bitts. There is also a normal height difference between the top cap of the bitts and the rollers.

This height difference between different mooring equipment contributed to an angle of the mooring rope under tension when it was run straight from the bitts to the rollers (this was the arrangement at the time of the accident) (Figure 7).

With this angle, a mooring rope under tension would create a vertical component of force that would displace the rope upward, potentially resulting in the mooring rope slipping off the bitt. Other alternative arrangements, such as the one represented in Figure 8, could have prevented the mooring rope from slipping the bitts.

- .1 The immediate cause of the accident was the angle taken by the mooring rope running straight from the bitts to the rollers, creating a vertical component of force that displaced the rope upwards off the bitts and hitting the crew member.
