ELANDRA BALTIC CASUALTY INVESTIGATION REPORT

Man Overboard

Port Approaches Fos-sur-Mer, French Republic | 13 April 2020

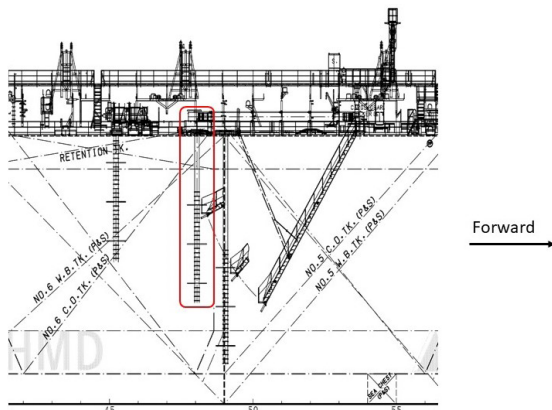
9. The pilot ladder can be rigged in one of three positions (*see Figure 1*). The pilot ladder is located at either of the two forward positions when a combination pilot ladder is rigged. On 13 April 2020, the pilot ladder was rigged in the middle position. Access to this location was through an opening in the ship's guardrail that could be closed using chains. The guardrail had to be open when rigging or recovering both the accommodation and pilot ladders.

Figure 1: A portion of the ship's General Arrangement drawing showing the location of the pilot boarding area on the starboard side. The arrangements on the port side are identical. The position where the pilot ladder was rigged on 13 April 2021 is circled in red.

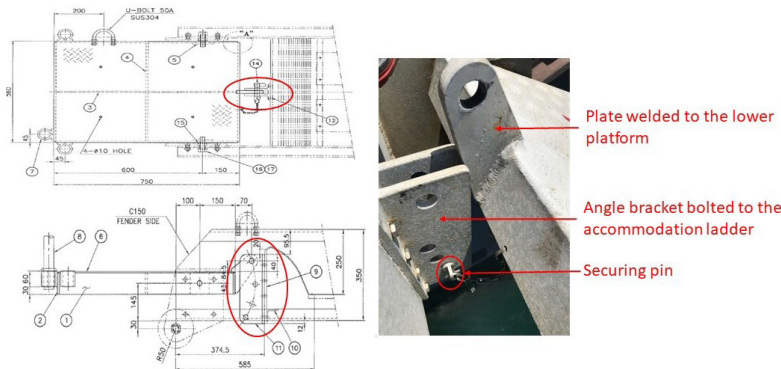
10. The Bosun reported that they decided, after rigging the pilot ladder, that the lower platform of the accommodation ladder needed adjusting to be parallel with the water. The ASD2 then went down the accommodation ladder without putting back on his lifejacket and safety harness.
11. The lower platform is held in position by a securing pin that passes through one of four sets of holes in the angle bracket, which is bolted to the accommodation ladder, and a hole in the rectangular bar welded to the lower platform (see Figure 2). The angle of the lower platform is determined by which set of holes on the angle bracket that the securing pin is passed through.

Figure 2: On the left is a drawing of the lower platform of the accommodation ladder showing the angle bracket and plate (circled in red). On the right is a picture of the angle bracket, plate, and securing pin. The lower platform was not secured in position when the picture was taken.

The platform would not have dropped if the securing pin had been passed through the set of holes in the angle bracket on the accommodation ladder and the hole in the bar welded to the platform (*see Figures 2 and 3*).

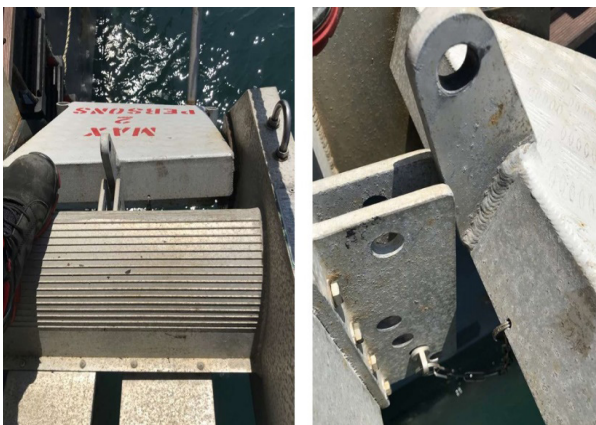
25. When the lower platform was checked by a crewmember before being secured so the pilot could board, the securing pin was found through one of the four sets of holes in the angle bracket. It did not pass through the hole in the bar welded to the lower platform (*see Figure 3*).

Figure 3: The lower platform of the accommodation shown as found after the ASD2 fell overboard. These pictures were taken while the ship was at anchor after the SAR operation was suspended. The securing pin had not been passed through the hole on the bar welded to the platform when it was put through the holes on the angle bracket.

The Bosun stated that the ASD2 fell overboard when the lower platform of the accommodation ladder dropped as he stood up after changing its position. After the incident, the platform was checked and it was determined that it had not been properly secured (*see Figure 3*) when adjusted by the ASD2.
