Rapport d'enquête Investigation report

**Échouement du vraquier *SEA EAGLE*
le 11 décembre 2019, en Seine**

**Grounding of the bulk carrier *SEA EAGLE*
on 11 December 2019, in Seine River**

Rapport publié : novembre 2020

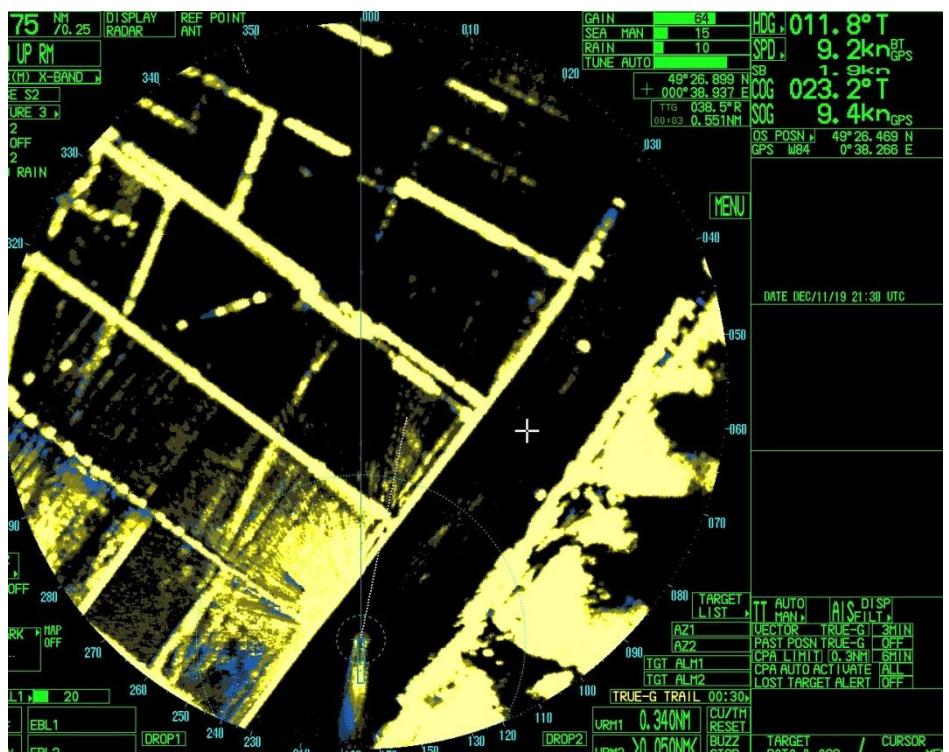
VDR : capture écran radar

À 22h28 le sondeur indique 6,10 m. Le *SEA EAGLE* fait une grande embardée à gauche. Le pilote demande aussitôt la barre toute à droite.

À 22h29 le cap passe au 029°, la vitesse est de 10,2 nœuds. Le navire poursuit son évolution sur la gauche. Le capitaine appelle le chef mécanicien et lui demande de vérifier en urgence la position de la barre dans le local appareil à gouverner. Moins d'une minute après, celui-ci rappelle le capitaine et confirme la position de la barre « à droite toute ». Aucune alarme sur la barre ne s'est déclenchée, aussi bien en passerelle que dans le local appareil à gouverner.

À 22h30 le navire réduit son embardée sous l'effet de la barre. La vitesse est de 9,4 nœuds.

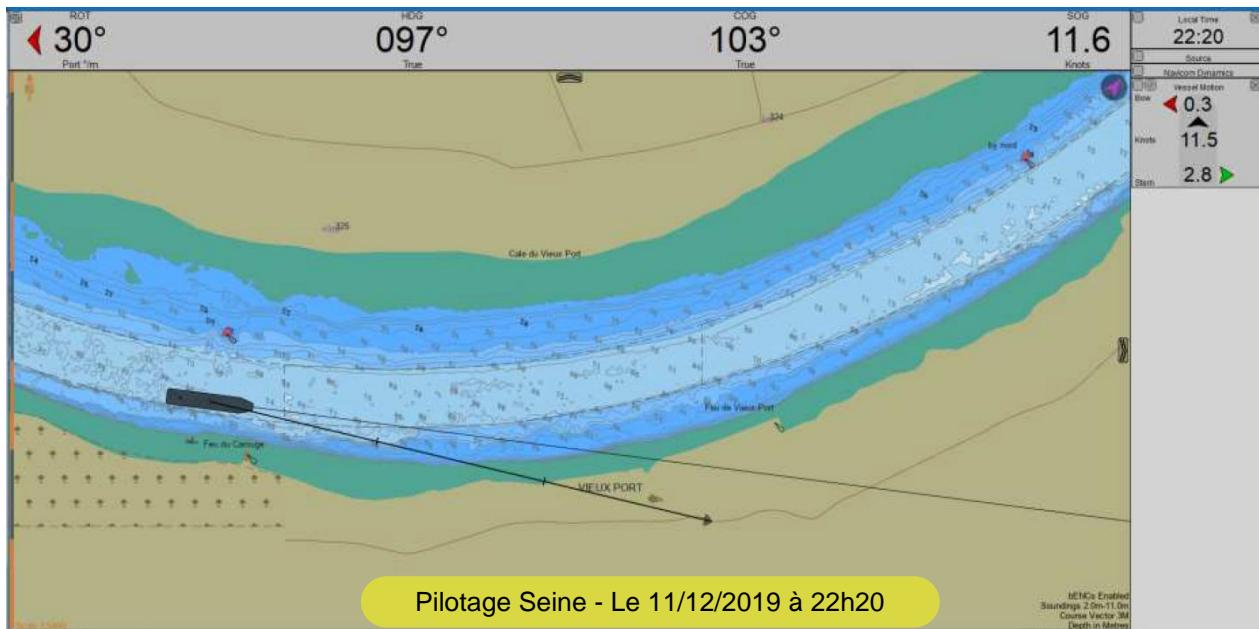
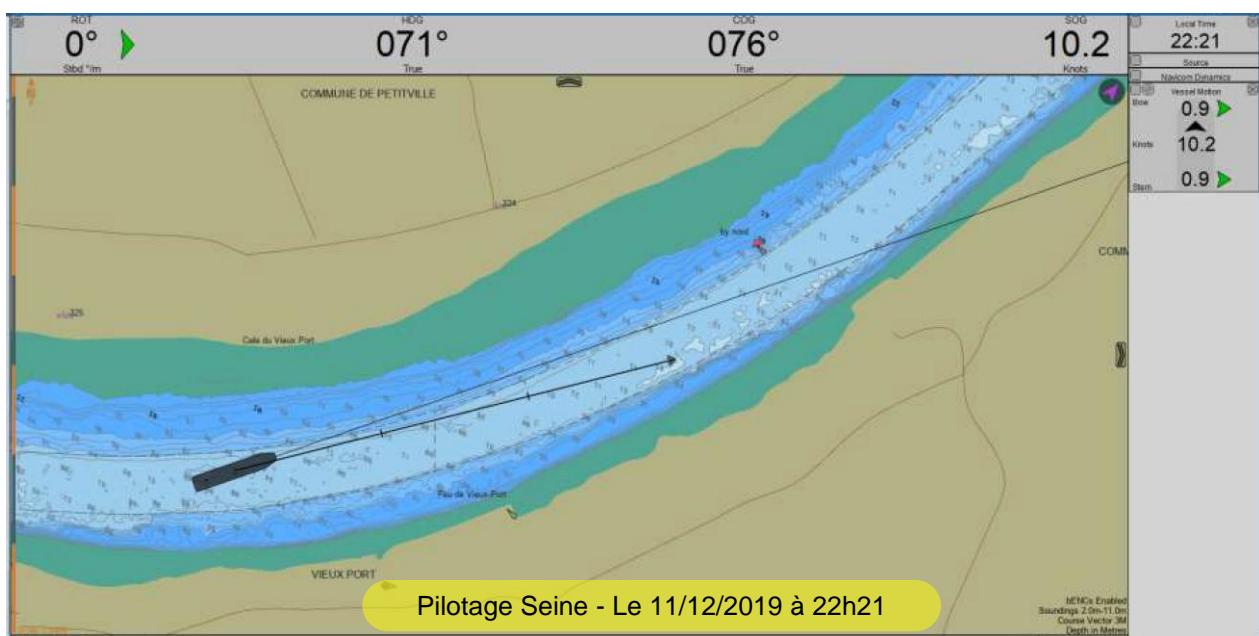
À **22h21** le navire fait une embardée sur la gauche et atteint la partie nord de la gaine. Le pilote contre l'embardée en demandant la barre 10°, puis 20°, puis toute à droite. Le navire revient au cap.

À **22h25** le navire est stabilisé dans le milieu de la gaine, cap au 058°, à hauteur de la bouée latérale bâbord Vieux Port Nord.

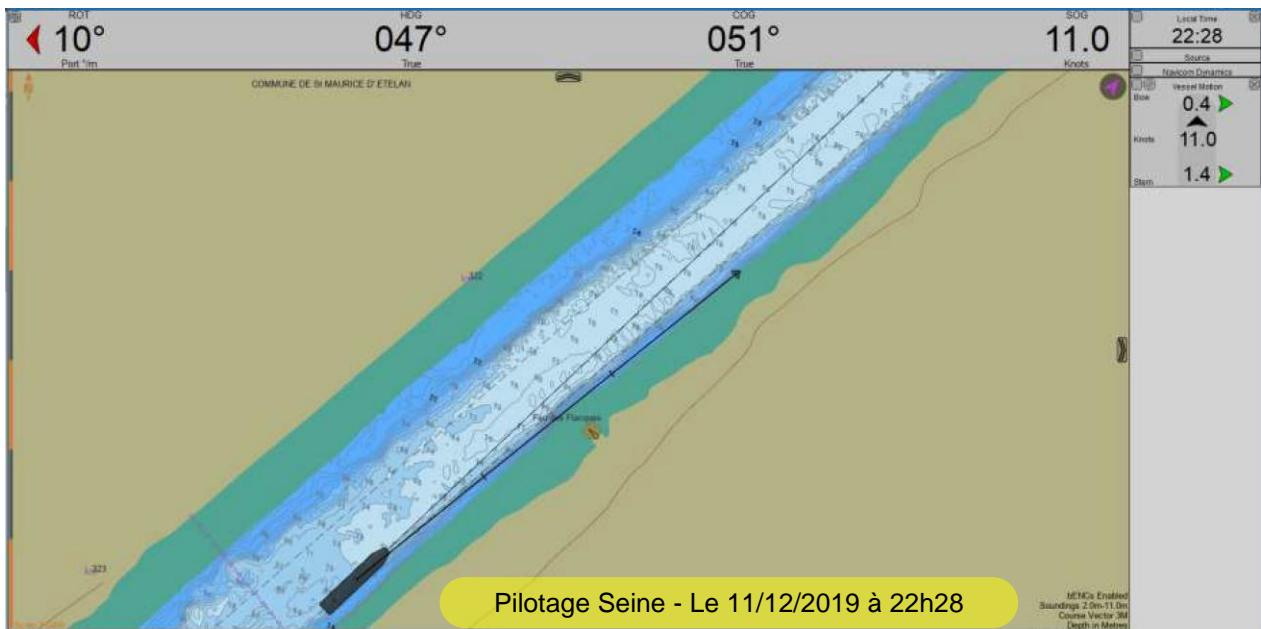
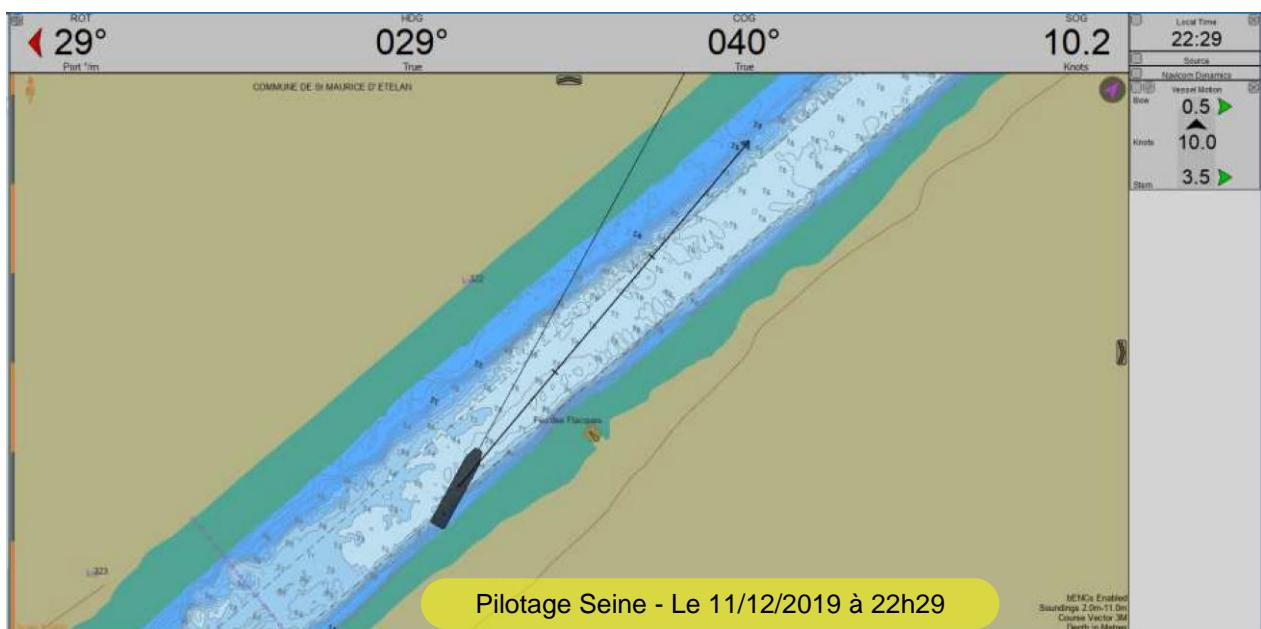
De **22h27** à **22h28** le cap passe du 049° au 047° à la demande du pilote, la vitesse de 11,3 nœuds à 11 nœuds.

Dans les secondes qui suivent le navire fait une embardée sur la gauche.

À **22h29** à hauteur du feu vert Les Flacques, le cap est au 029°, malgré l'ordre de barre à droite toute. L'indicateur de giration est à son maximum sur bâbord (29°/min).

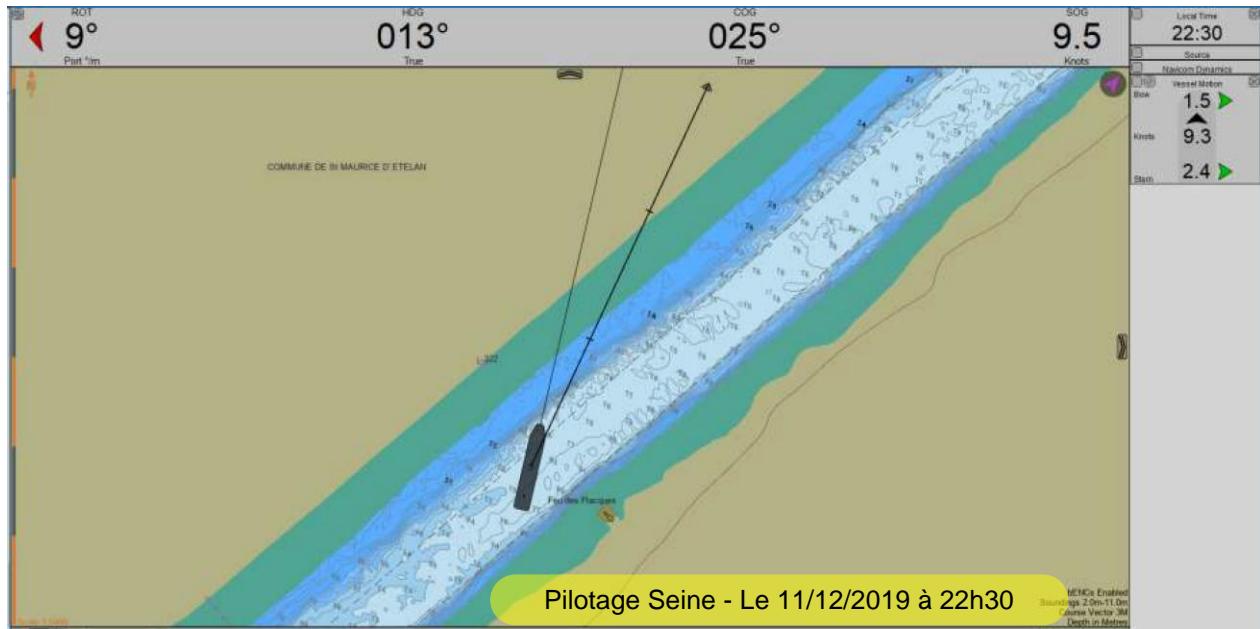
À **22h30** l'indicateur de taux giration diminue à 9°/min, toujours sur bâbord. Le cap est au 013° à 9,5 nœuds.

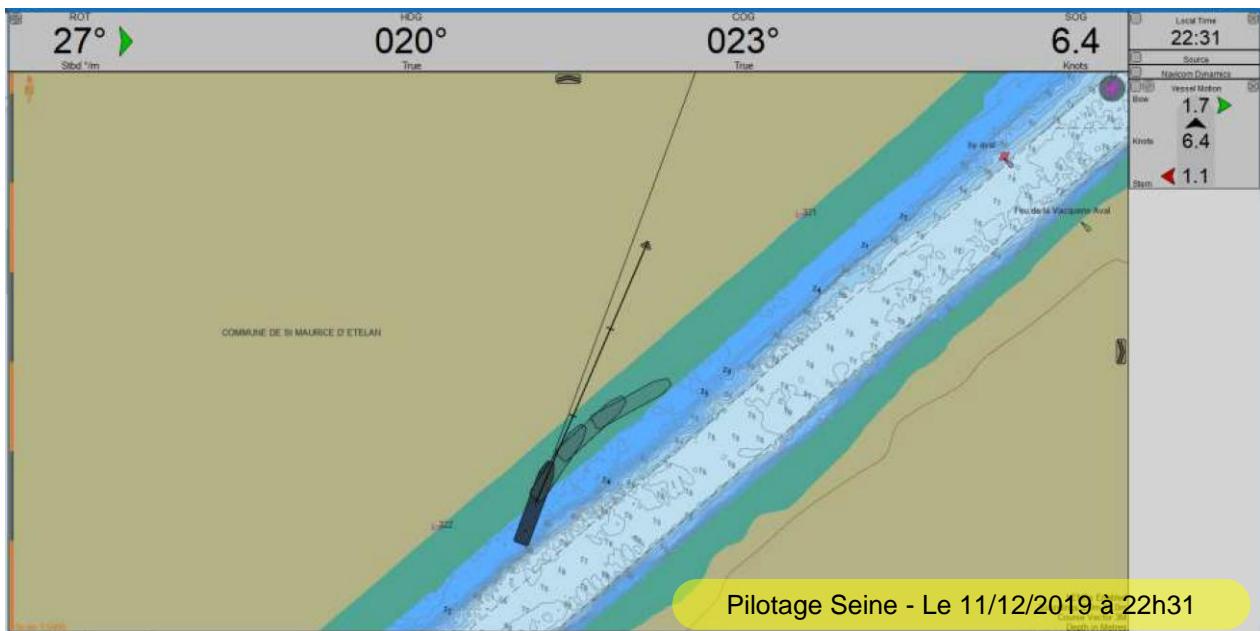
À 22h31 l'indicateur de giration est à 27°/min, cette fois sur tribord. Le cap est au 020° à 6,4 nœuds.

À 22h32 le navire est échoué.

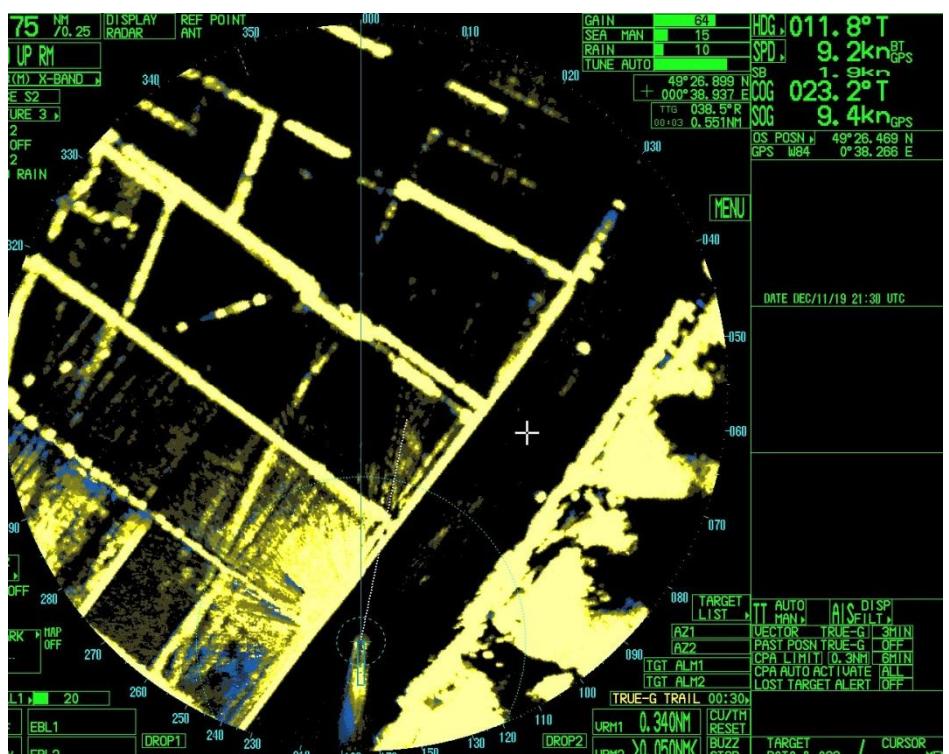
VDR: radar display

At 10.29 pm the heading was 029°, the speed was 10.2 knots. The vessel continued her port swing. The master called the chief engineer and asked him to check urgently the rudder angle in the steering gear compartment. Less than one minute later, the latter called back the master and confirmed the position of the helm « hard-a-starboard ». No steering gear alarm triggered, at the bridge as well as in the steering gear compartment.

At 10.30 pm the vessel reduced her yaw as a result of the helm effect. The speed was 9.4 knots.

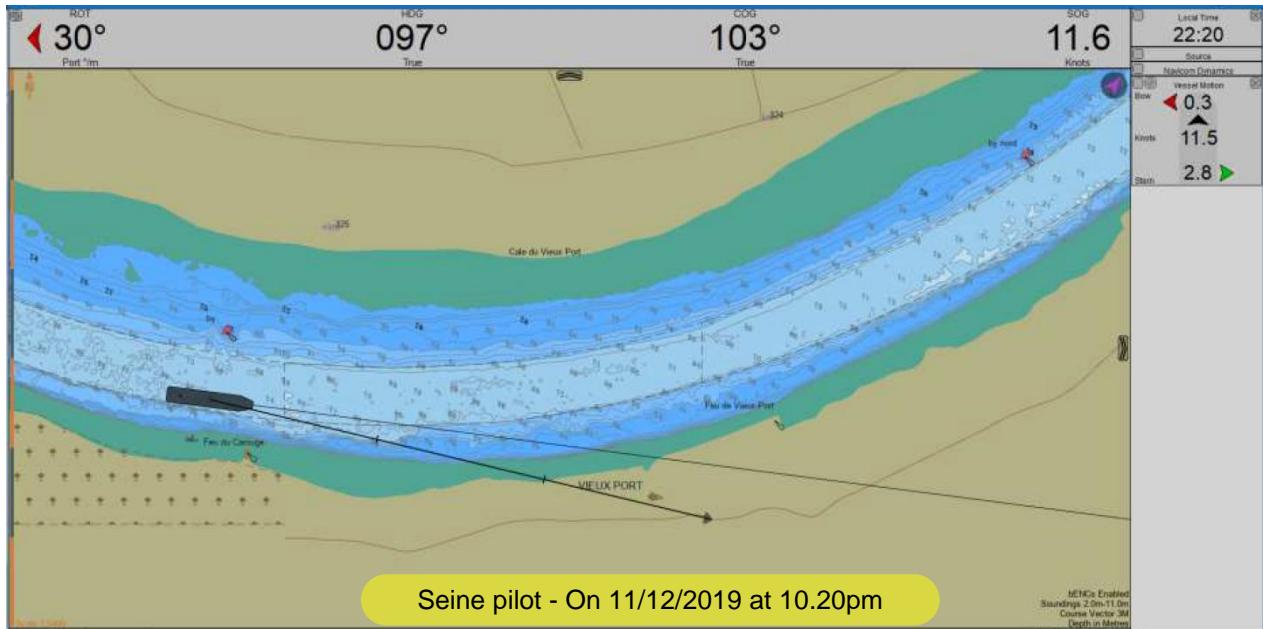
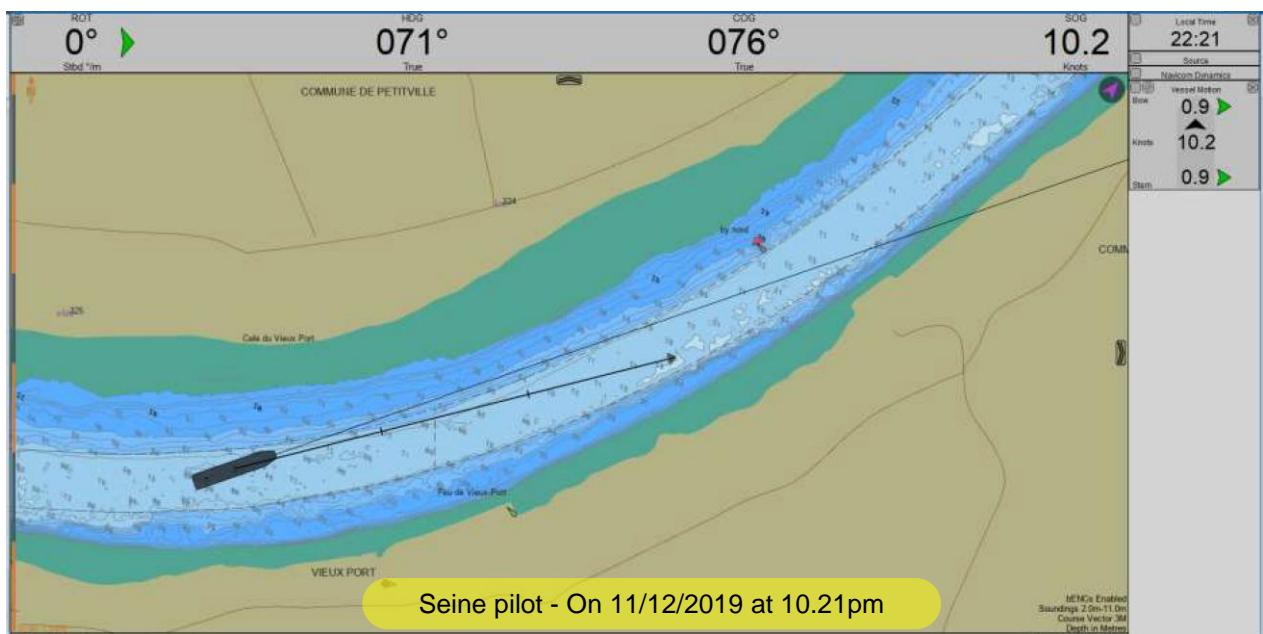
At **10.21 pm** the vessel took a sheer to port and reached the northern part of the “gaine”. The pilot checked the sheer by requesting starboard ten, then twenty, then hard-a-starboard. The vessel resumed her course.

At **10.25 pm** the vessel had steadied in the middle of the “gaine”, heading 058°, passing by *Vieux Port Nord* port lateral buoy.

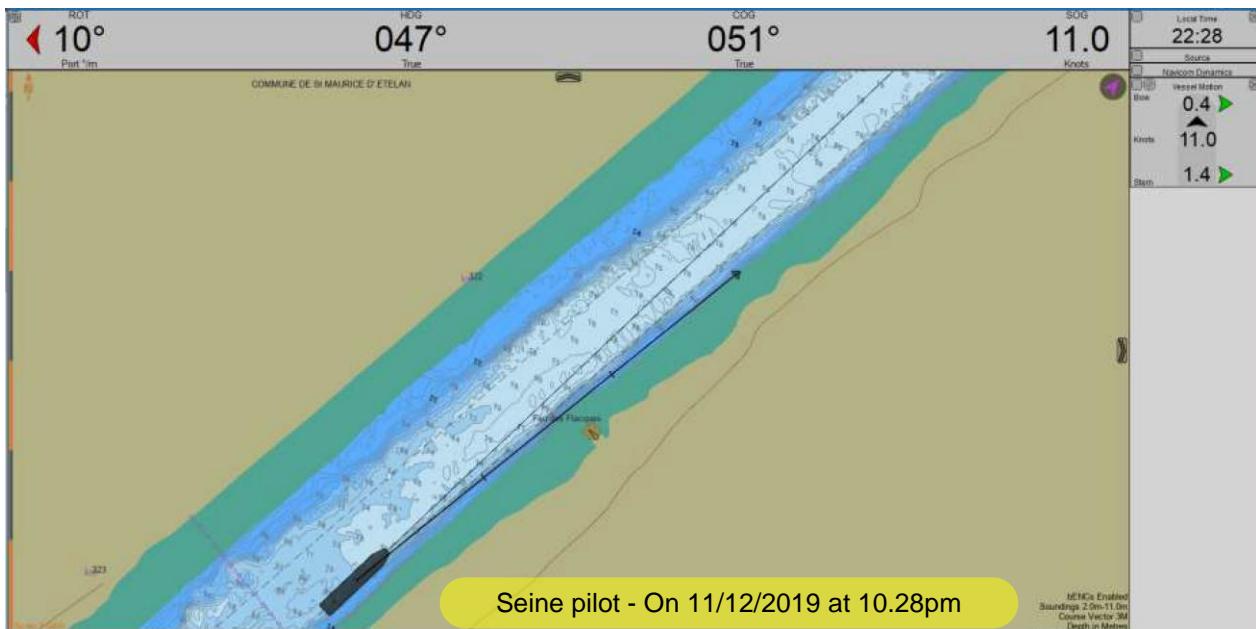
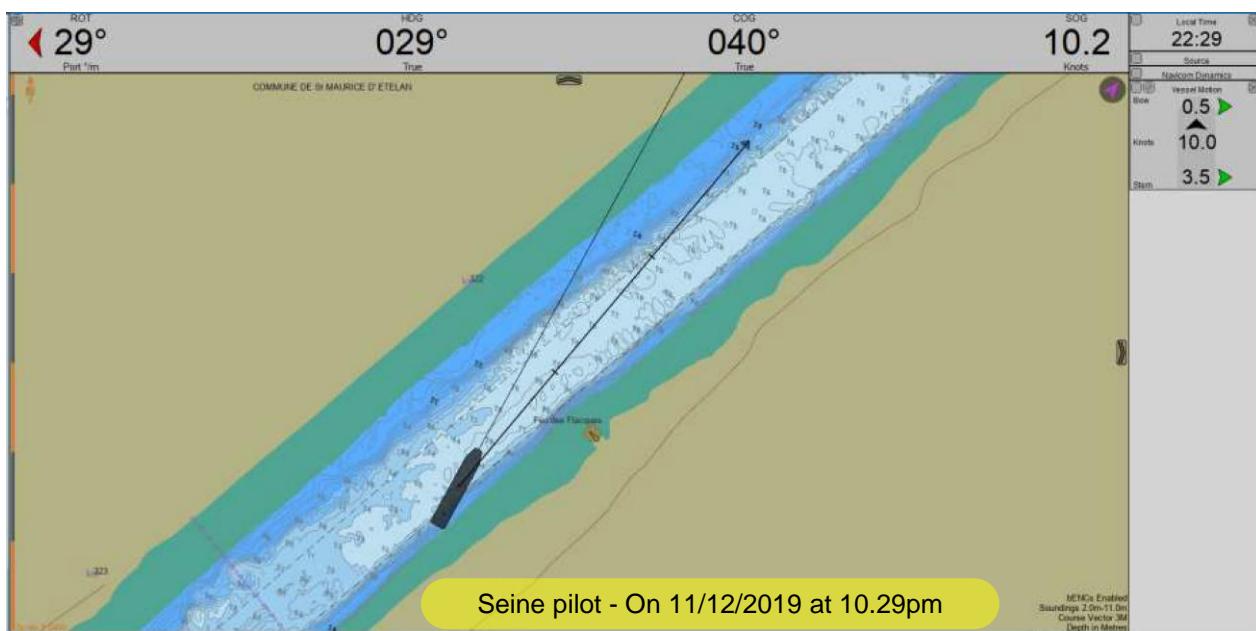
From **10.27 pm** to **10.28 pm** the heading was altered from 049° to 047° on pilot’s request, the speed from 11.3 knots to 11 knots.

Within the next few seconds the vessel took a sheer to port.

At **10.29 pm** by *Les Flacques* green light, the heading was 029°, despite the wheel order hard-a-starboard. The Rate Of Turn indicator was at its maximum to port (29°/min).

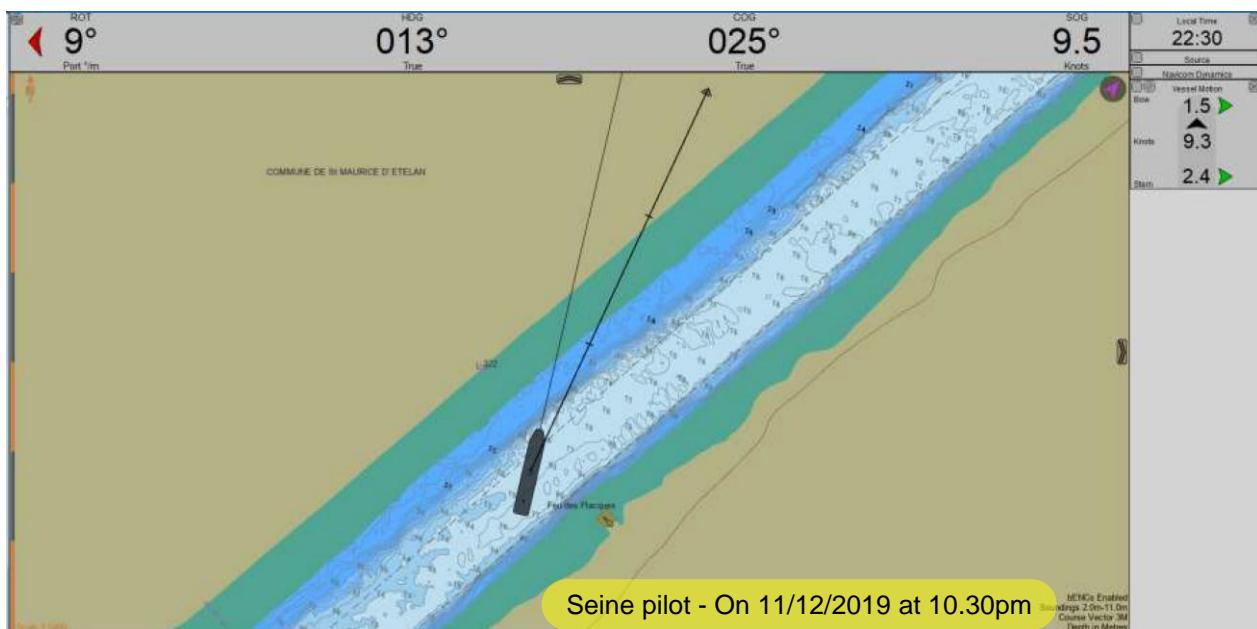
At **10.30 pm** the Rate Of Turn indicator decreased to 9°/min, still to port. The heading was 013° at 9.5 knots.

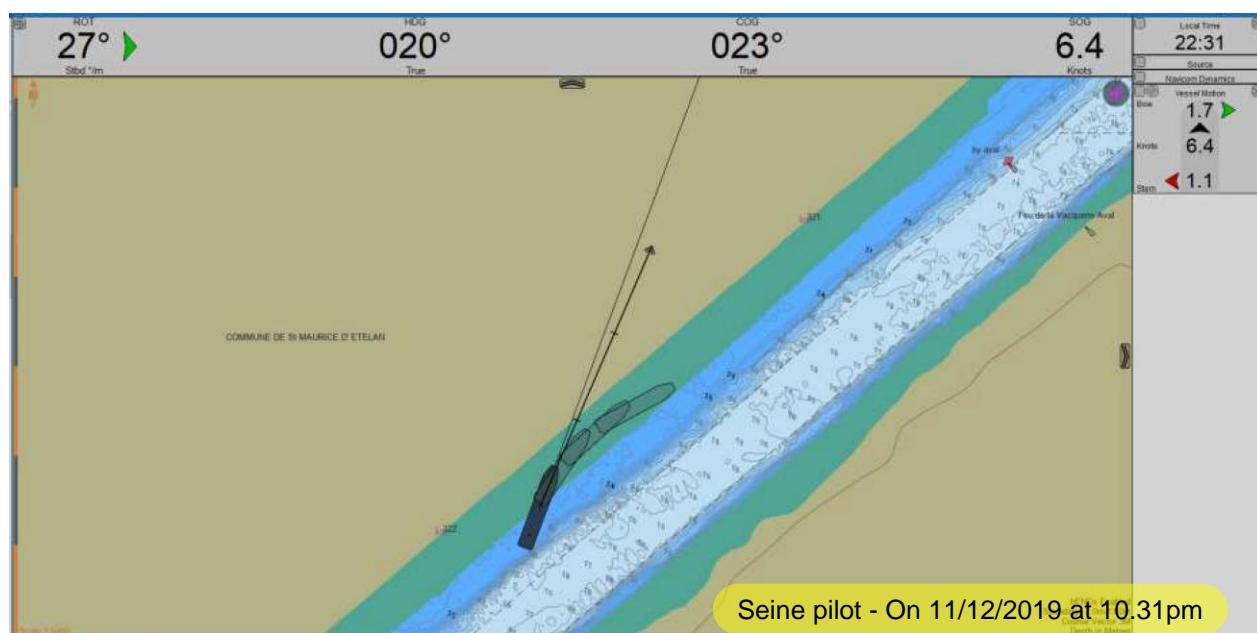
At **10.31 pm** the Rate Of Turn indicator was 27°/min, now to starboard. The heading was 020° at 6.4 knots.

At **10.32 pm** the vessel was grounded.

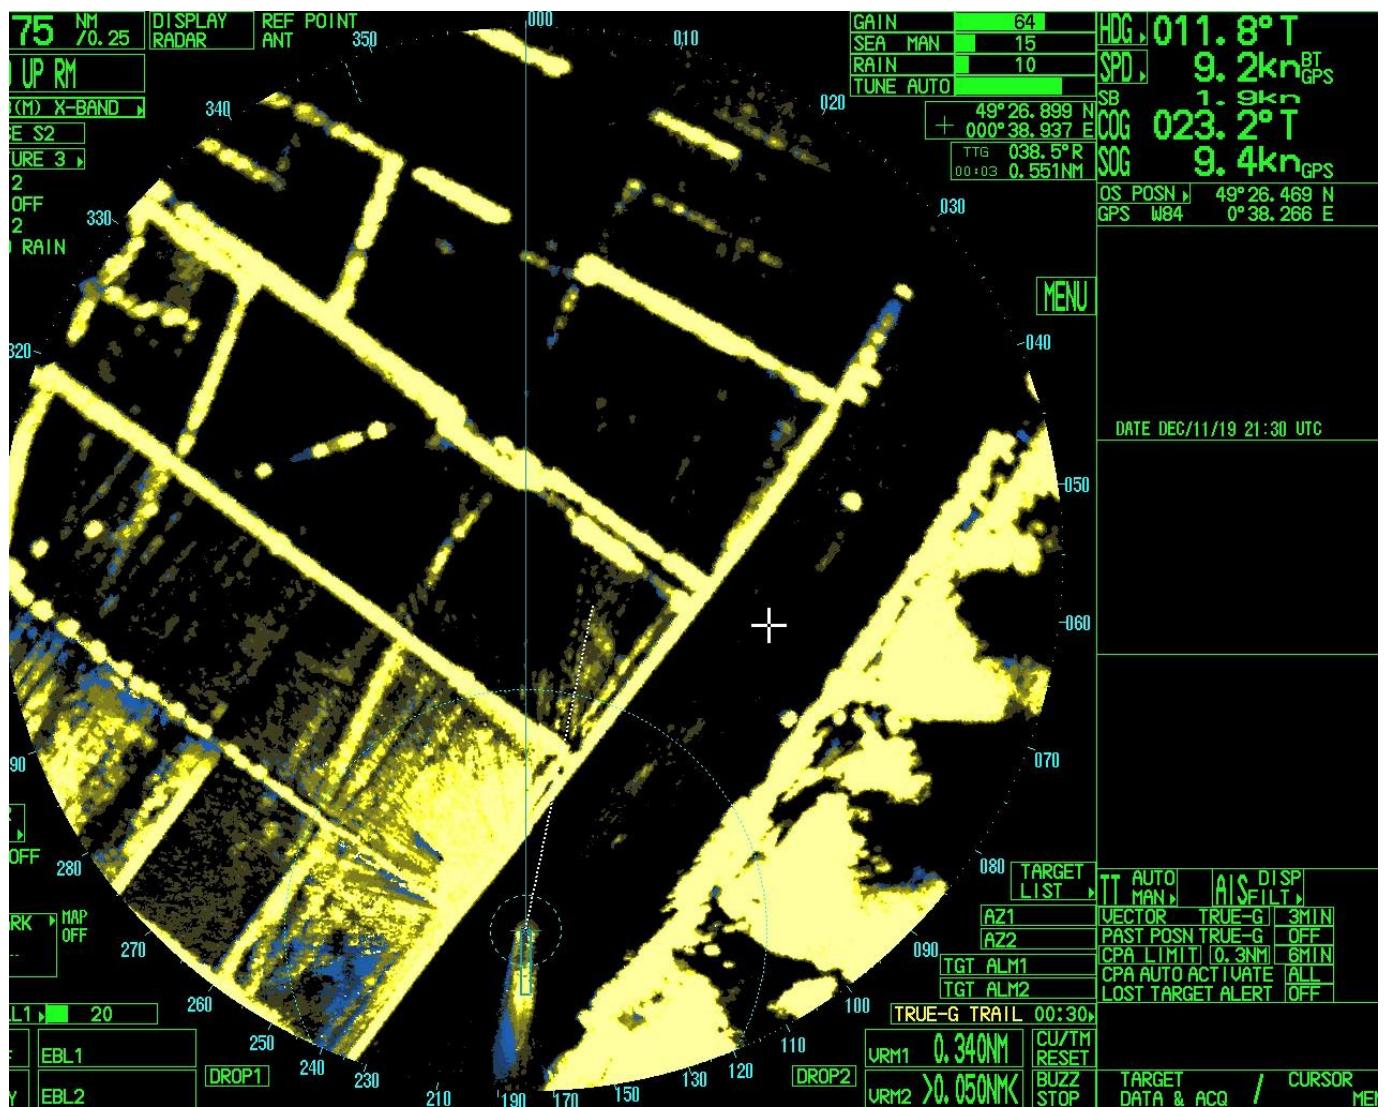
Radar à 21h30mn39s
Radar display at 09.30:39 pm (UTC)

Sondeur à 21h28mn01s : 6.10 m

Echo-sounder at 09.28:01 pm (UTC): 6.10 m

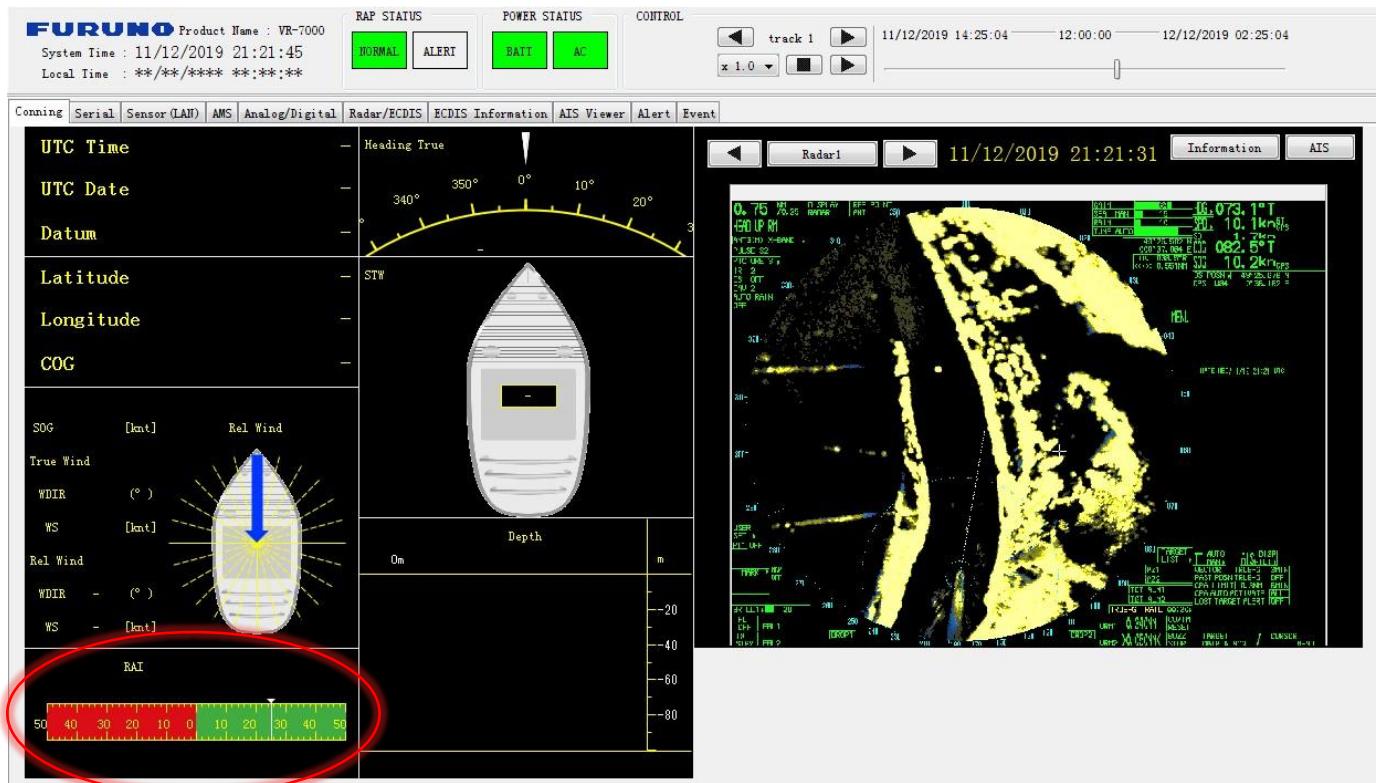
Mode conning du VDR : indication d'angle de barre à 21h21mn45s (TU) : 25°

VDR conning mode: rudder angle at 09.21:45 pm (UTC): 25°
