# Simplified report of safety investigation

**COLLISION BETWEEN THE TRAWLER *ALYA*  
AND THE CARGO VESSEL *KAPITAN ZHIKHAREV*  
ON 27 SEPTEMBER 2012 OFF PORTSALL (NORTH-BRITTANY)**

Bureau d'enquêtes sur les événements de mer

Report published on : June 2013

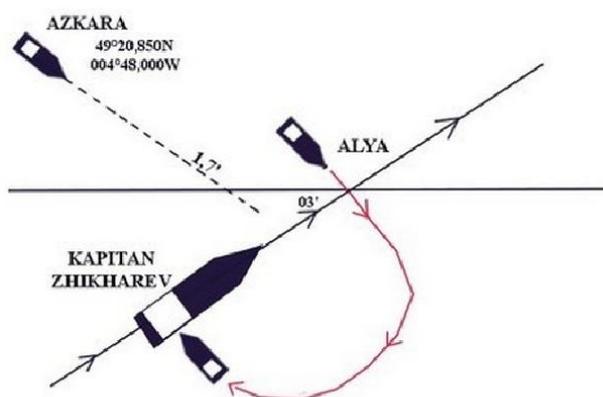
*Tracks of the vessels*

The trawler crossed at 0.3 mile ahead of the cargo vessel because the latter reduced her speed from 9.2 knots to 7.3 knots in order to give her way. The lookout was thus maintained on the cargo vessel bridge.

After he had crossed the track of the cargo vessel, the man on watch shifted the wheel to manual and undertook a manoeuvre. The trawler circled and came to collide the cargo vessel in the area of the bridge on the starboardside. During this manoeuvre, the AIS anti-collision alarm actuated again.

The manoeuvre undertaken which resulted in the collision with the cargo vessel was due to an error of judgement.
