Simplified report of safety investigation

**COLLISION BETWEEN THE FRENCH TRAWLER *BILLABONG*
AND THE FINNISH TANKER VESSEL *PURHA*
ON 9 NOVEMBER 2012 OFF BELLE-ÎLE**

Bureau d'enquêtes sur les événements de mer

Report published : May 2013

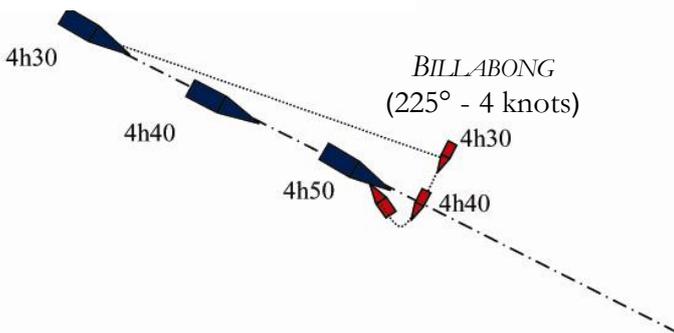
PURHA (120° - 12.7 knots)

Around **4.40 am**, *BILLABONG* crossed ahead *PURHA* at about 3 miles heading a south-westerly course at 4 knots. She began then to turn on starboard to the northwest.

Around **4.45 am**, the officer of the watch aboard *PURHA* observed that *BILLABONG* had altered course. But *BILLABONG* was not yet stabilized at her new course and she perceived her as coming on her portside. She was at 1 mile and was disappearing in the radar sea clutter. She did not manoeuvre because she thought it was too late.

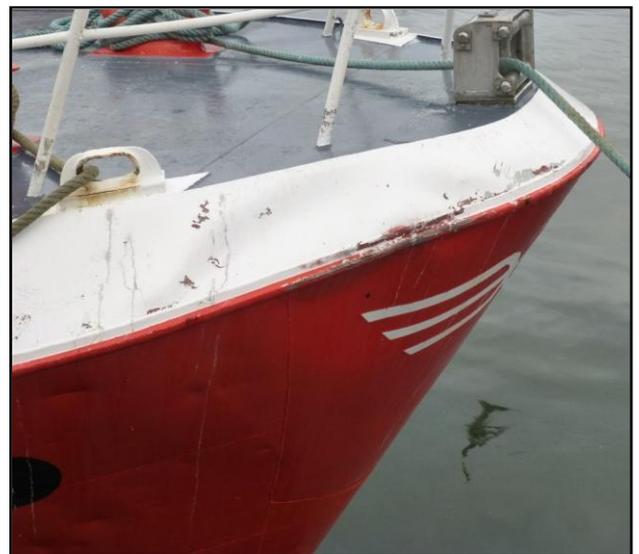
Bow, tweendeck and shelter deck distorted with several structural members unsoldered. A weld broken on the gantry crane. The winding drum was to be checked.
