Report on the technical inquiry into the

LOSS OVERBOARD OF CONTAINERS CARRIED ON DECK

CMA CGM OTELLO

BAY OF BISCAY 17TH FEBRUARY 2006

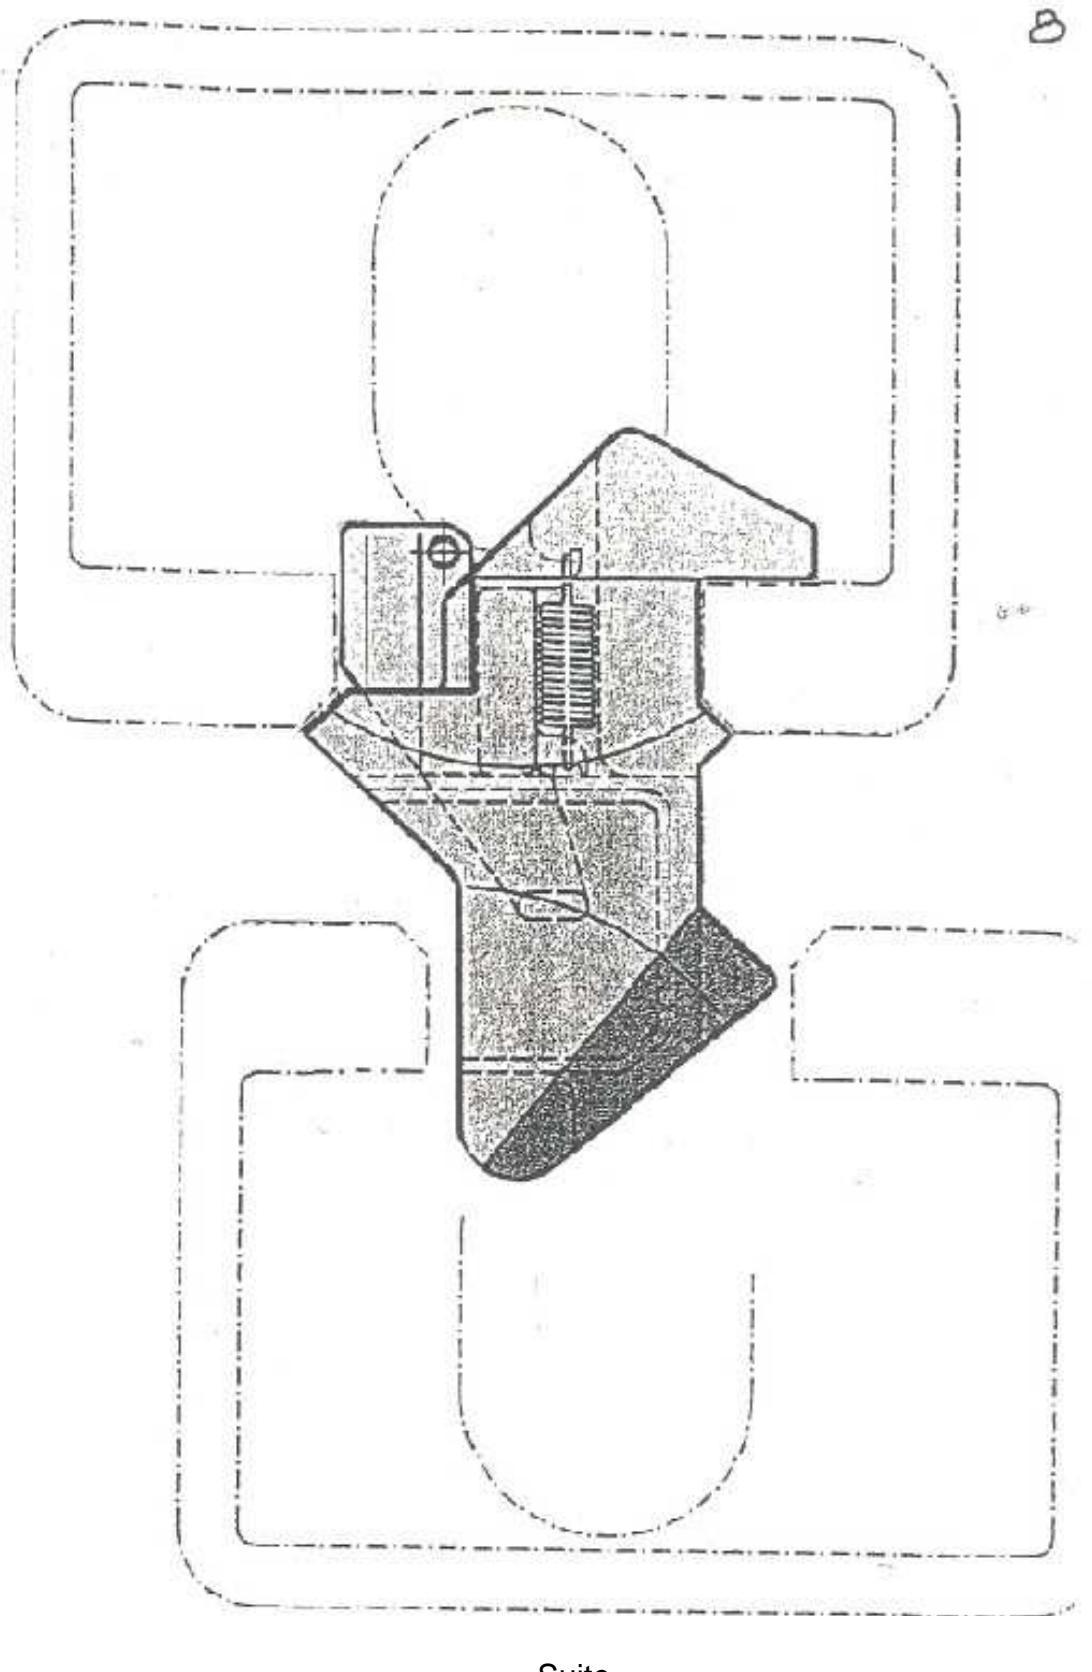
(noter le décalage des deux conteneurs à cet instant).

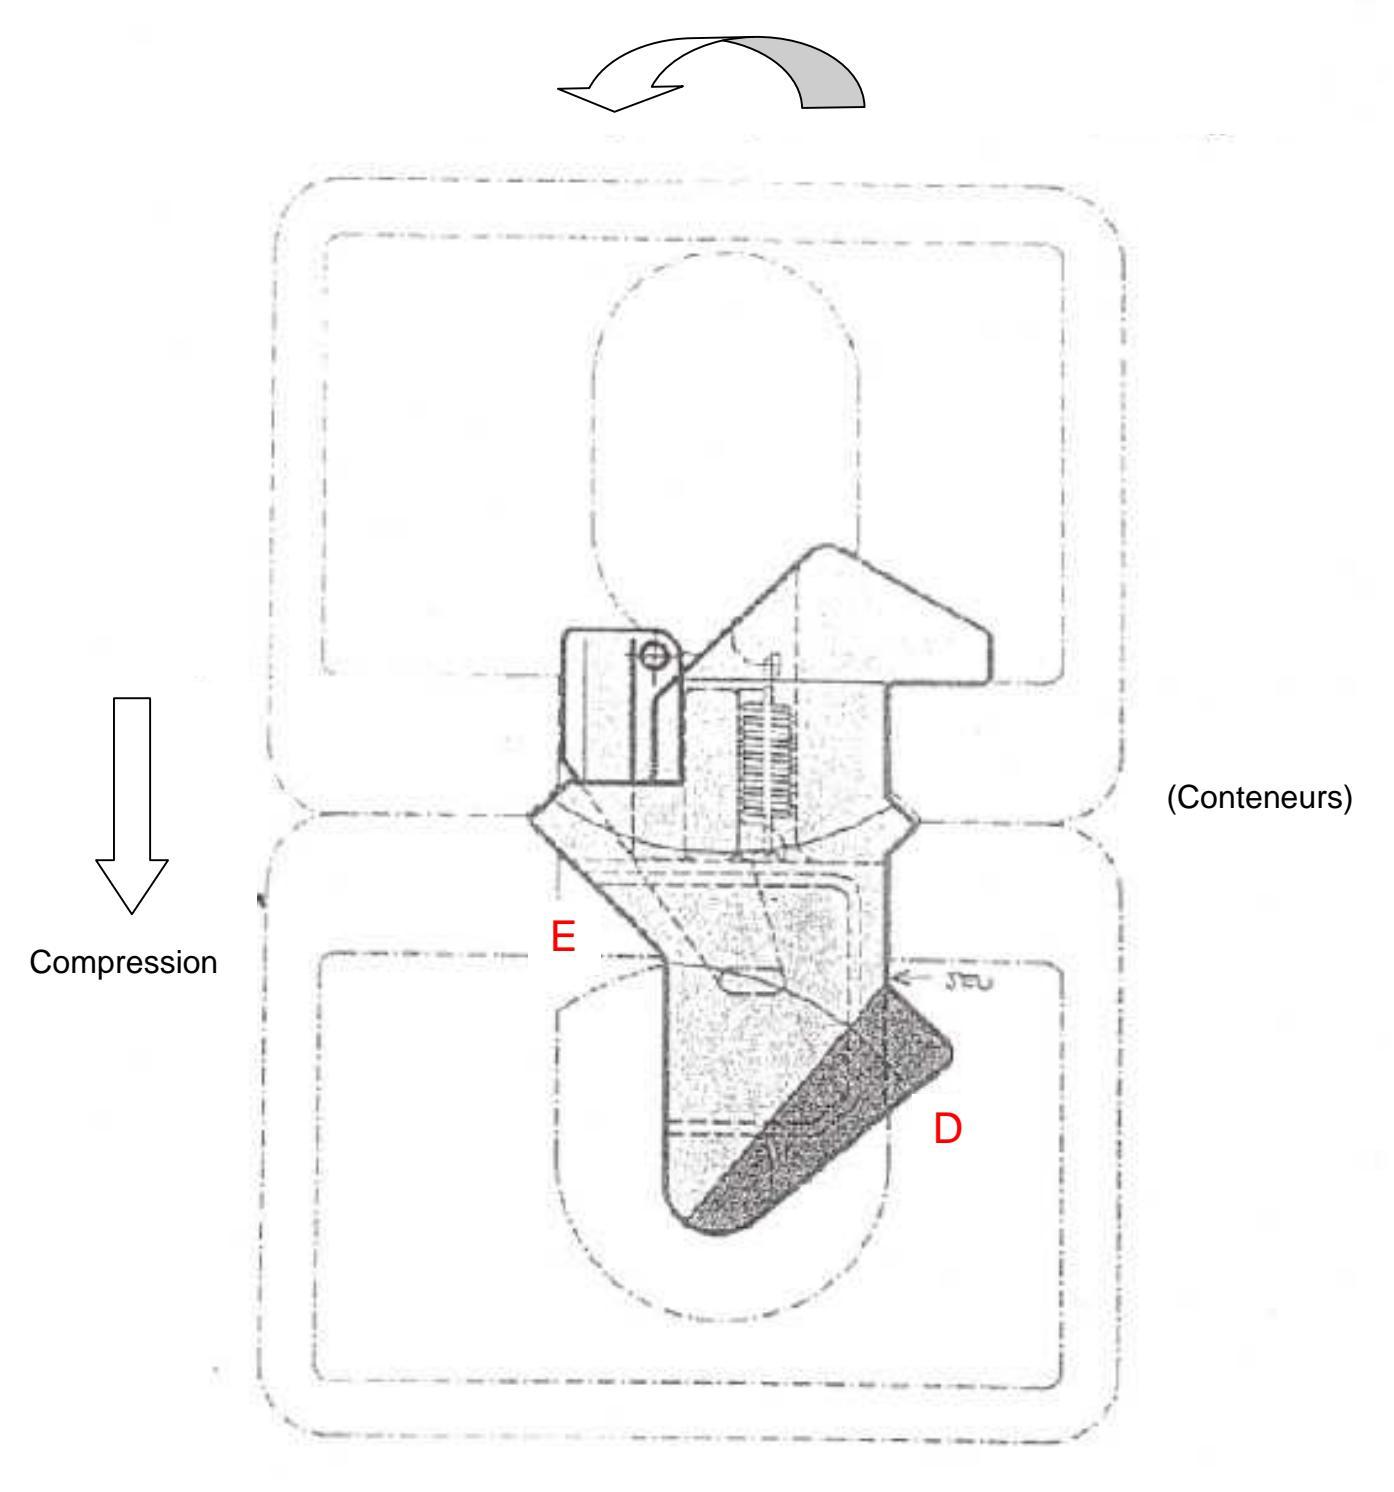
Fonctionnement à la gîte sur bâbord d'un TA dans des pièces de coin bâbord.

Travail à la compression : rien ne bouge.

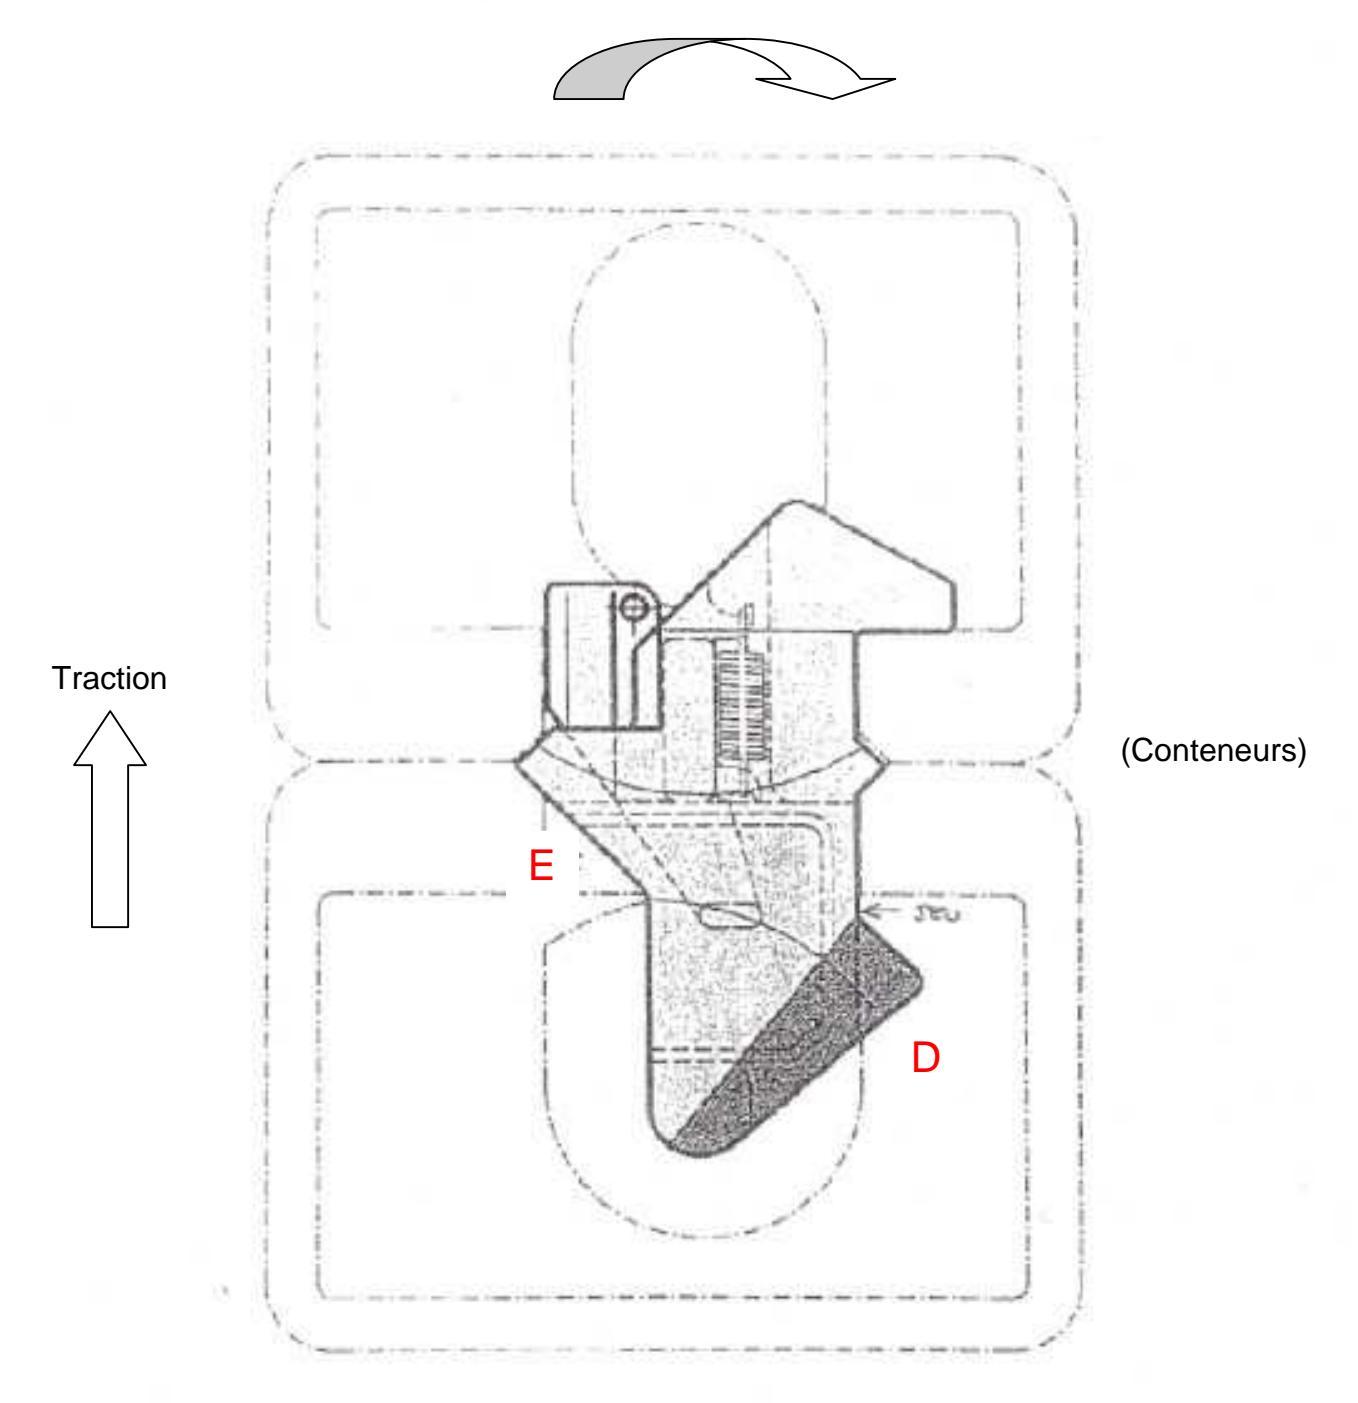
Fonctionnement à la gîte sur tribord d'un TA dans des pièces de coin bâbord.

Travail à la Traction : le jeu, si faible soit-il, qui permet le déchargement, plus ou moins l'usure de la glissière E, autorisent un « début » de sortie, voire plus, de la partie inférieure du TA.
