MARINE SAFETY INVESTIGATION REPORT

Safety investigation into the over-pressurisation of a cargo tank on board the Maltese registered chemical tanker

UMAR 1

in Fos sur Mer, France on 19 October 2013

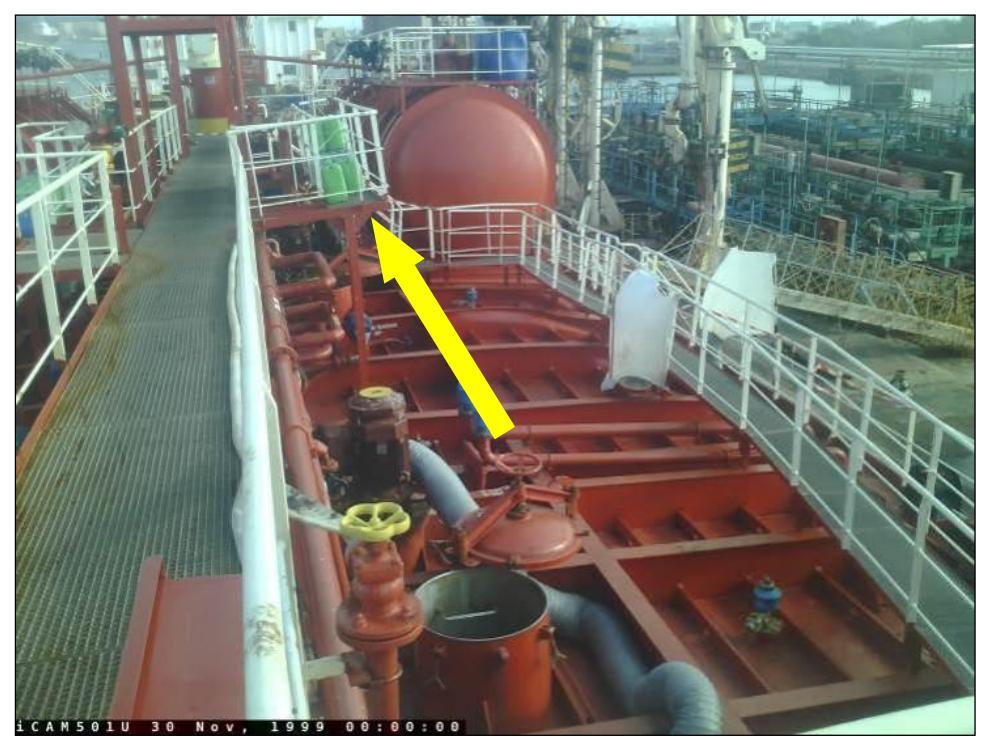
Figure 7: Damage to the deck catwalk

It would appear that the main deck above cargo tank no. 2 port had risen by over 500 mm and caused the distortion of the deck catwalk (Figure 7), deck framing (Figure 8) and associated pipework. The deck transverse framing in way of cargo tank no. 2 port had crumpled around the edges of the cargo tank.

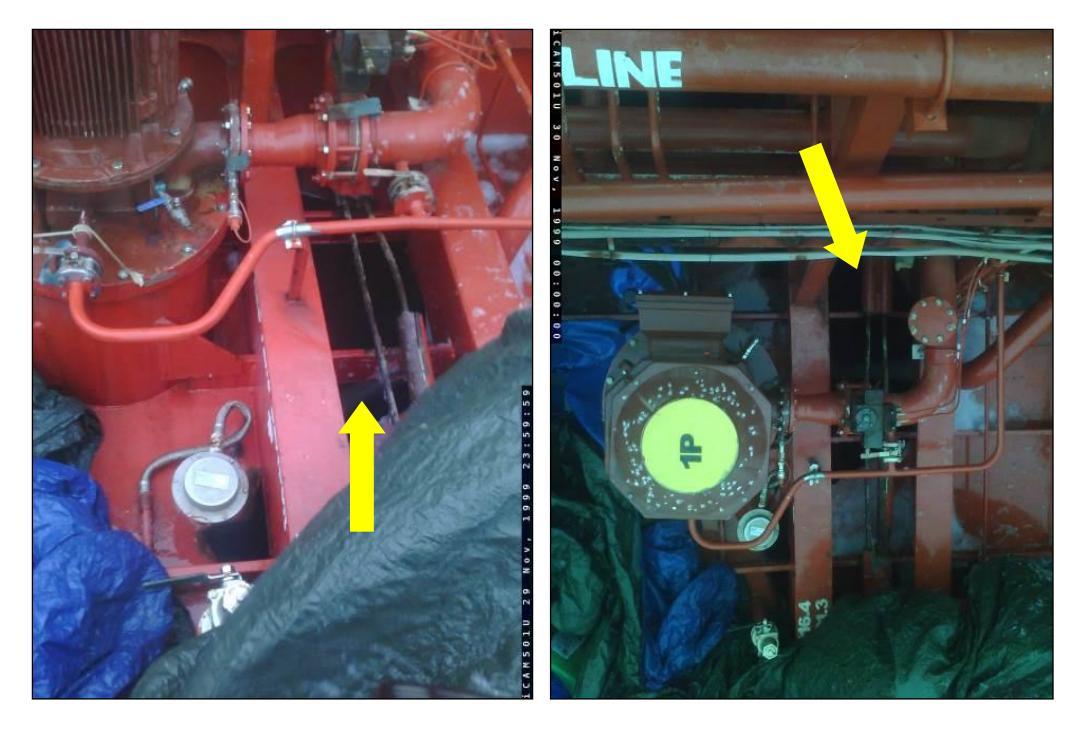
Figures 9a and 9b: Missing deck plating

A section of the main deck between frames 110 and 113, measuring about 1000 mm by 500 mm, in way of the transverse bulkhead between cargo tanks no. 1 port and no. 2 port, had been torn and set into the cargo tanks (Figures 9a and 9b).

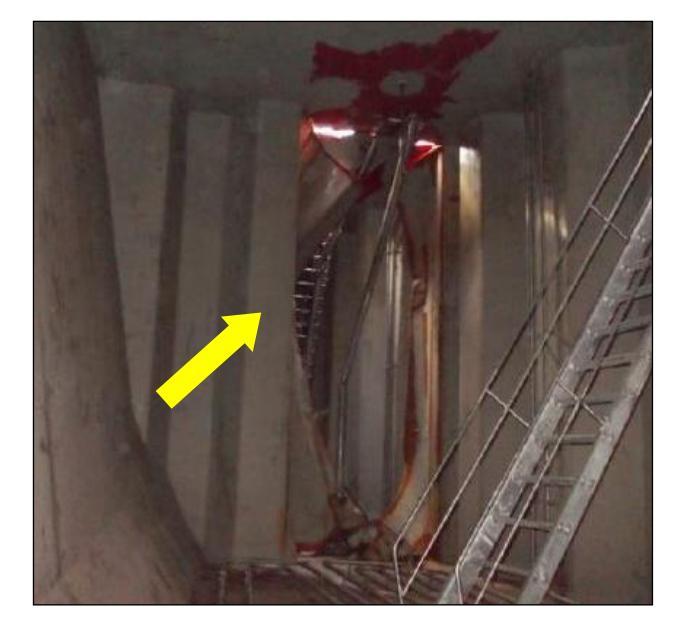
Figure 10: Damaged transverse corrugated bulkhead between cargo tanks nos. 1 port and 2 port

The transverse bulkhead between cargo tanks no. 1 port and no. 2 port had split from the main deck right down to the double bottom tank tops (Figure 10) and collapsed into cargo tank no. 1 port, damaging cargo pump no. 1 port, pipes and the access ladder. In addition, the transverse bulkhead had ruptured the welding at the top and bottom on several corrugated bays.

The cargo pump and associated pipework in cargo tank no. 1 port, which was attached and secured to the bulkhead, was also damaged as the bulkhead imploded into cargo tank no. 1 port.

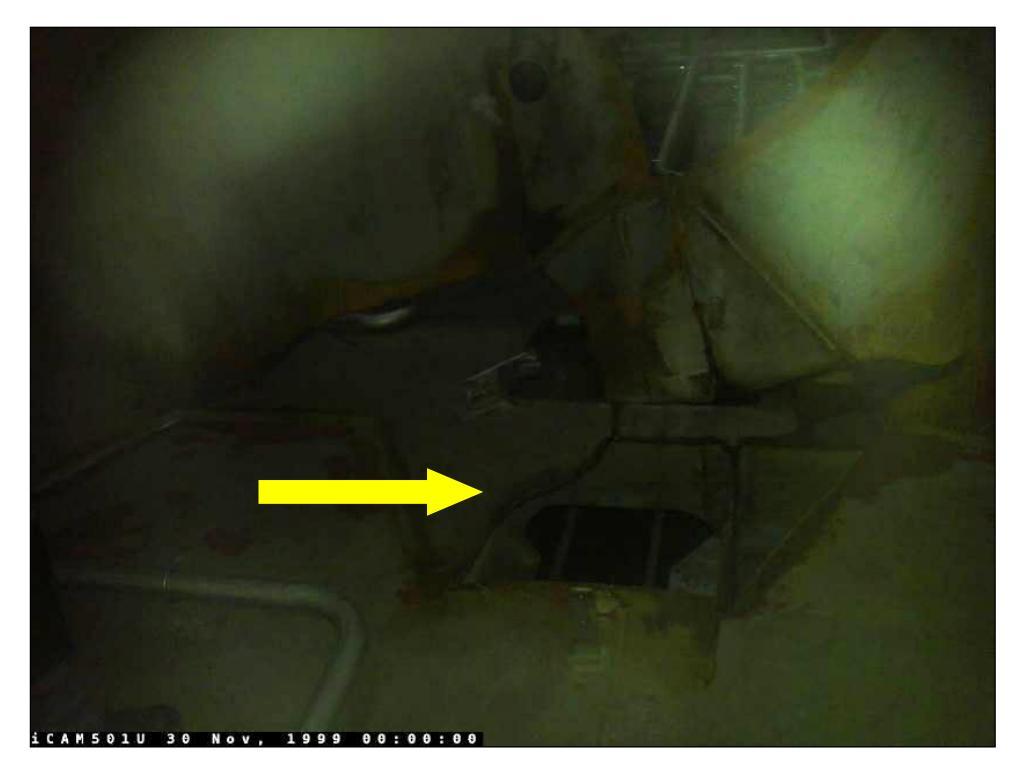
Figure 11: Damage to the tank top

The tank top between frames 110 and 112 to double bottom ballast tanks no. 1 port and no. 2 port, in way of the transverse bulkhead had been ripped away by the bulkhead when it imploded into cargo tank no. 1 port (Figure 11). Both double bottom tanks were contaminated with MTBE.

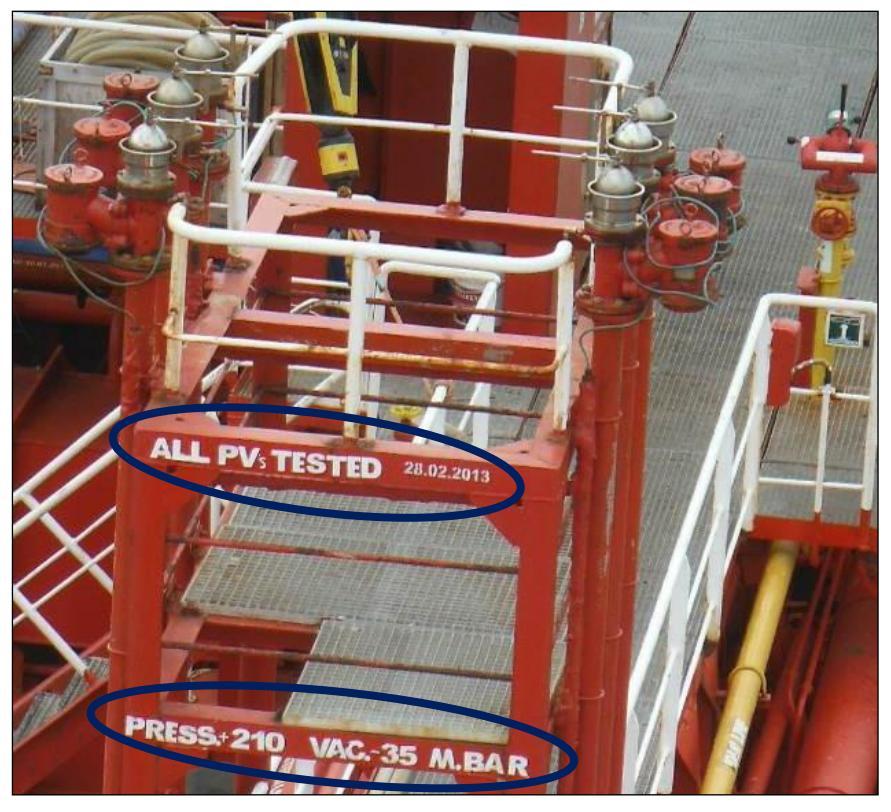
Figure 12: PV valve test date and pressures marked on the vent stacks

During the course of the safety investigation, it transpired that the Unitech PV valves had last been tested ashore on 28 February 2013 and had been set to open at +210 mbar pressure and -35 mbar vacuum (Figure 12). The test date was stencilled on the vent stacks on deck.

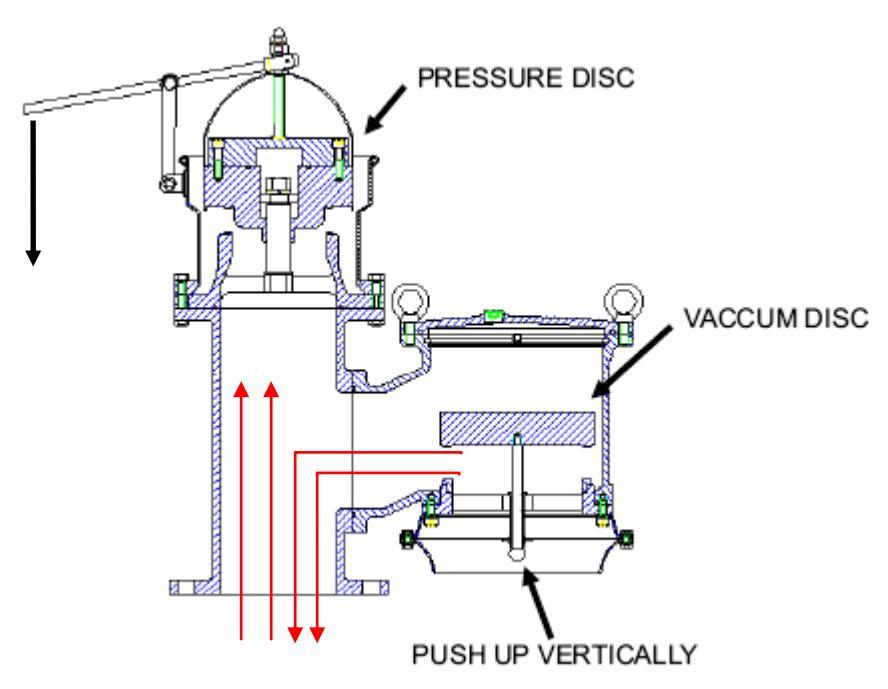
Figure 13: Testing of the PV valves

The vacuum side of each PV valve was checked by pushing up the button below the vacuum side of the valve (Figure 13). This side of the PV valve appeared to have also been checked by using a pole from the catwalk and not locally by climbing up the vent stack and physically operating it by hand.

During the course of the safety investigation and the interviews with the crew members, it seemed that a pole was normally used from the catwalk level to check the PV valves, rather than climbing up to the PV valve platform and physically test the PV valves by hand.

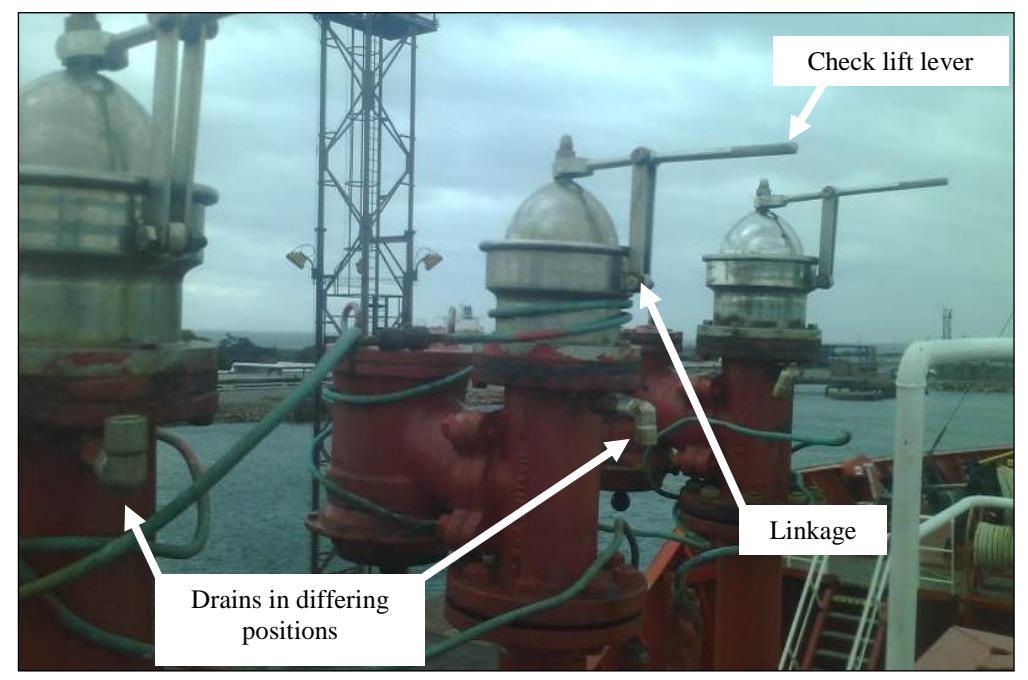
Figure 14: Check lift levers permanently fitted to the valve tops

The PV valves had the check lift levers permanently fitted to the valve tops and the connecting linkage on the valve body (Figure 14).

The check lift lever was restricted in movement as the linkage appeared to be hard up against the body valve and in some cases, it also appeared seized in position⁵.

As part of the safety investigation, all of the check lift levers were checked and tested. Although several valve spindles had been found slightly bent, all of the PV valves lifted *relatively* easily except for the one fitted on cargo tank no. 2 port. It was not clear, however, if the PV valve had been damaged by the over-pressurisation during the course of the accident. However, it was noted that some of the other PV valves and check lift levers were stiffer than others to operate and required additional effort to lift. After several attempts to rotate and manipulate the cargo tank no. 2 port valve top, it lifted with some effort, but jammed every time it was released.

- .1 The PV valve check lift levers, which had been fitted to the valve tops, caused damage to the valve spindles and thus prevented several of them from operating correctly at the pre-set pressure.

- All PV valves on board the *Umar 1* have been replaced with a newer model of PV valve;
- A new Appendix has been added to the Cargo Loading Rate Pressure in the cargo tanks, which is now being recorded every 30 minutes. These records include both data from the cargo monitoring system and the manometers on the PV line;

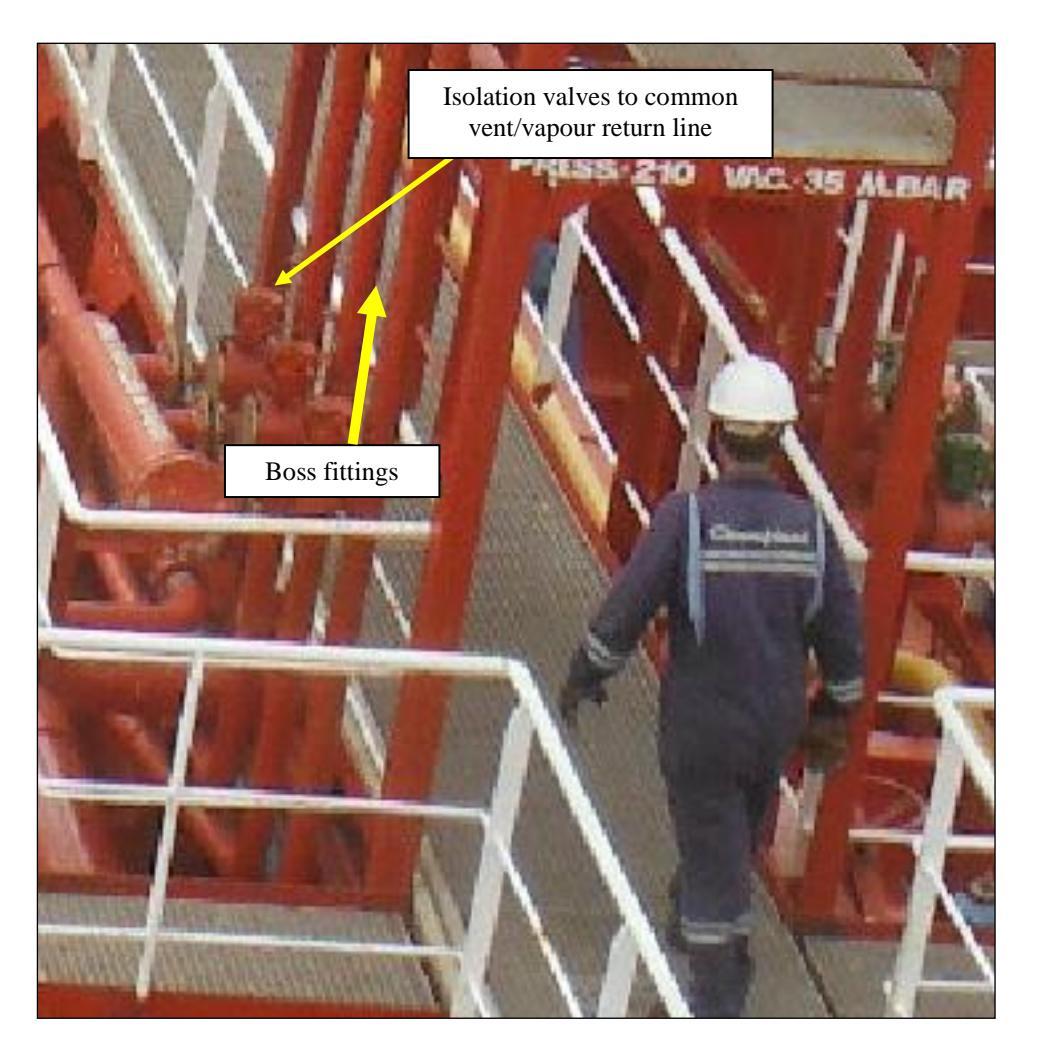
Figure 16: Location of boss fitting for pressure gauges

It was also noted that at the bottom of each cargo tank vent pipe stack, situated at the catwalk height, just above the isolation valves to the common vent line, a boss was available to enable the fitting of a manual pressure gauge (Figure 16). It would appear that all of the bosses had not been used in a very long time. This was confirmed by the chief mate and although there were some pressure gauges available on board, none had been used.

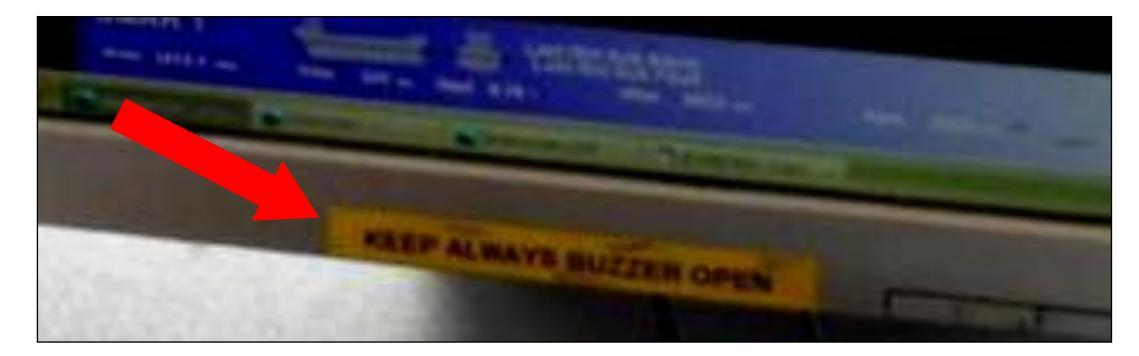
Figure 17: Buzzer notice affixed on the loading computer screen

alarm message was still active, and the alarms were also muted. This appeared an unsafe system to operate when (against to on board procedures (Figure 17)), alarms were muted and the screen visual effects not monitored constantly or acted upon immediately. It would seem that this led to a blurred situation awareness, as a result of inadequate cargo watch and the disabling of the audible component of a preventive barrier.

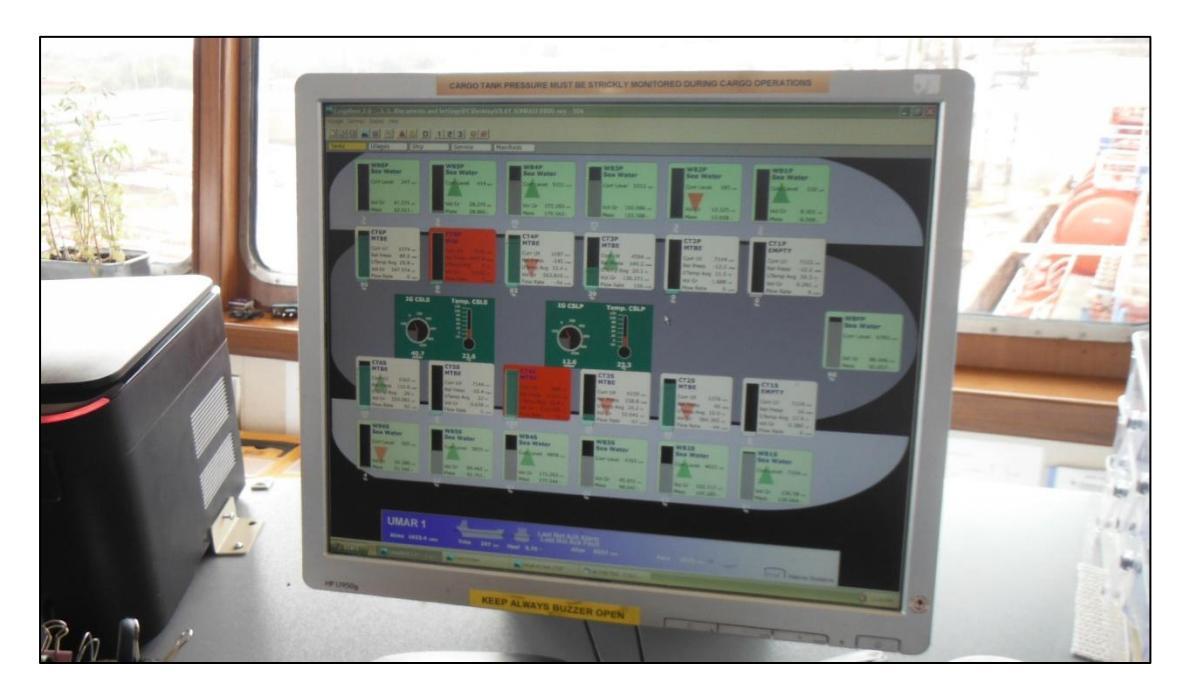
Figure 18: Cargo tank information on the loading computer screen

Moreover, it was also established that he had managed to take the ullage / rate readings at 0200 and 0300. Therefore, he must have consulted the screen to calculate the rate. As yet, he still did not appreciate the 'red' warnings, even if he had muted the audible alarm on the bridge; unless, of course, the cargo tank colour had changed from 'red' to 'white' when the pressure exceeded 950 mbars.
