Report of safety investigation

SAMCO EUROPE
MSC PRESTIGE

Collision

on 7 December 2007 in Aden Gulf

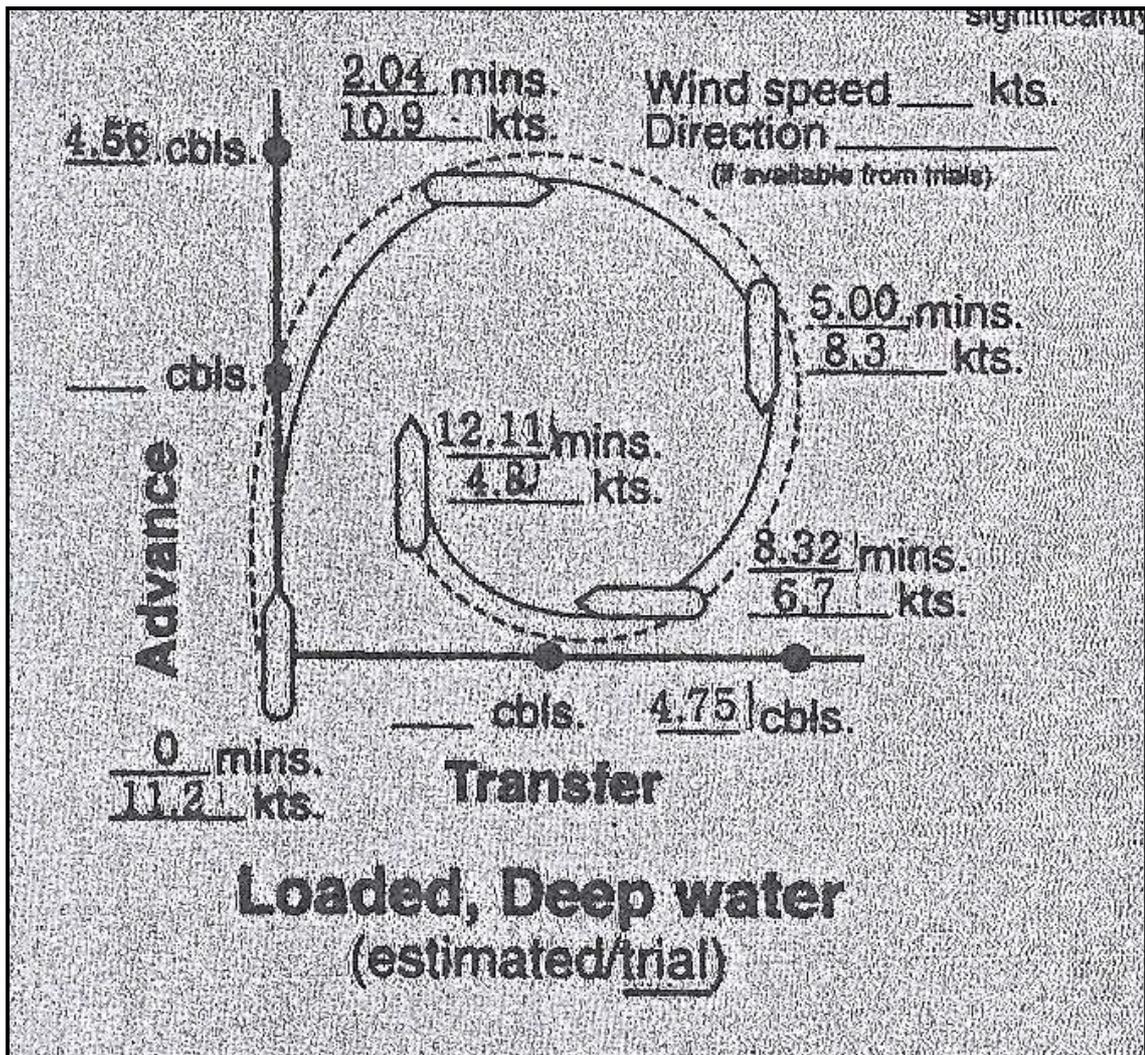
Turning circle: Full Ahead with maximum rudder angle.

Vessel loaded, in deep water : less than 5 cables to alter course of 90° (cf. turning circle). For comparison, a large cruise ship equipped with pods has a turning circle diameter of about 3 cables, with an approach speed of 24 knots.

By stopping engine, 6.5 minutes are necessary to reduce speed at 12 knots. 5 minutes are necessary with engine astern.

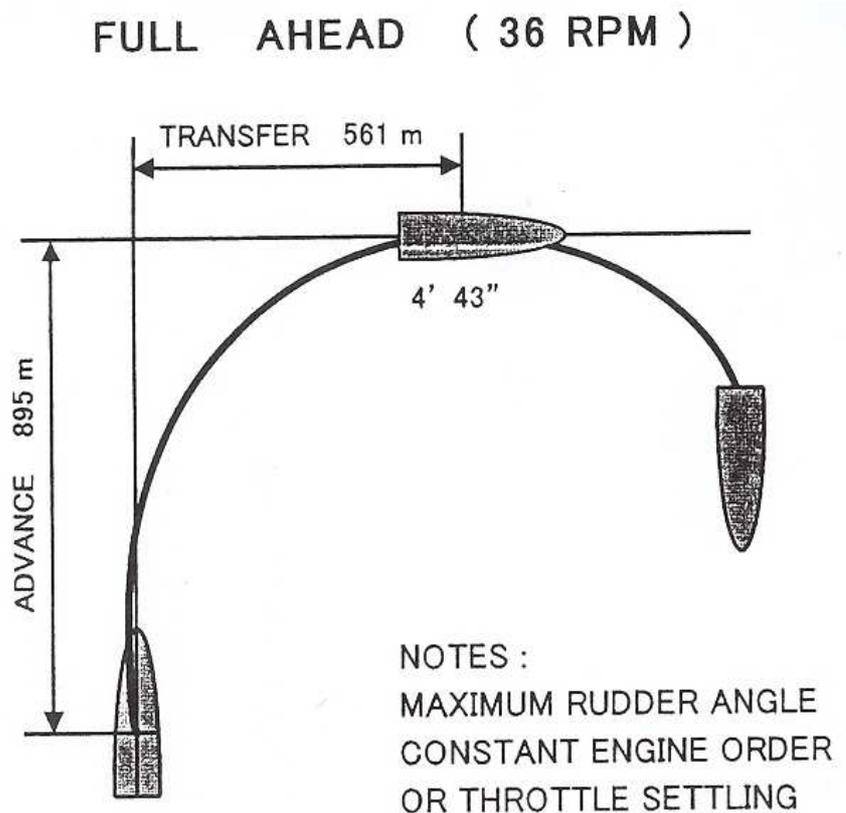
Turning circle: Full ahead with maximum rudder angle.

Vessel loaded, in deep water : 561 m to alter course of 90° (cf. turning circle). The manoeuvrability of the vessel even creates an excess of confidence of the OOW who “accepts” a very close situation ahead of *SAMCO EUROPE*.

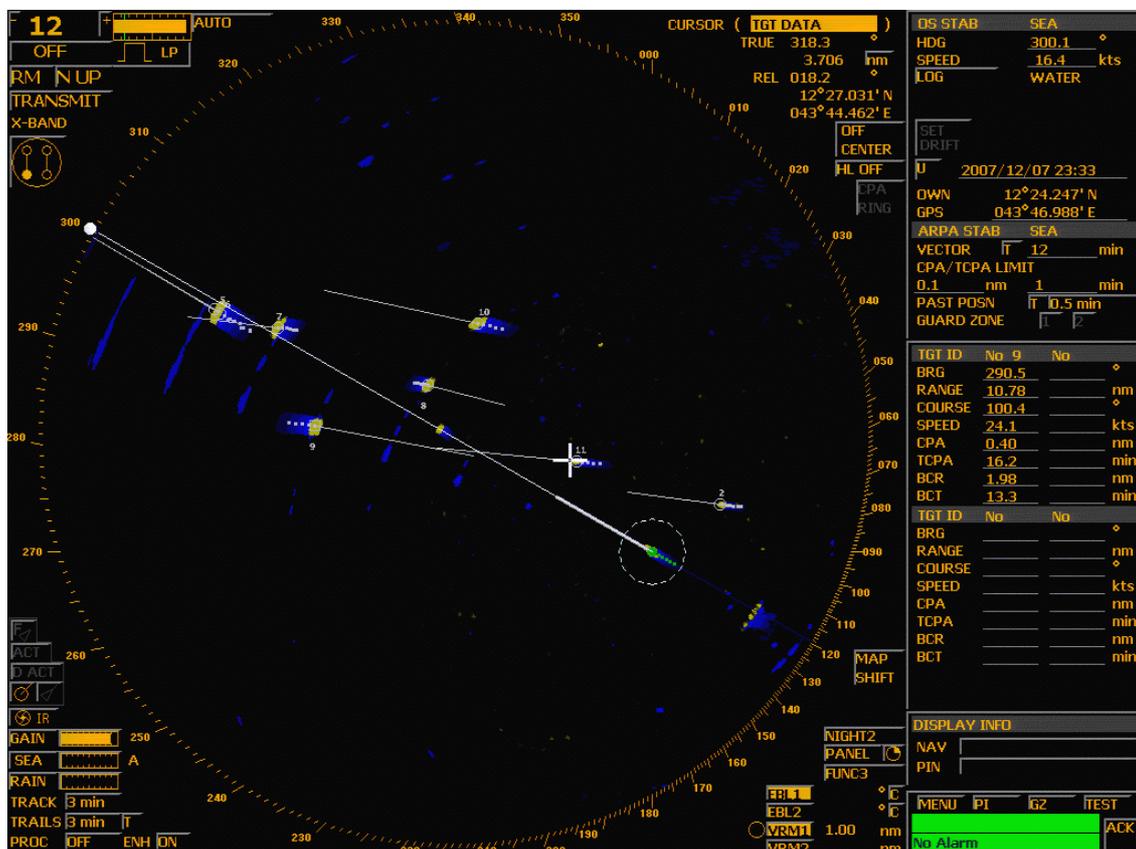
At 23H31 (VDR time), *SAMCO EUROPE* course is 300° and she is 21 miles from the southern entrance of Bab El Mandeb TSS. *MSC PRESTIGE* is the target n°9, just taken into account by ARPA calculator.

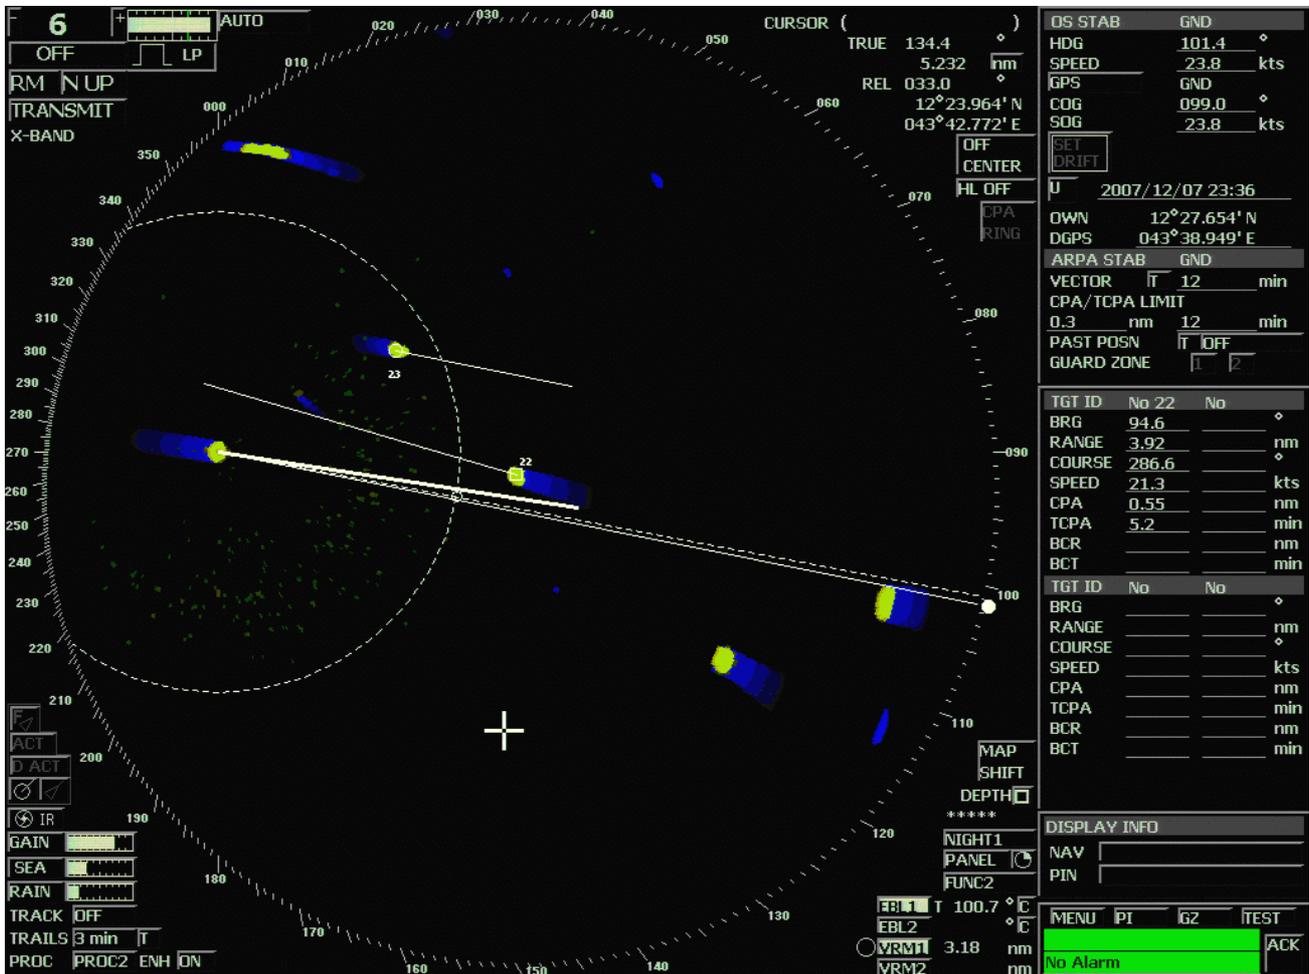
At **23H36**, *MSC PRESTIGE* course is 101° and she is ready to alter her course on starboard to pass between the two vessels ahead, respectively at # 7 NM in the bearing 112° (*SAMCO EUROPE*), and at # 9 NM in the bearing 102° (target n°2 on the *SAMCO EUROPE* ARPA). Target n°22, a passing ship, is clear, on her portside :

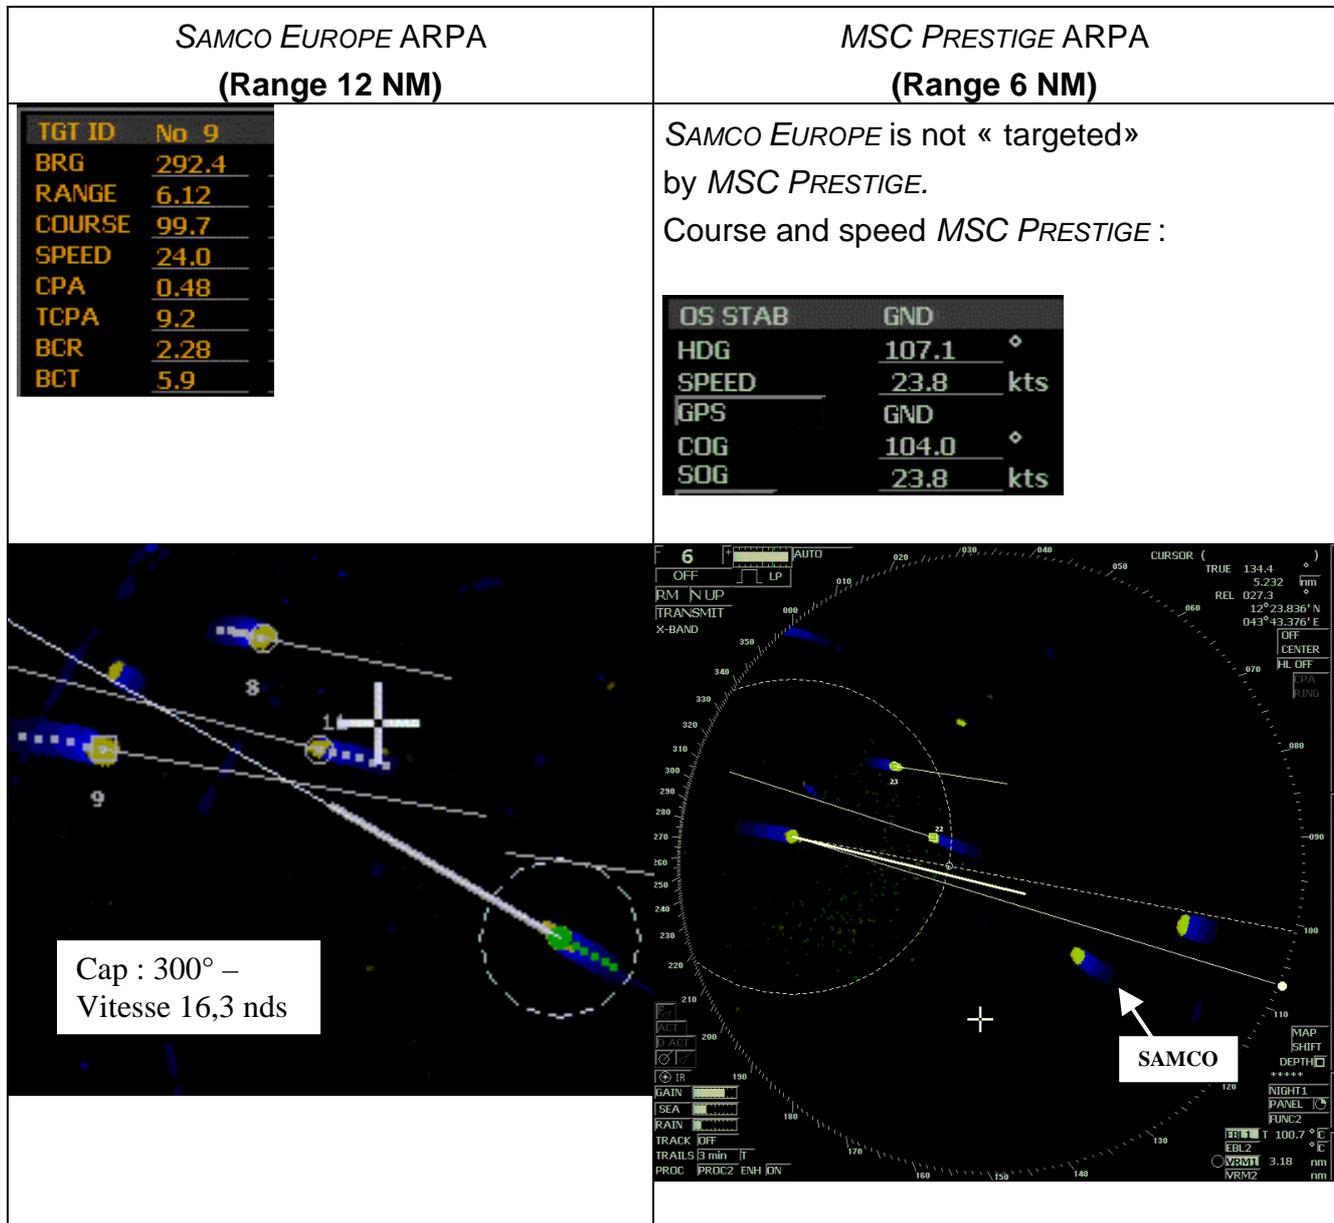
At **23H37**, initial situation, *SAMCO EUROPE* course is 300° and *MSC PRESTIGE* gyro course is now 107° (course over the ground 104°). If no change of course is done, *MSC PRESTIGE* will pass ahead of *SAMCO EUROPE* at 2,28 NM and CPA will be 0,48 MN (data calculated by the *SAMCO EUROPE* ARPA which has not yet “seen” the alteration of course of the *MSC PRESTIGE*).

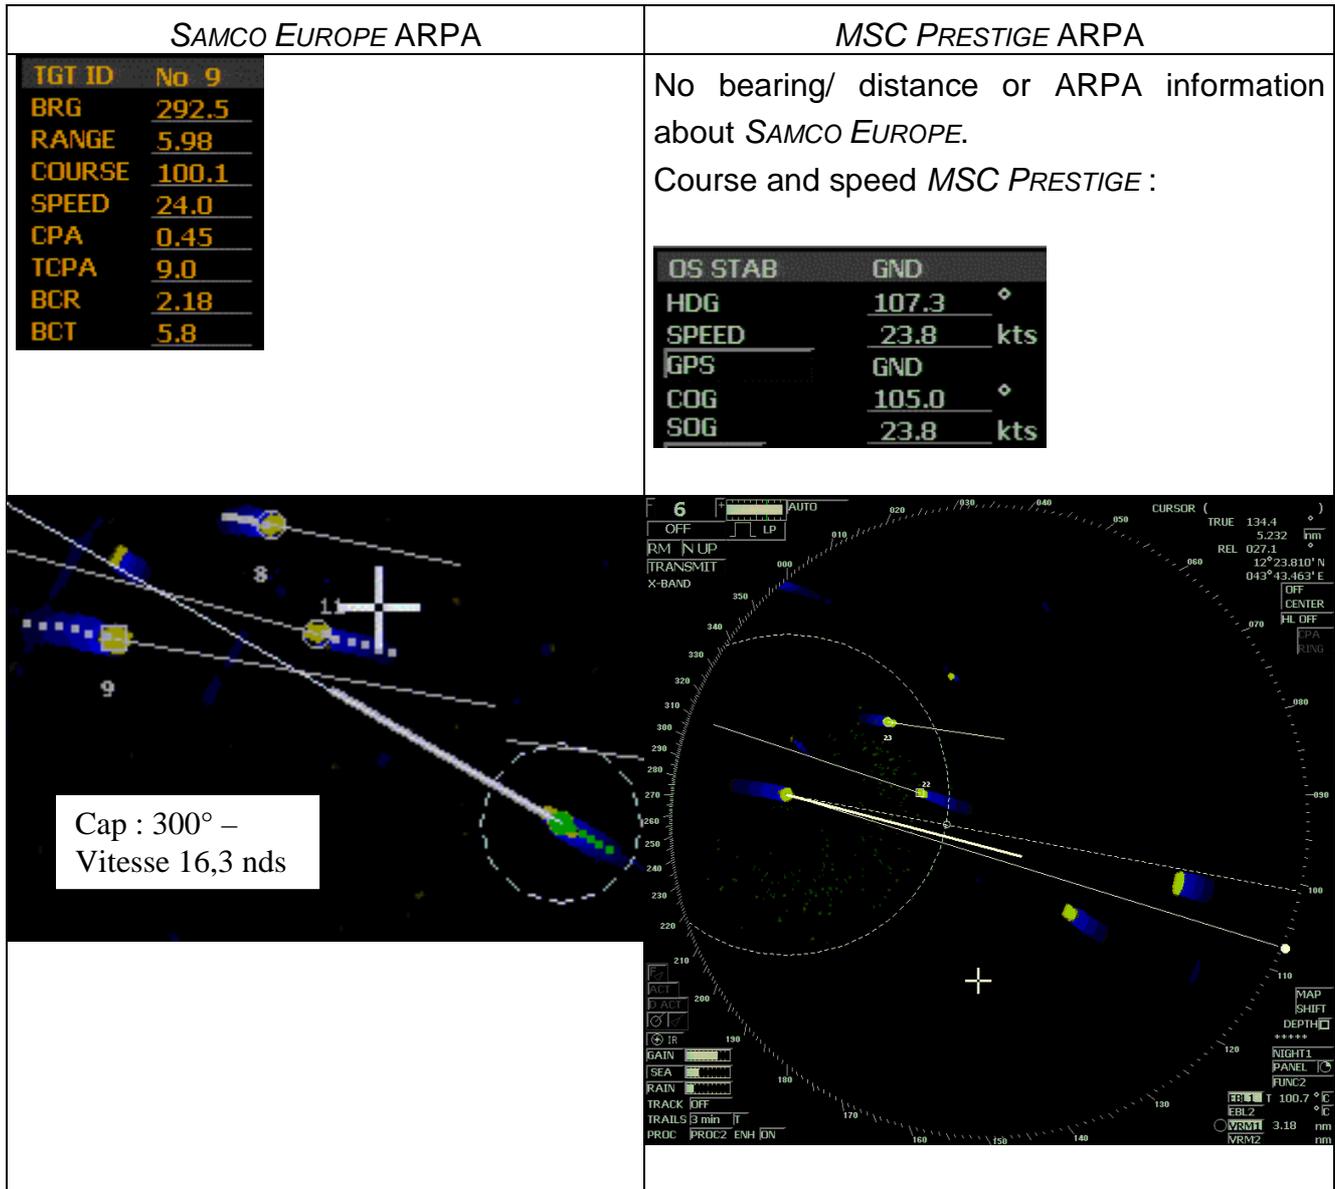
Situation at **23H38** :

The difference between the course calculated by ARPA SAMCO EUROPE and the course displayed on MSC PRESTIGE remains.

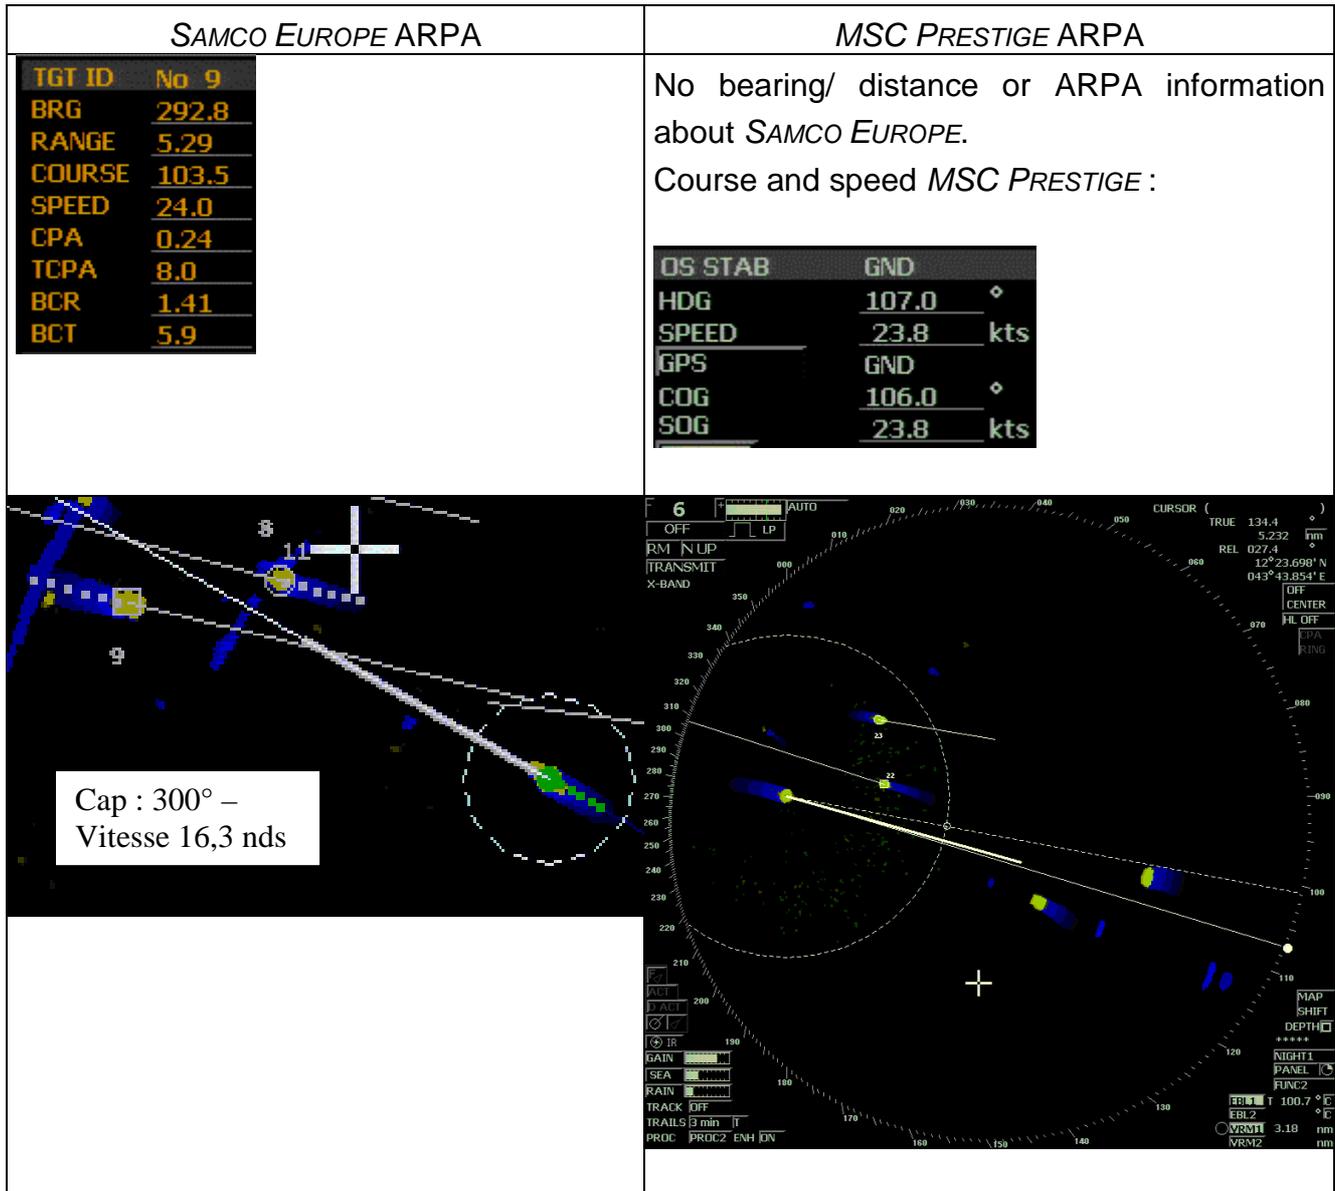
Situation at **23H39** :

Two minutes after the « initial situation », CPA is divided by 2. The difference between the course calculated by SAMCO EUROPE and display of the MSC PRESTIGE course tends to decrease.

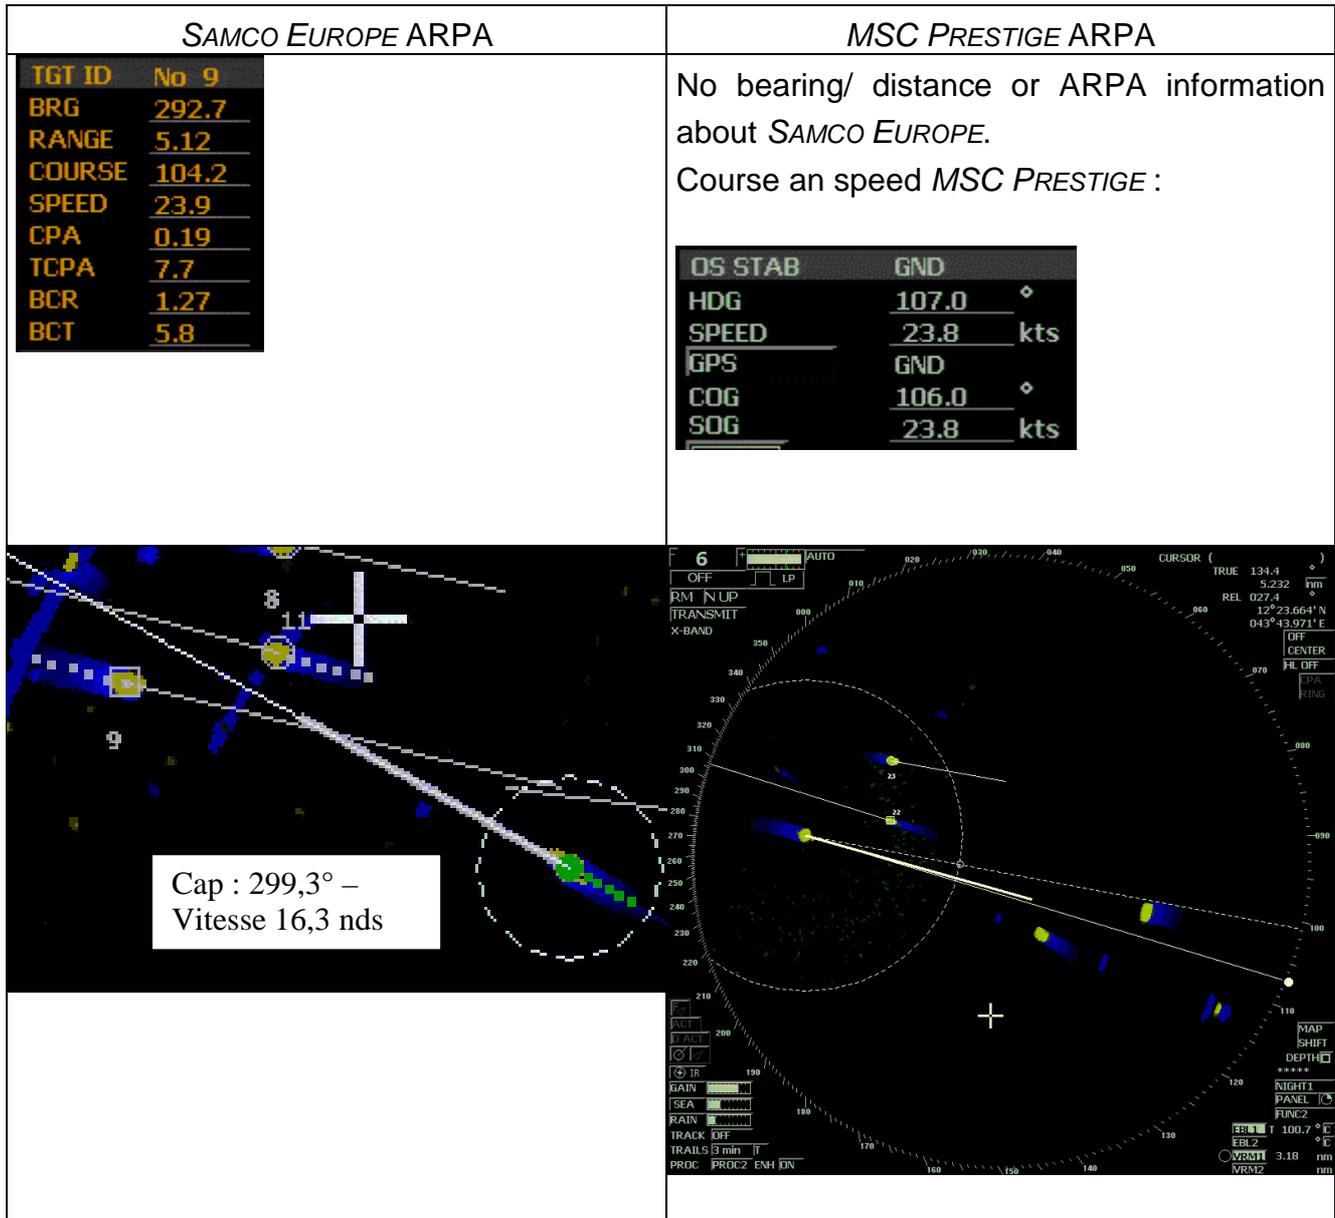
Situation at **23H39min15sec** :

SAMCO EUROPE began to alter her course to portside (The helm is "Port 10" up to a course of 295°). CPA decreases yet.

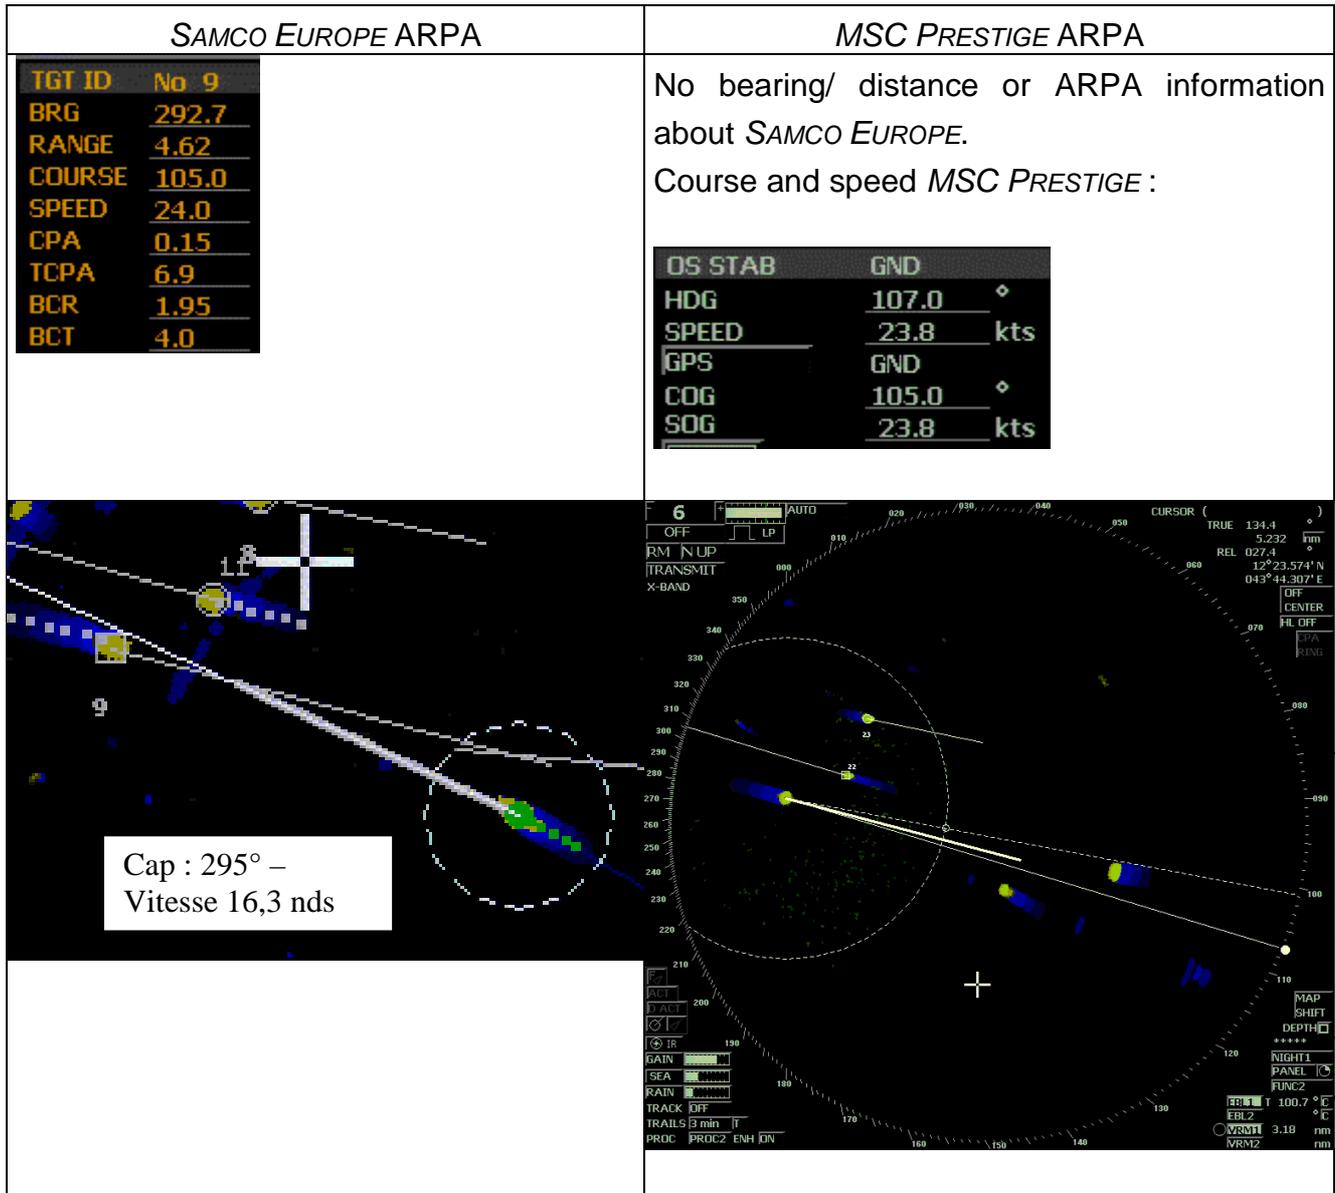
Situation at **23H40** :

The CPA is below a ship's length.

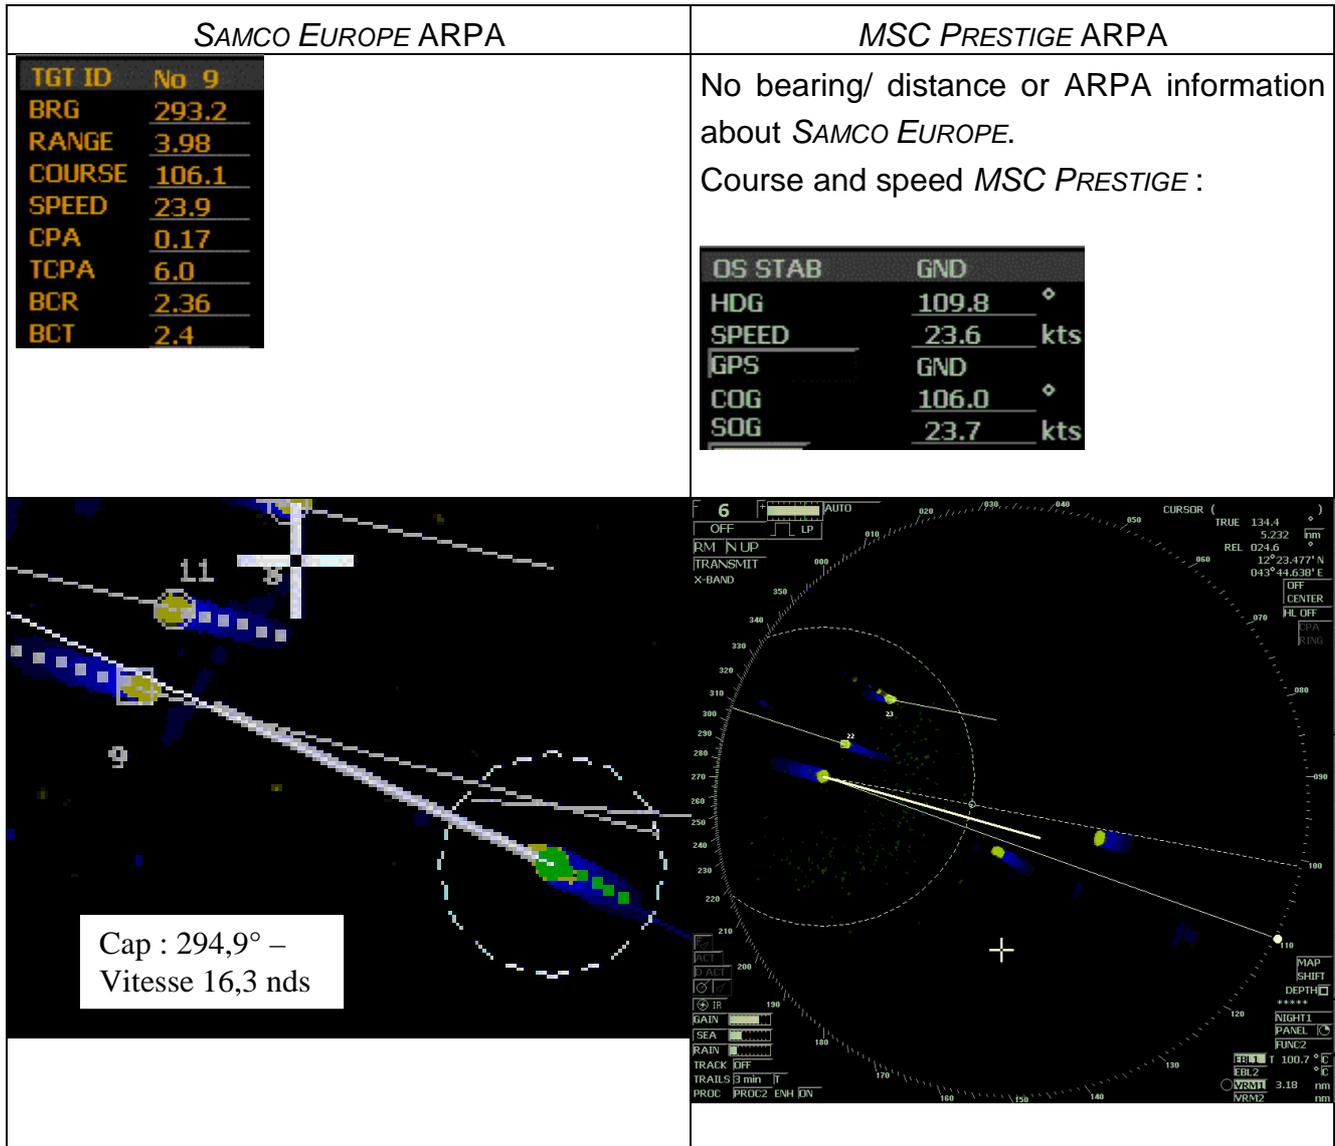
Situation at **23H41** :

The change of course of the *MSC PRESTIGE*, to a “port to port” passing, appears on the course and speed display of the *MSC PRESTIGE*.

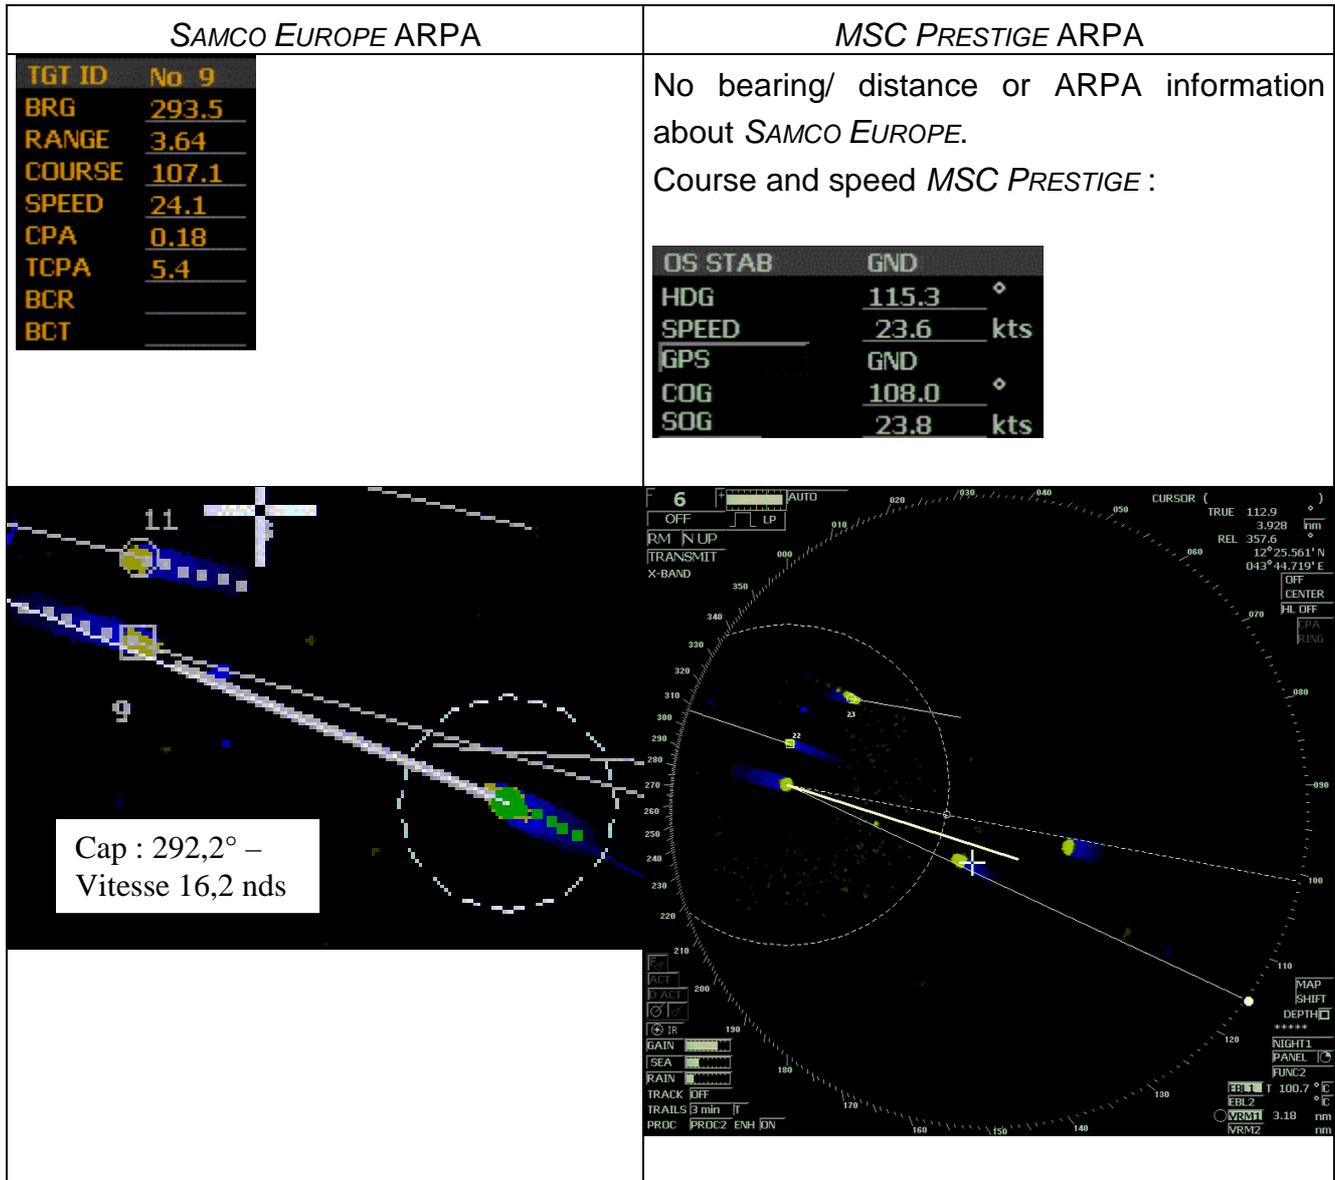
Situation at **23H41min45sec** :

SAMCO EUROPE ARPA : MSC PRESTIGE has just passed on the starboard side of SAMCO EUROPE.

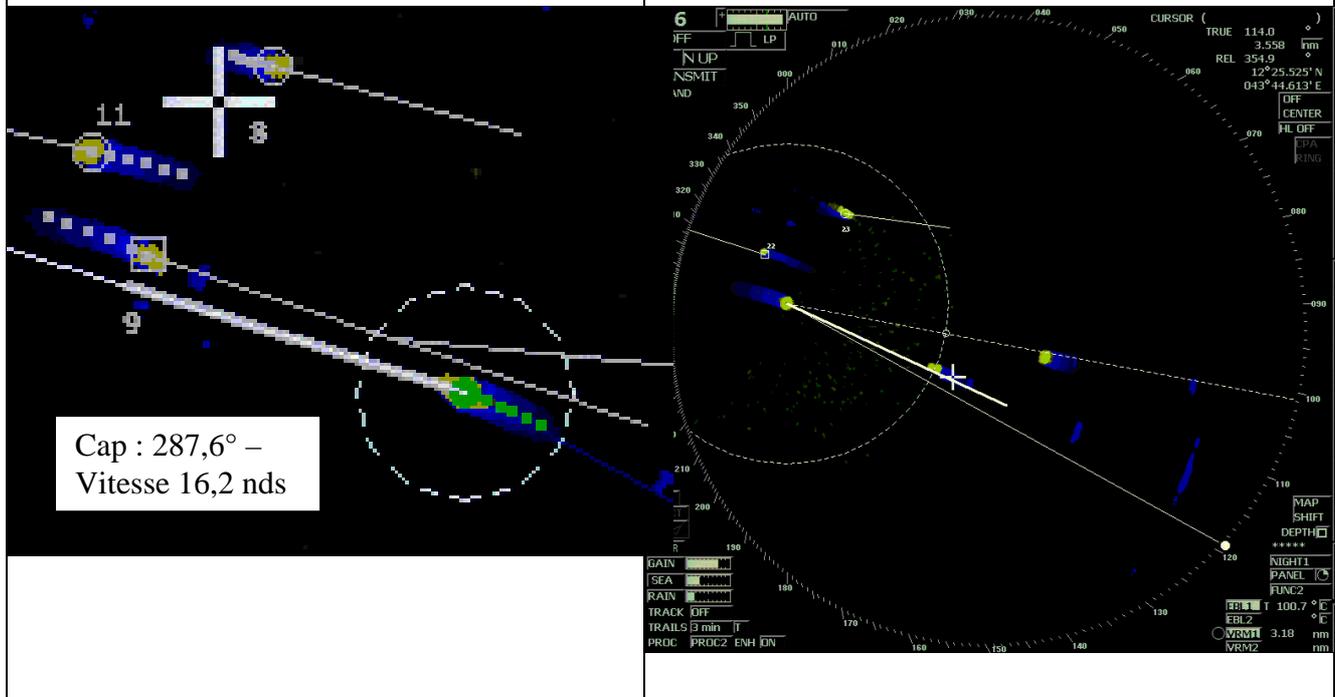
Situation at **23H42** :

<i>SAMCO EUROPE</i> ARPA	<i>MSC PRESTIGE</i> ARPA																																		
<table border="1"> <tr><td>TGT ID</td><td>No 9</td></tr> <tr><td>BRG</td><td>293.5</td></tr> <tr><td>RANGE</td><td>3.14</td></tr> <tr><td>COURSE</td><td>108.9</td></tr> <tr><td>SPEED</td><td>24.1</td></tr> <tr><td>CPA</td><td>0.13</td></tr> <tr><td>TCPA</td><td>4.7</td></tr> <tr><td>BCR</td><td></td></tr> <tr><td>BCT</td><td></td></tr> </table>	TGT ID	No 9	BRG	293.5	RANGE	3.14	COURSE	108.9	SPEED	24.1	CPA	0.13	TCPA	4.7	BCR		BCT		<p><i>SAMCO EUROPE</i> « cuts » VRM1 set at 3.18 NM. Course and speed <i>MSC PRESTIGE</i> :</p> <table border="1"> <tr><td>OS STAB</td><td>GND</td></tr> <tr><td>HDG</td><td>119.1</td><td>◊</td></tr> <tr><td>SPEED</td><td>23.8</td><td>kts</td></tr> <tr><td>GPS</td><td>GND</td></tr> <tr><td>COG</td><td>115.0</td><td>◊</td></tr> <tr><td>SOG</td><td>23.9</td><td>kts</td></tr> </table>	OS STAB	GND	HDG	119.1	◊	SPEED	23.8	kts	GPS	GND	COG	115.0	◊	SOG	23.9	kts

The difference of distance between the pictures (range ARPA *SAMCO EUROPE* = 3.14 NM and VRM1 radar MSC = 3.18 NM) is 0.04 NM, i.e. # 6 secondes.

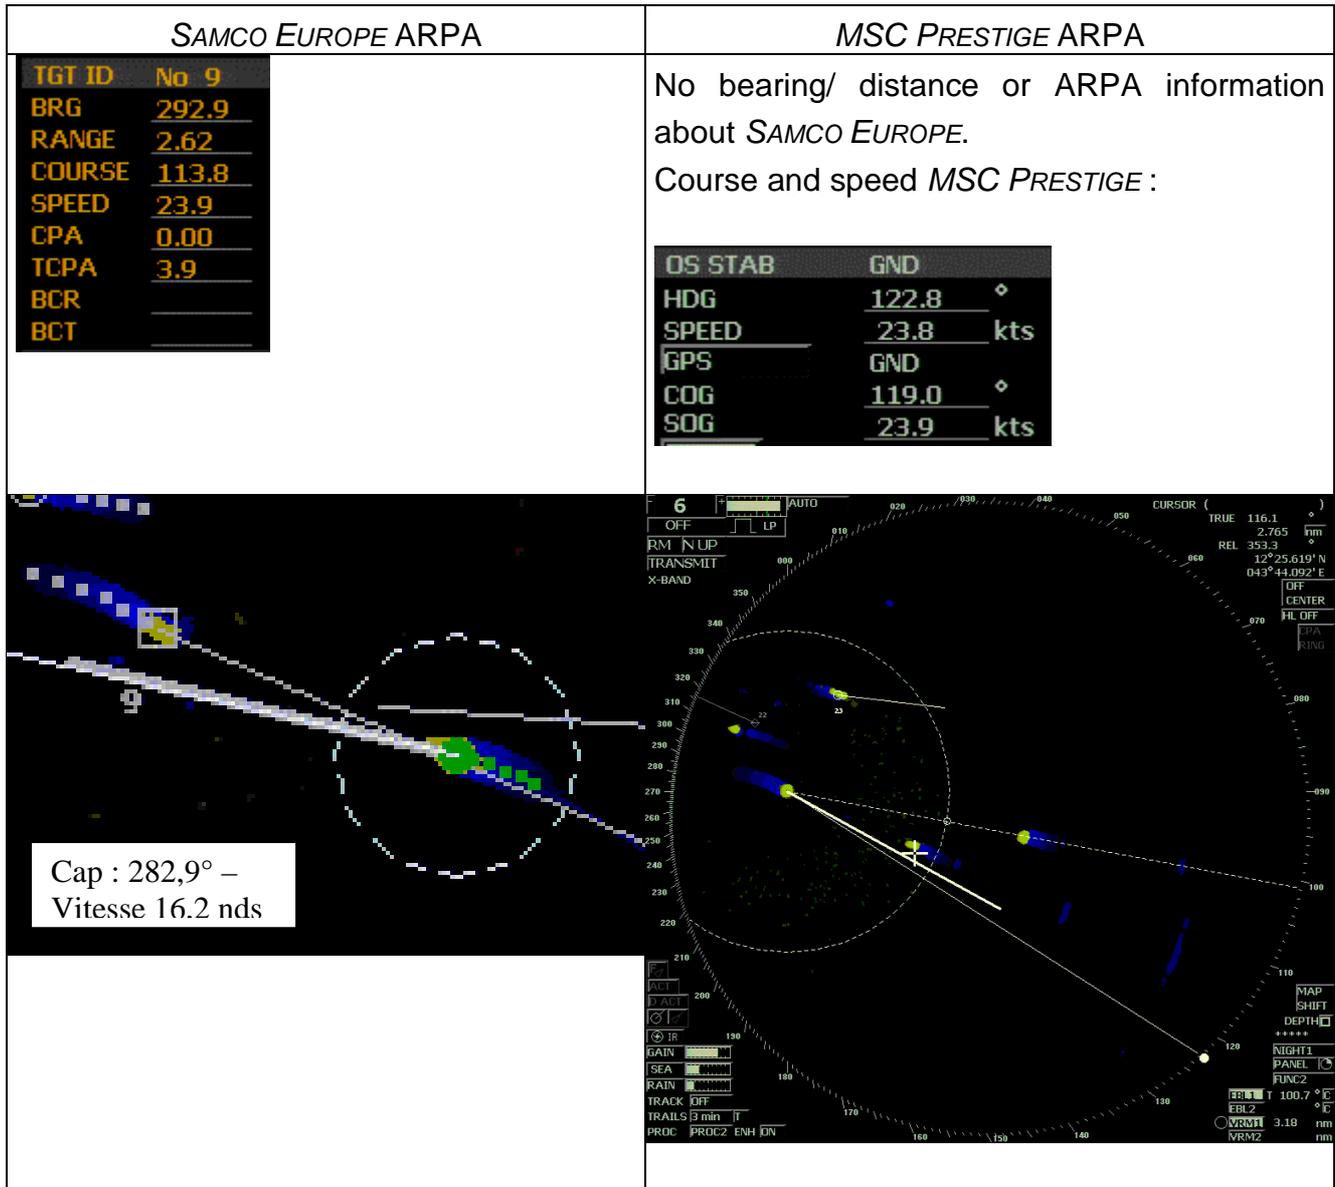
Situation at **23H43** :

The CPA is nil.

On the *MSC PRESTIGE* display the *SAMCO EUROPE* is at # 2,6 NM bearing 114°, which is consistent with *SAMCO EUROPE* display indications.

But the *SAMCO EUROPE* blip is on the left of the *MSC PRESTIGE* heading line : there is an “offset” with the *SAMCO EUROPE* display (*MSC PRESTIGE* course headed right towards the *SAMCO*).

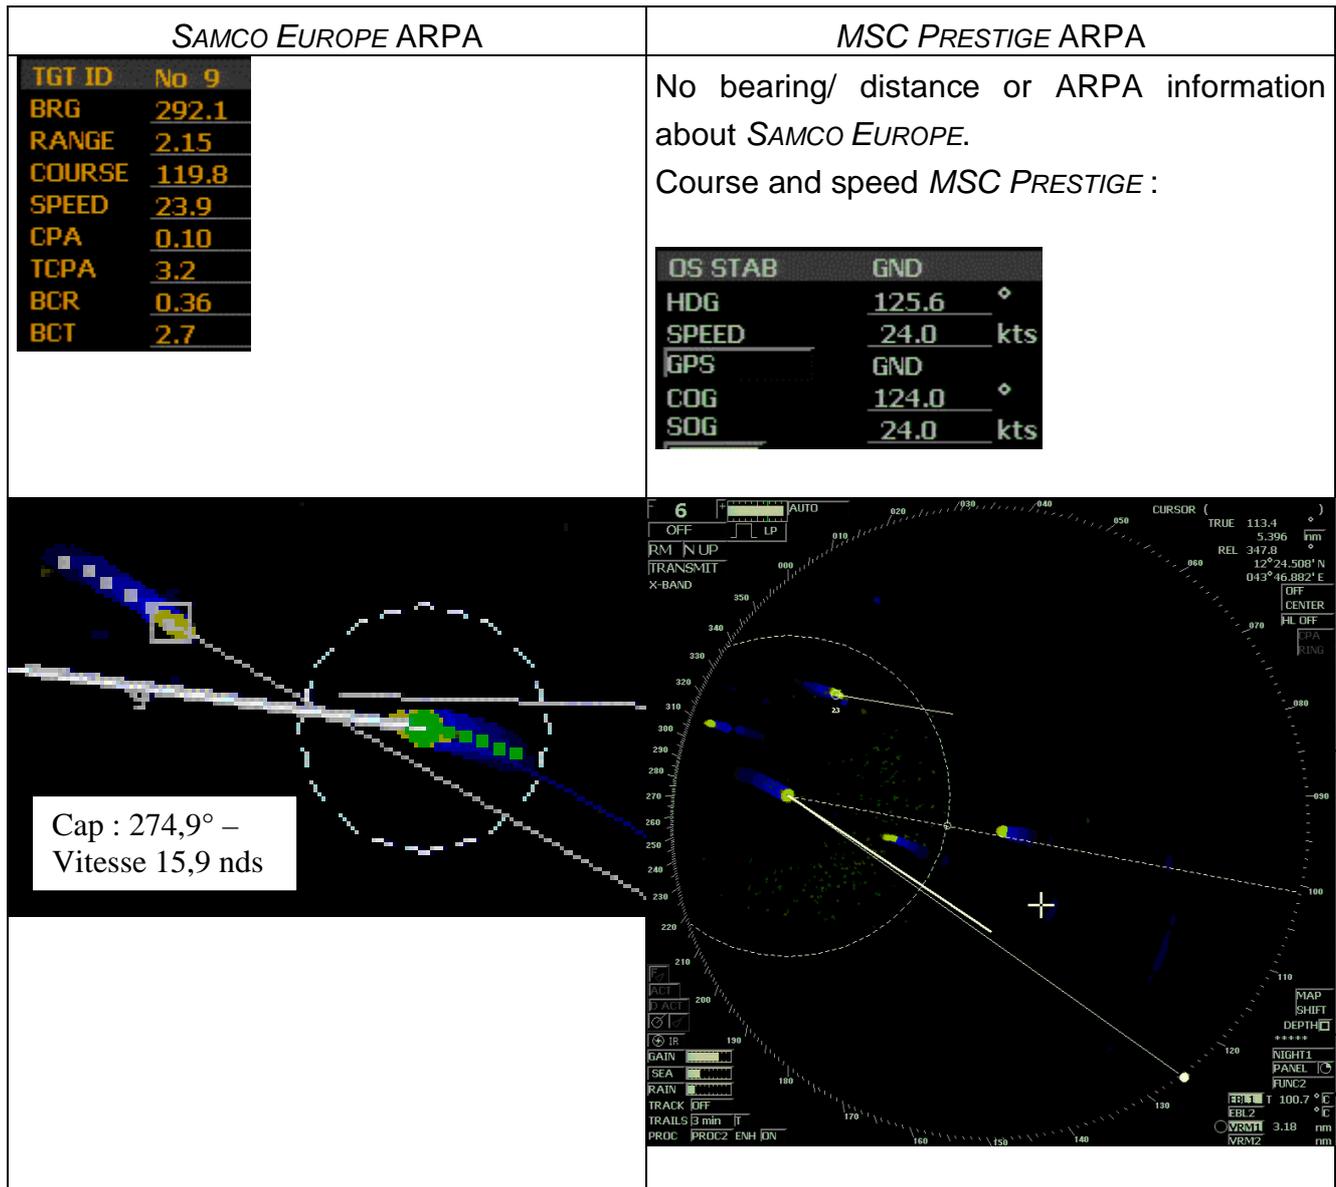
Situation at **23H44** :

Both vessels continue to change course

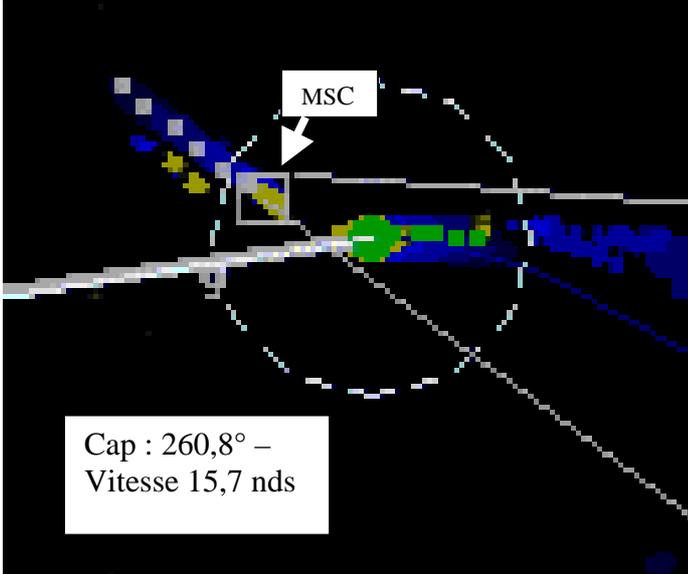
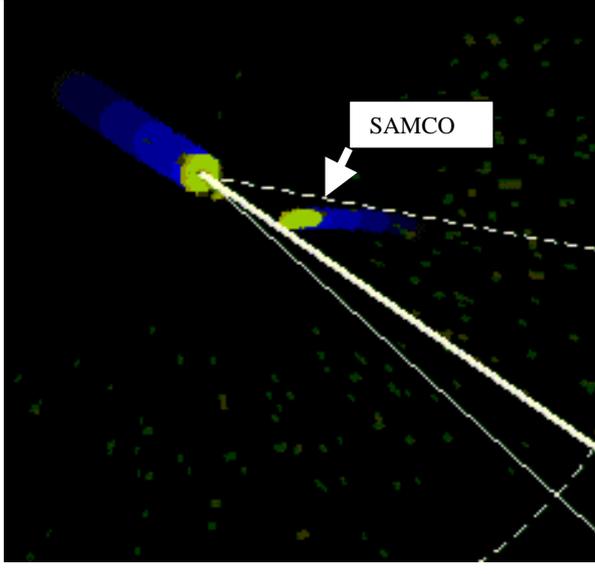
Situation at **23H46** :

<i>SAMCO EUROPE</i> ARPA	<i>MSC PRESTIGE</i> ARPA																																		
<table border="1"> <tr><td>TGT ID</td><td>No 9</td></tr> <tr><td>BRG</td><td>289.2</td></tr> <tr><td>RANGE</td><td>0.68</td></tr> <tr><td>COURSE</td><td>127.0</td></tr> <tr><td>SPEED</td><td>25.3</td></tr> <tr><td>CPA</td><td>0.06</td></tr> <tr><td>TCPA</td><td>1.0</td></tr> <tr><td>BCR</td><td>0.11</td></tr> <tr><td>BCT</td><td>0.9</td></tr> </table>	TGT ID	No 9	BRG	289.2	RANGE	0.68	COURSE	127.0	SPEED	25.3	CPA	0.06	TCPA	1.0	BCR	0.11	BCT	0.9	<p>No bearing/ distance or ARPA information about <i>SAMCO EUROPE</i>.</p> <p>Course and speed <i>MSC PRESTIGE</i> :</p> <table border="1"> <tr><td>OS STAB</td><td>GND</td></tr> <tr><td>HDG</td><td>132.3</td><td>◊</td></tr> <tr><td>SPEED</td><td>23.6</td><td>kts</td></tr> <tr><td>GPS</td><td>GND</td></tr> <tr><td>COG</td><td>125.0</td><td>◊</td></tr> <tr><td>SOG</td><td>23.8</td><td>kts</td></tr> </table>	OS STAB	GND	HDG	132.3	◊	SPEED	23.6	kts	GPS	GND	COG	125.0	◊	SOG	23.8	kts

<p>Cap : 260,8° – Vitesse 15,7 nds</p>

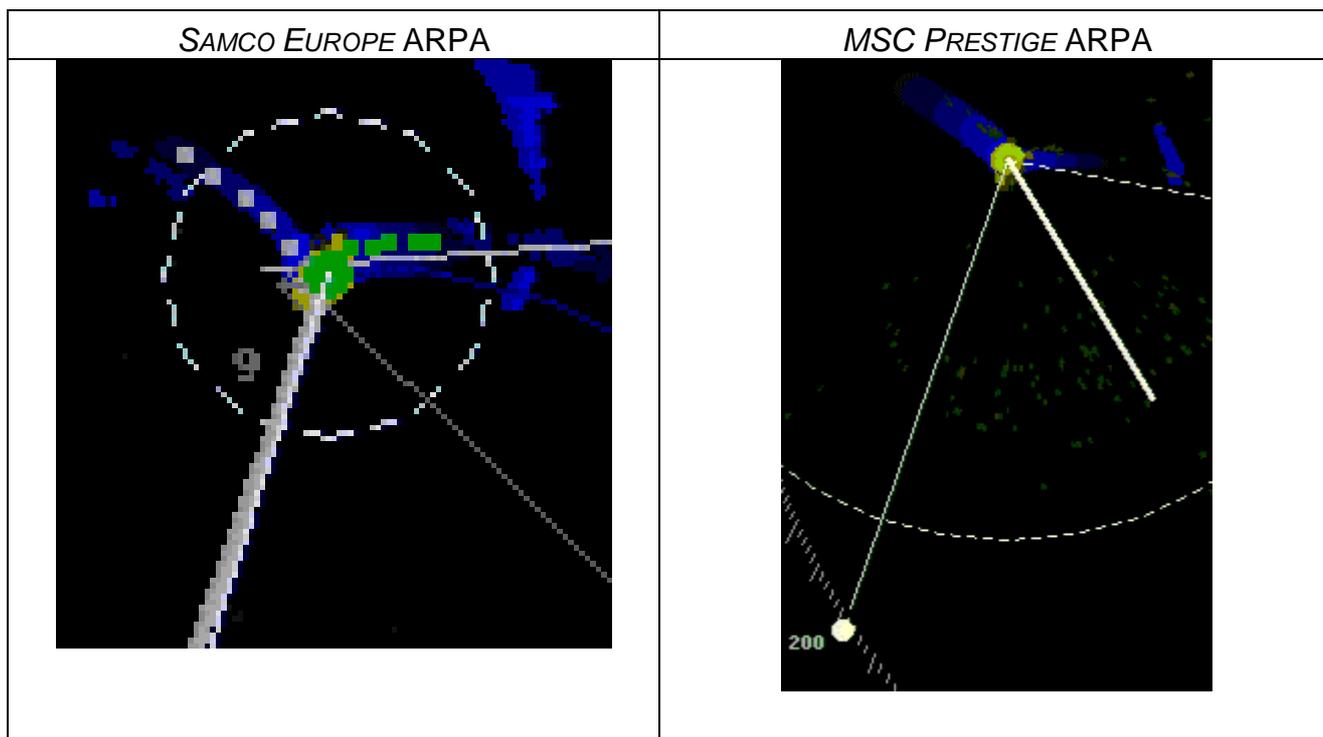
Situation at **23H47** :

SAMCO EUROPE engine is stopped, the helm is “hard to port”. The two vessels collided “bow against bow” then “plating against plating”, before *SAMCO EUROPE* had time to put her engine astern.

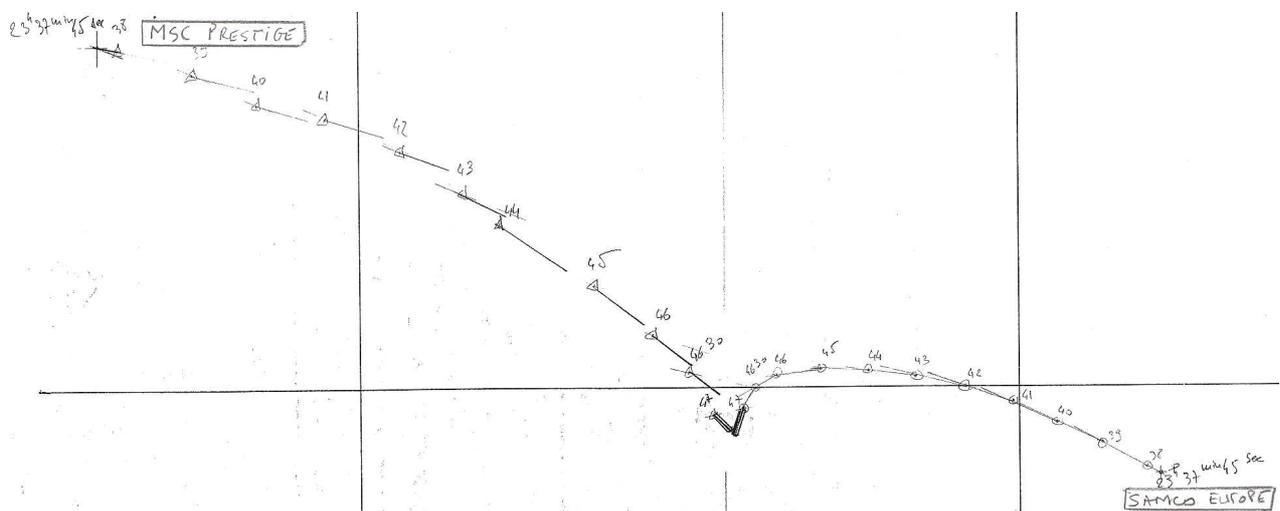
Path of the two vessels (from : ARPA *SAMCO EUROPE*) :
