Report of safety investigation

SAMCO EUROPE
MSC PRESTIGE

Collision

on 7 December 2007 in Aden Gulf

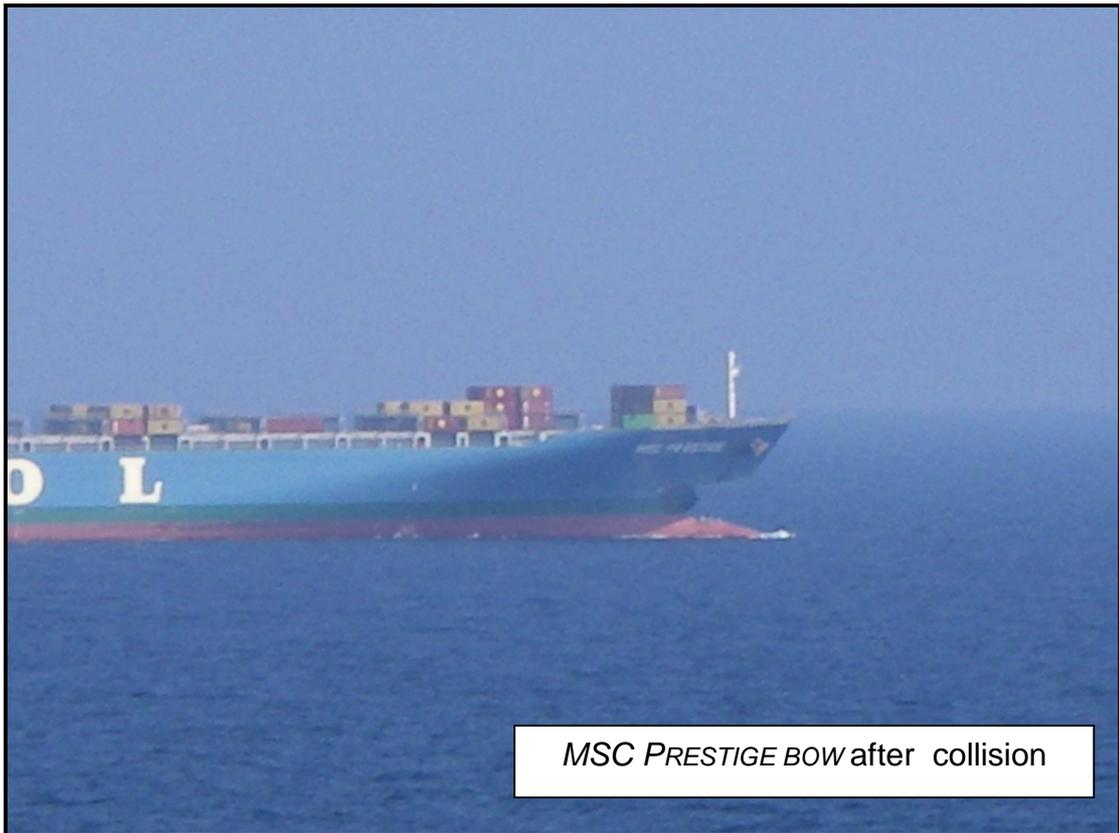
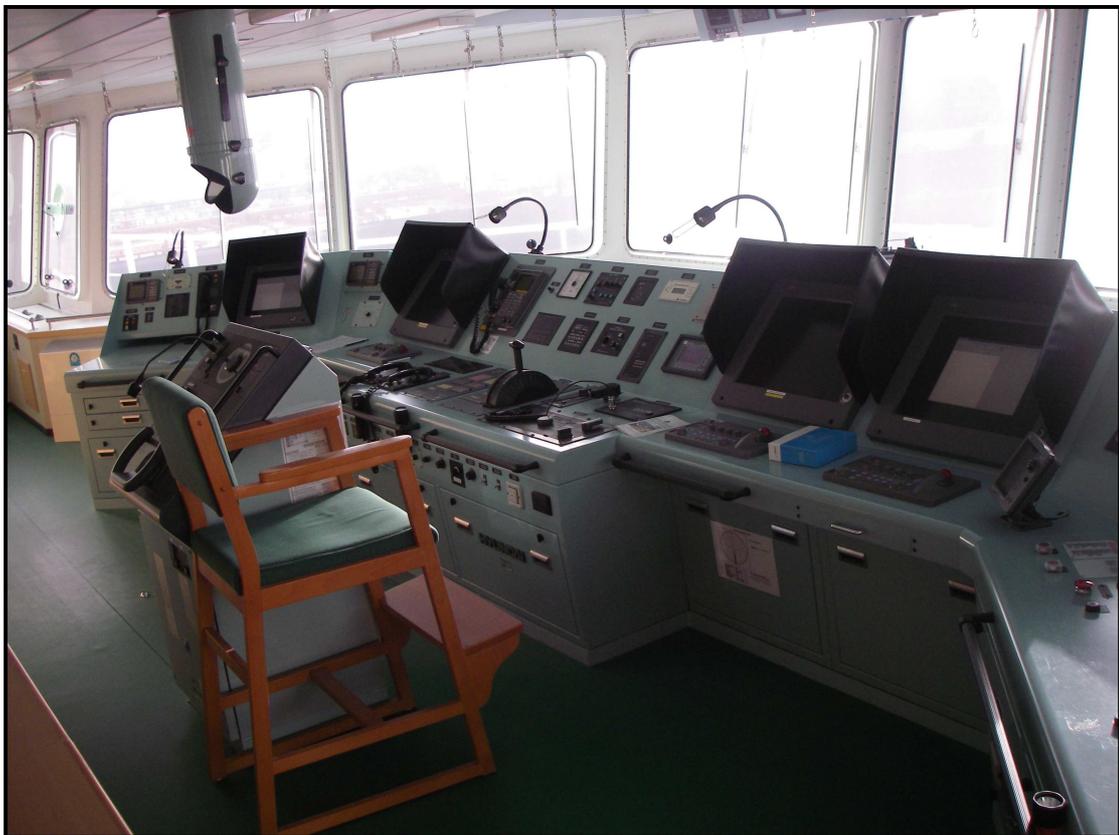
SAMCO EUROPE bridge
