Safety Investigation Report

**Collision with a channel buoy then striking
of the chemical/oil tanker vessel**

DORIS

on 3 April 2009

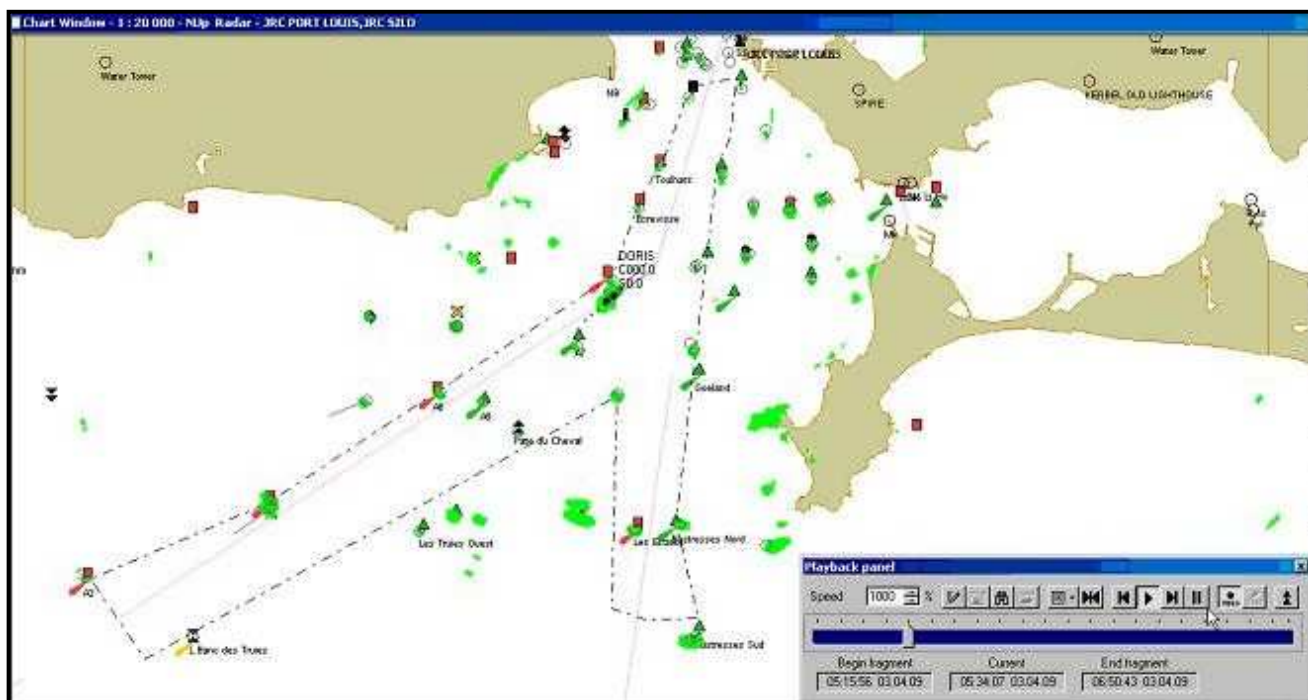
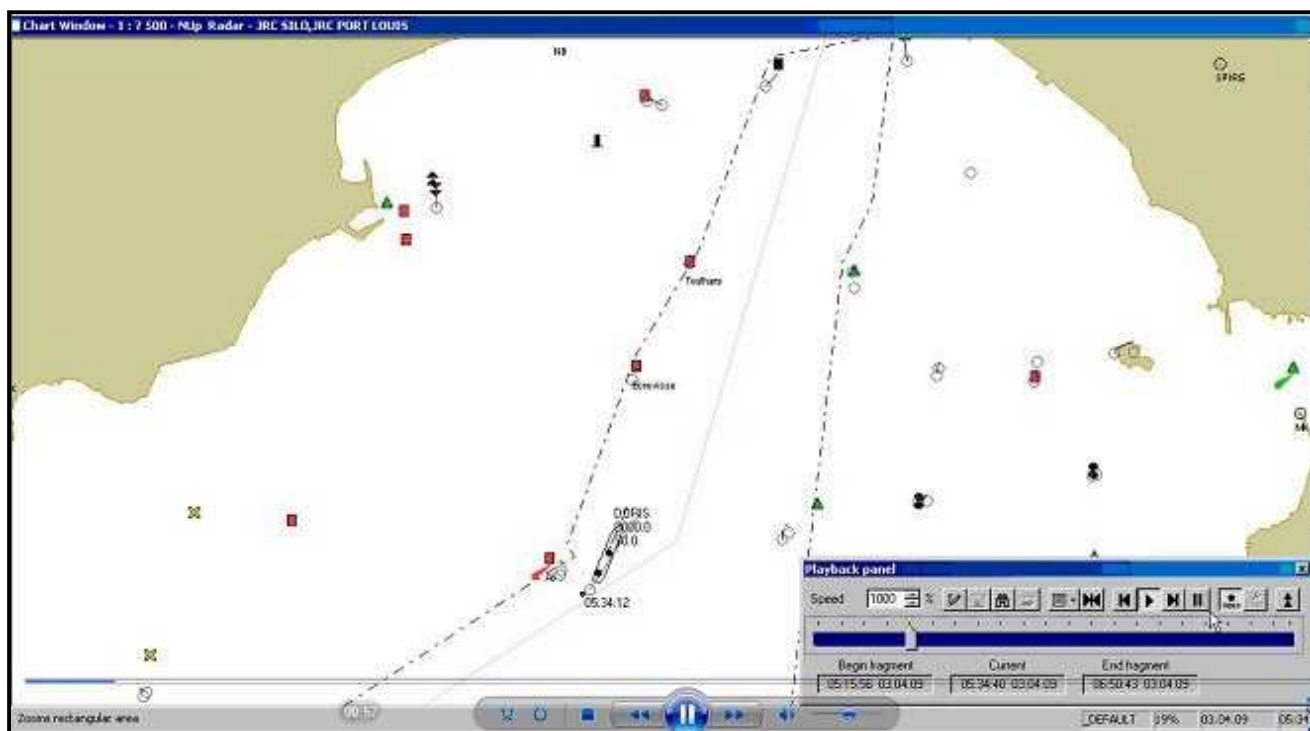
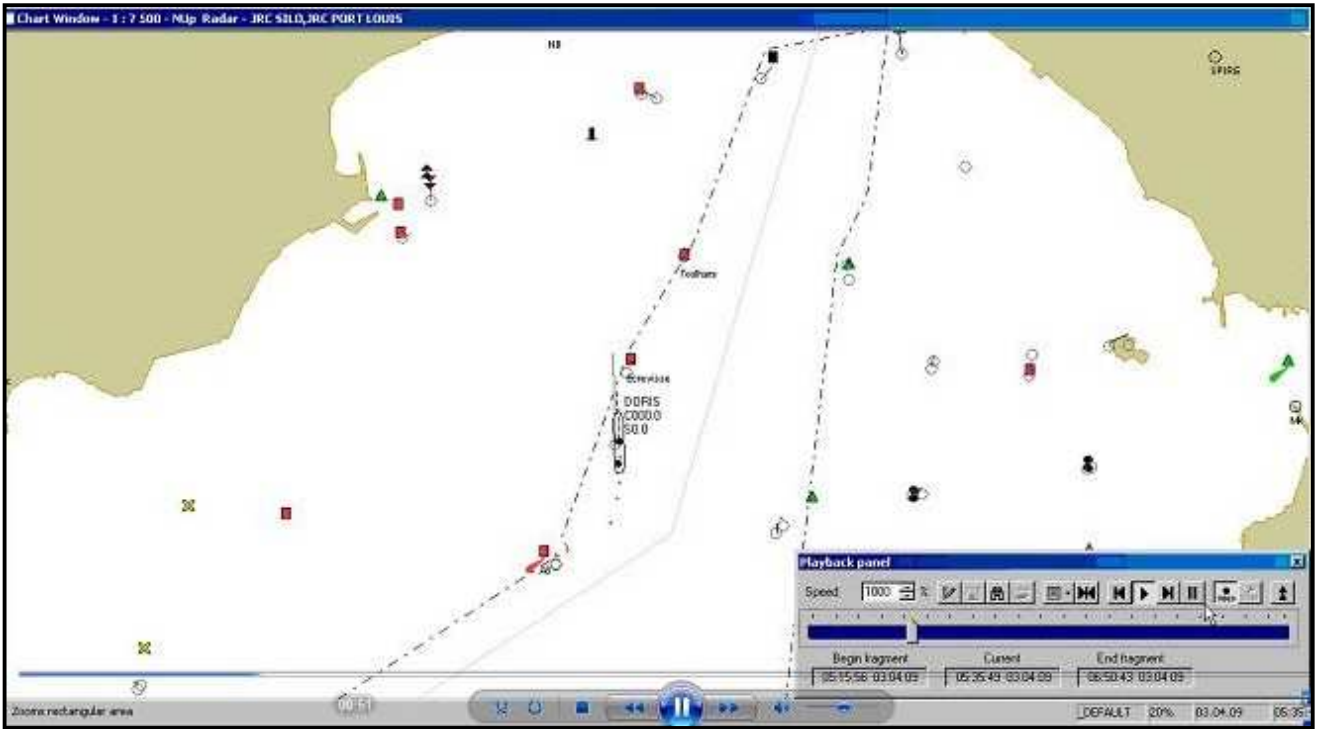
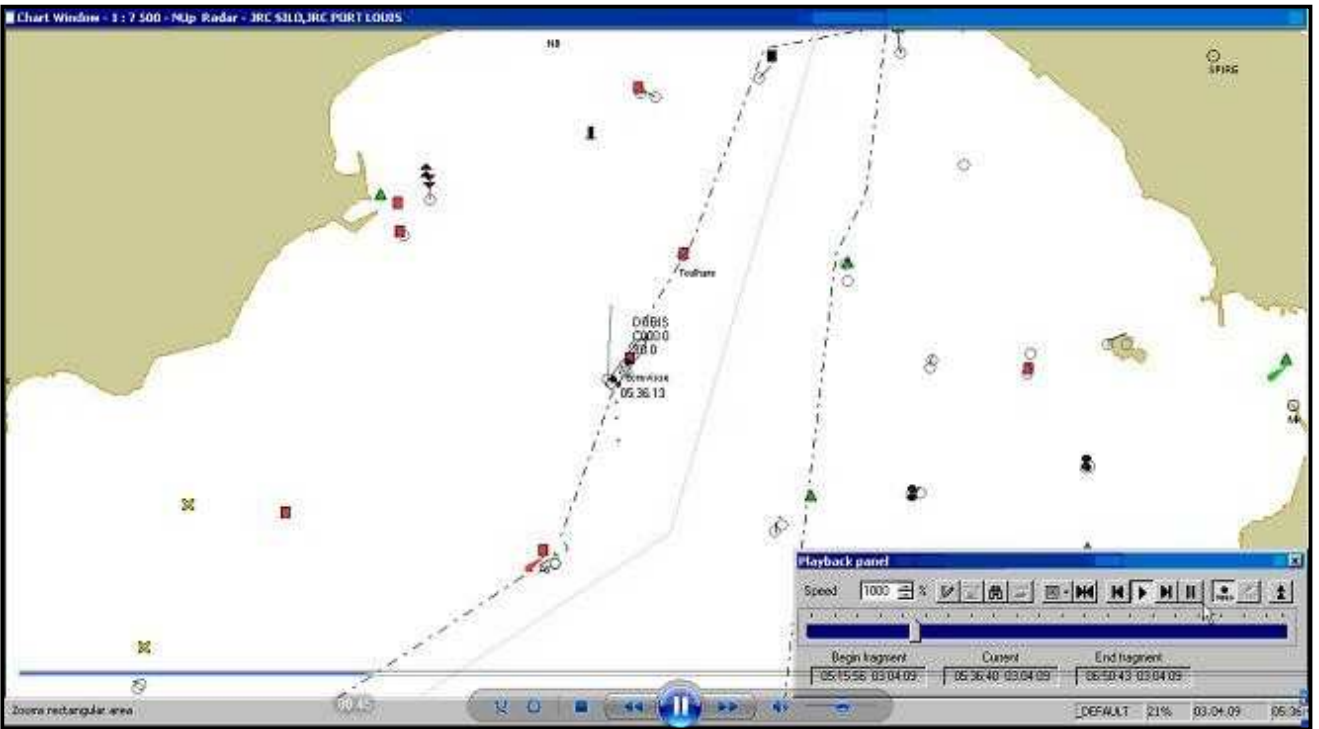
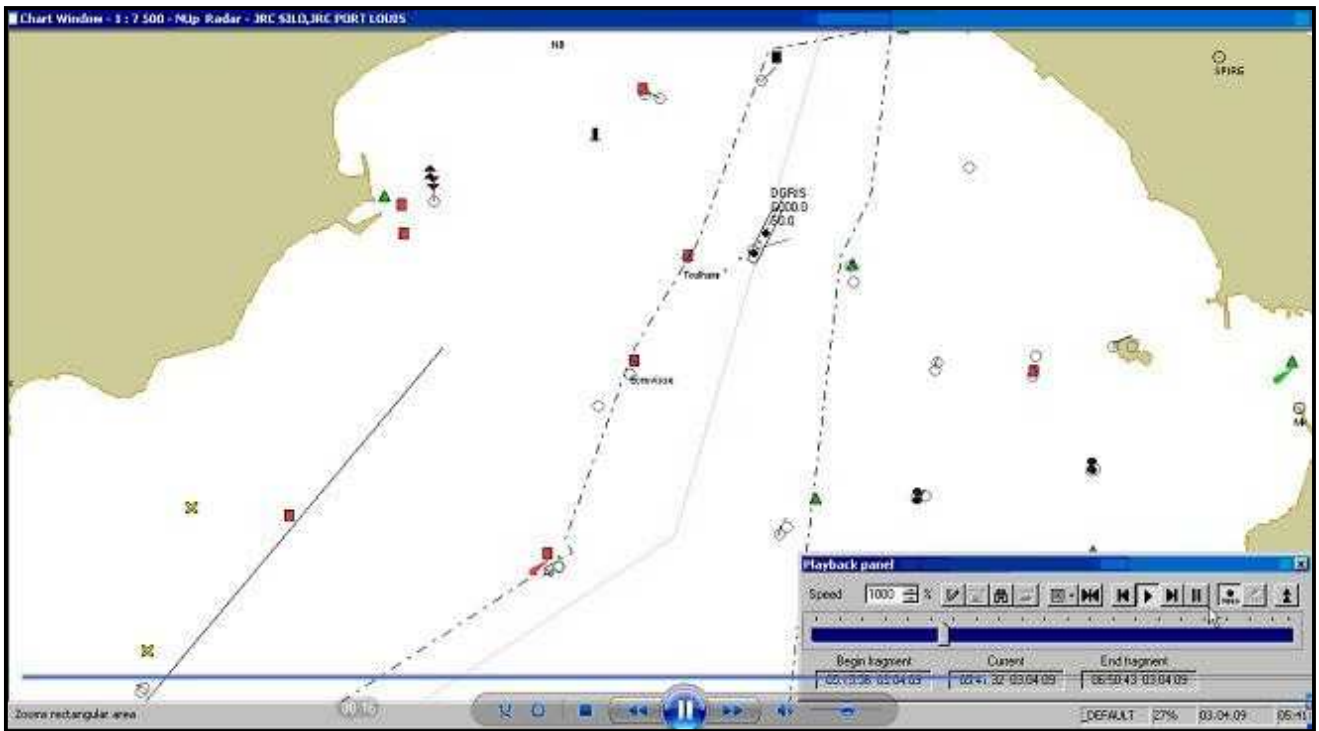
Abreast of buoy A8, a fault in the execution of a steering order led the vessel to swerve and to collide L'Ecrevisse buoy on her starboard. The mooring line of this buoy had been wound up onto the propeller hub, the concrete mud anchor had damaged the rudder.

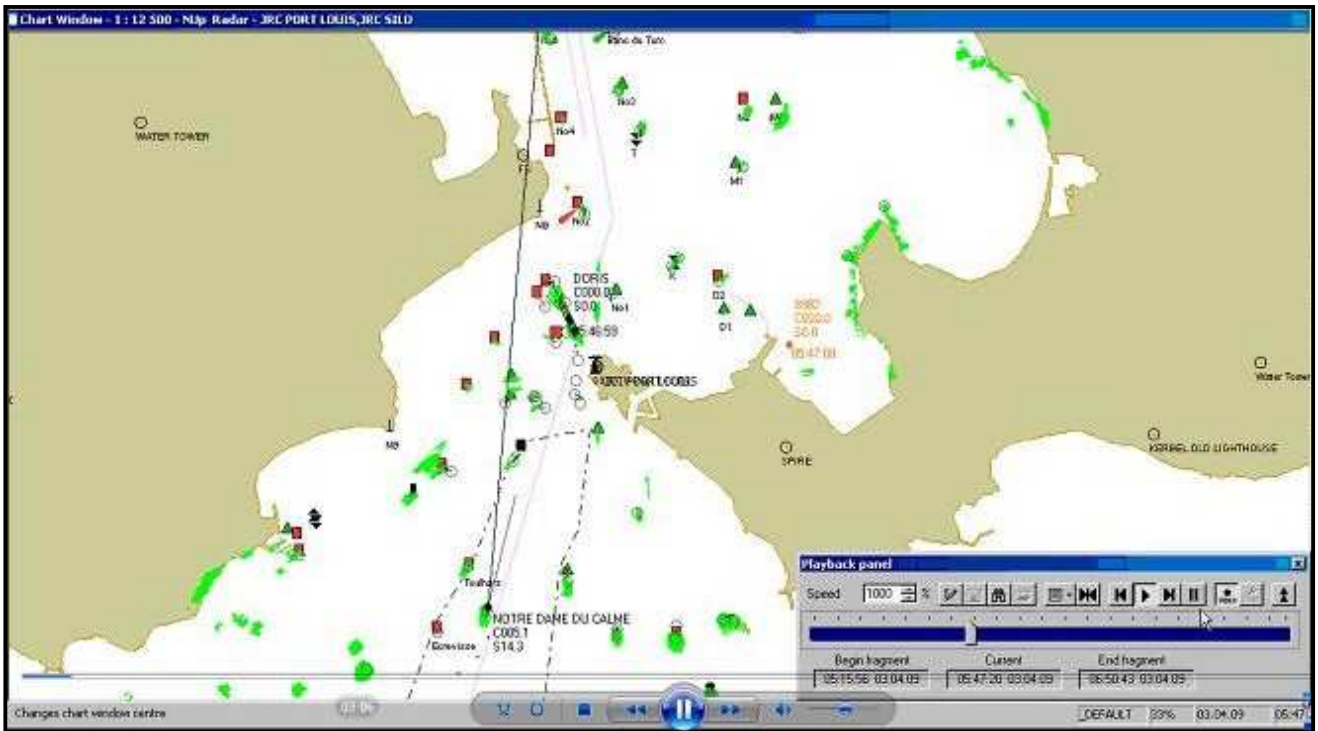
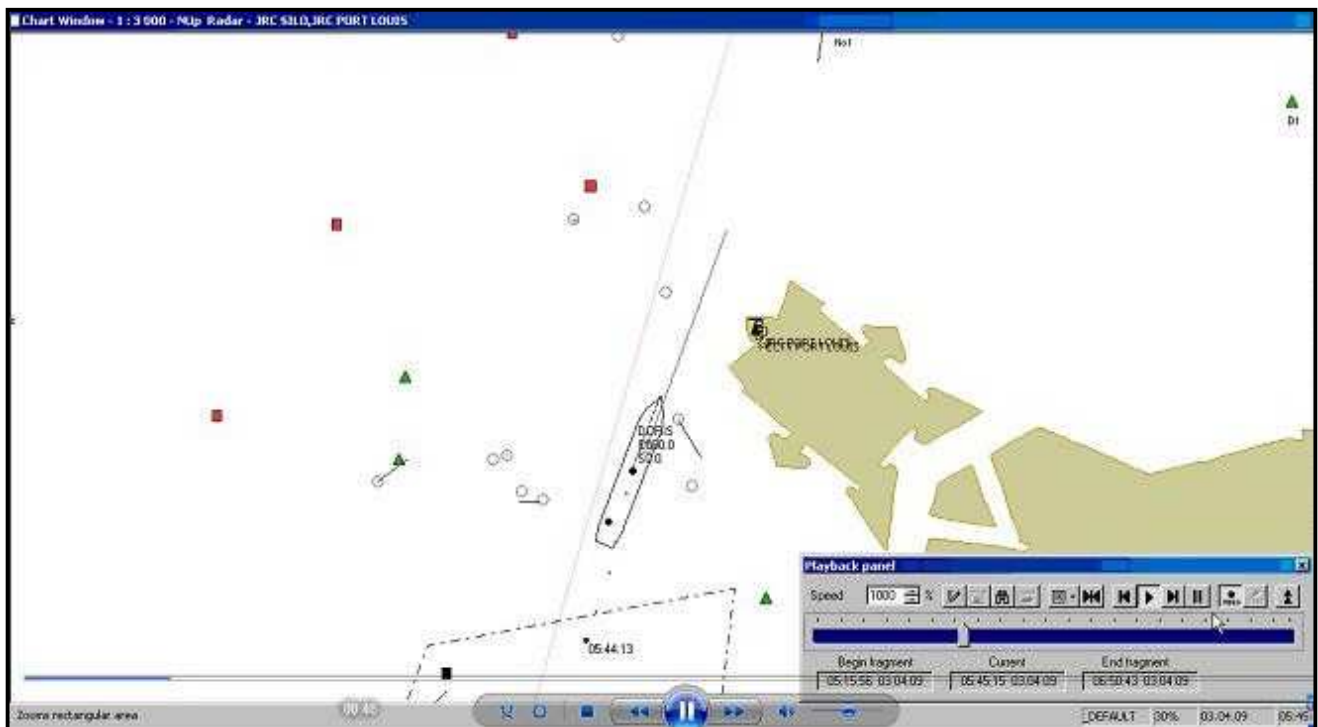
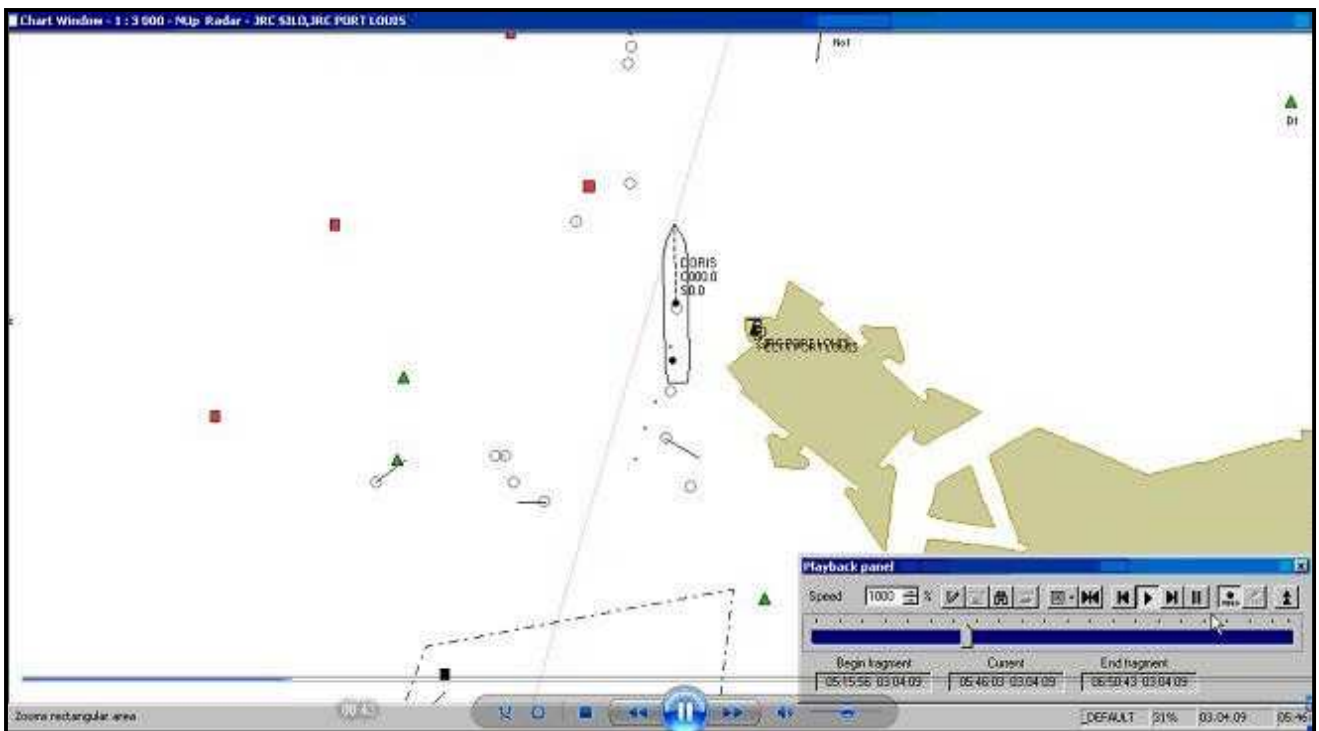
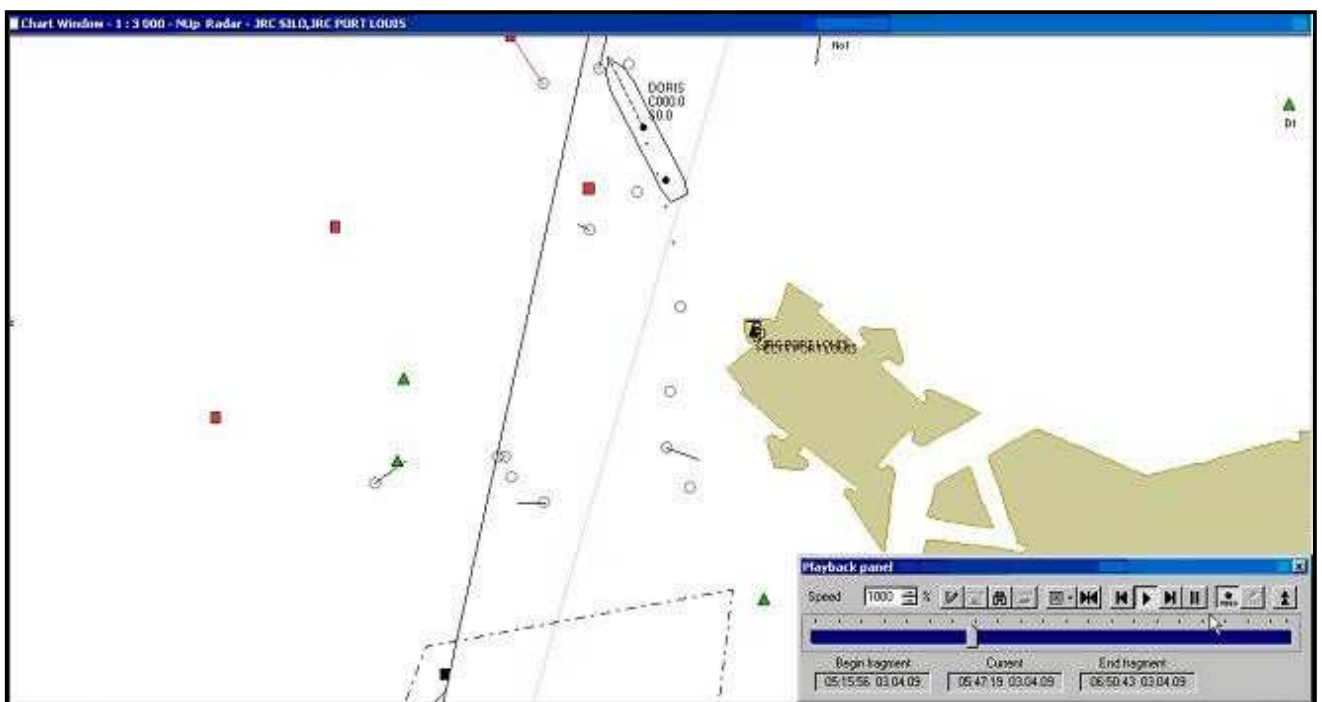
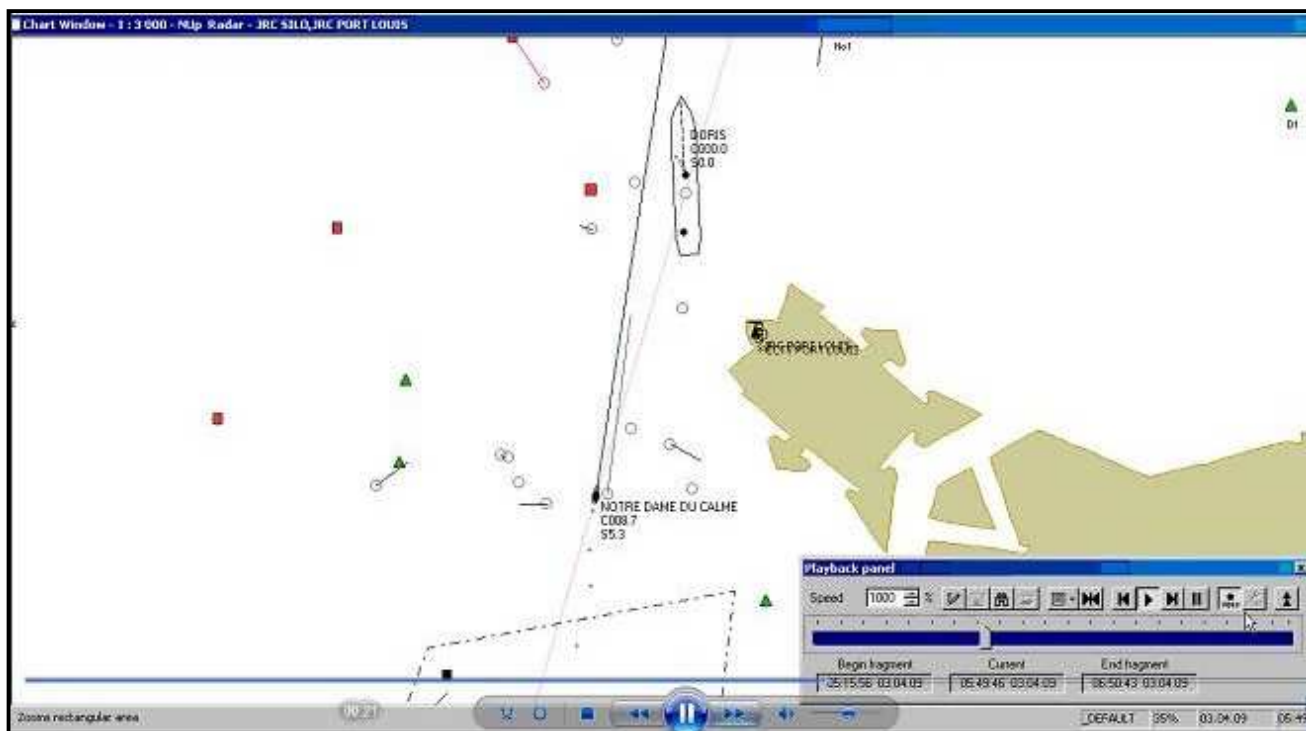
When La Citadelle was abeam, heading 016.5°, the vessel came by herself on port. *SCORFF* skipper informed immediately the pilot that *DORIS* was closing Le Cochon beacon tower; the visibility was only about 10 metres. At the same time a loud noise could be heard coming from astern as if *DORIS* had just struck, although she was in safe water according to the pilot.
