MARINE SAFETY INVESTIGATION REPORT

Safety investigation into the over-pressurisation of a cargo tank on board the Maltese registered chemical tanker

UMAR 1

in Fos sur Mer, France on 19 October 2013

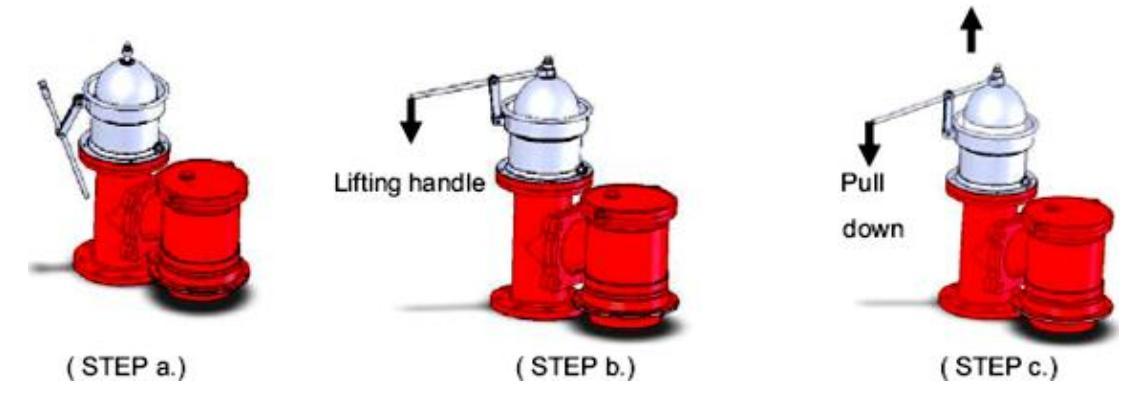
Figure 15: Check lift of pressure valve procedure as presented in the Instruction Manual

The check lift lever was restricted in movement as the linkage appeared to be hard up against the body valve and in some cases, it also appeared seized in position⁵.

Following repairs to the damaged cargo tanks at Tuzla and the testing of the PV valves, it was discovered that the check lift levers should not have been permanently connected as this restricted the movement of the valve top when it lifted during venting operations. This issue was also confirmed by the manufacturers, although the instruction manual did not clearly highlight this potential dangerous situation. In fact, as indicated in Figure 15, the Instruction Manual showed that the check lift lever had to be inserted in the lifting bush. This was implying, albeit not clearly, that during normal operations, check lift lever was not normally in the inserted position.

The safety investigation was unable to determine whether the 'permanent' fixing of the check lift levers was to allow the use of the pole for the free movement test of the valves or whether the check lift levers had always been permanently fitted.

As part of the safety investigation, all of the check lift levers were checked and tested. Although several valve spindles had been found slightly bent, all of the PV valves lifted *relatively* easily except for the one fitted on cargo tank no. 2 port. It was not clear, however, if the PV valve had been damaged by the over-pressurisation during the course of the accident. However, it was noted that some of the other PV valves and check lift levers were stiffer than others to operate and required additional effort to lift. After several attempts to rotate and manipulate the cargo tank no. 2 port valve top, it lifted with some effort, but jammed every time it was released.

No recommendations have been made to the ISM managers due to the safety actions already taken as a result of the accident. One recommendation was made to Topsafe Co. Ltd. to alert its clients on the importance of removing the check lift lever from the lifting bush immediately after the opening test is carried out.
