Report on the investigation of the contact
and grounding of the ro-ro passenger ferry

Pride of Kent

Calais, France

REPORT NO 3/2019

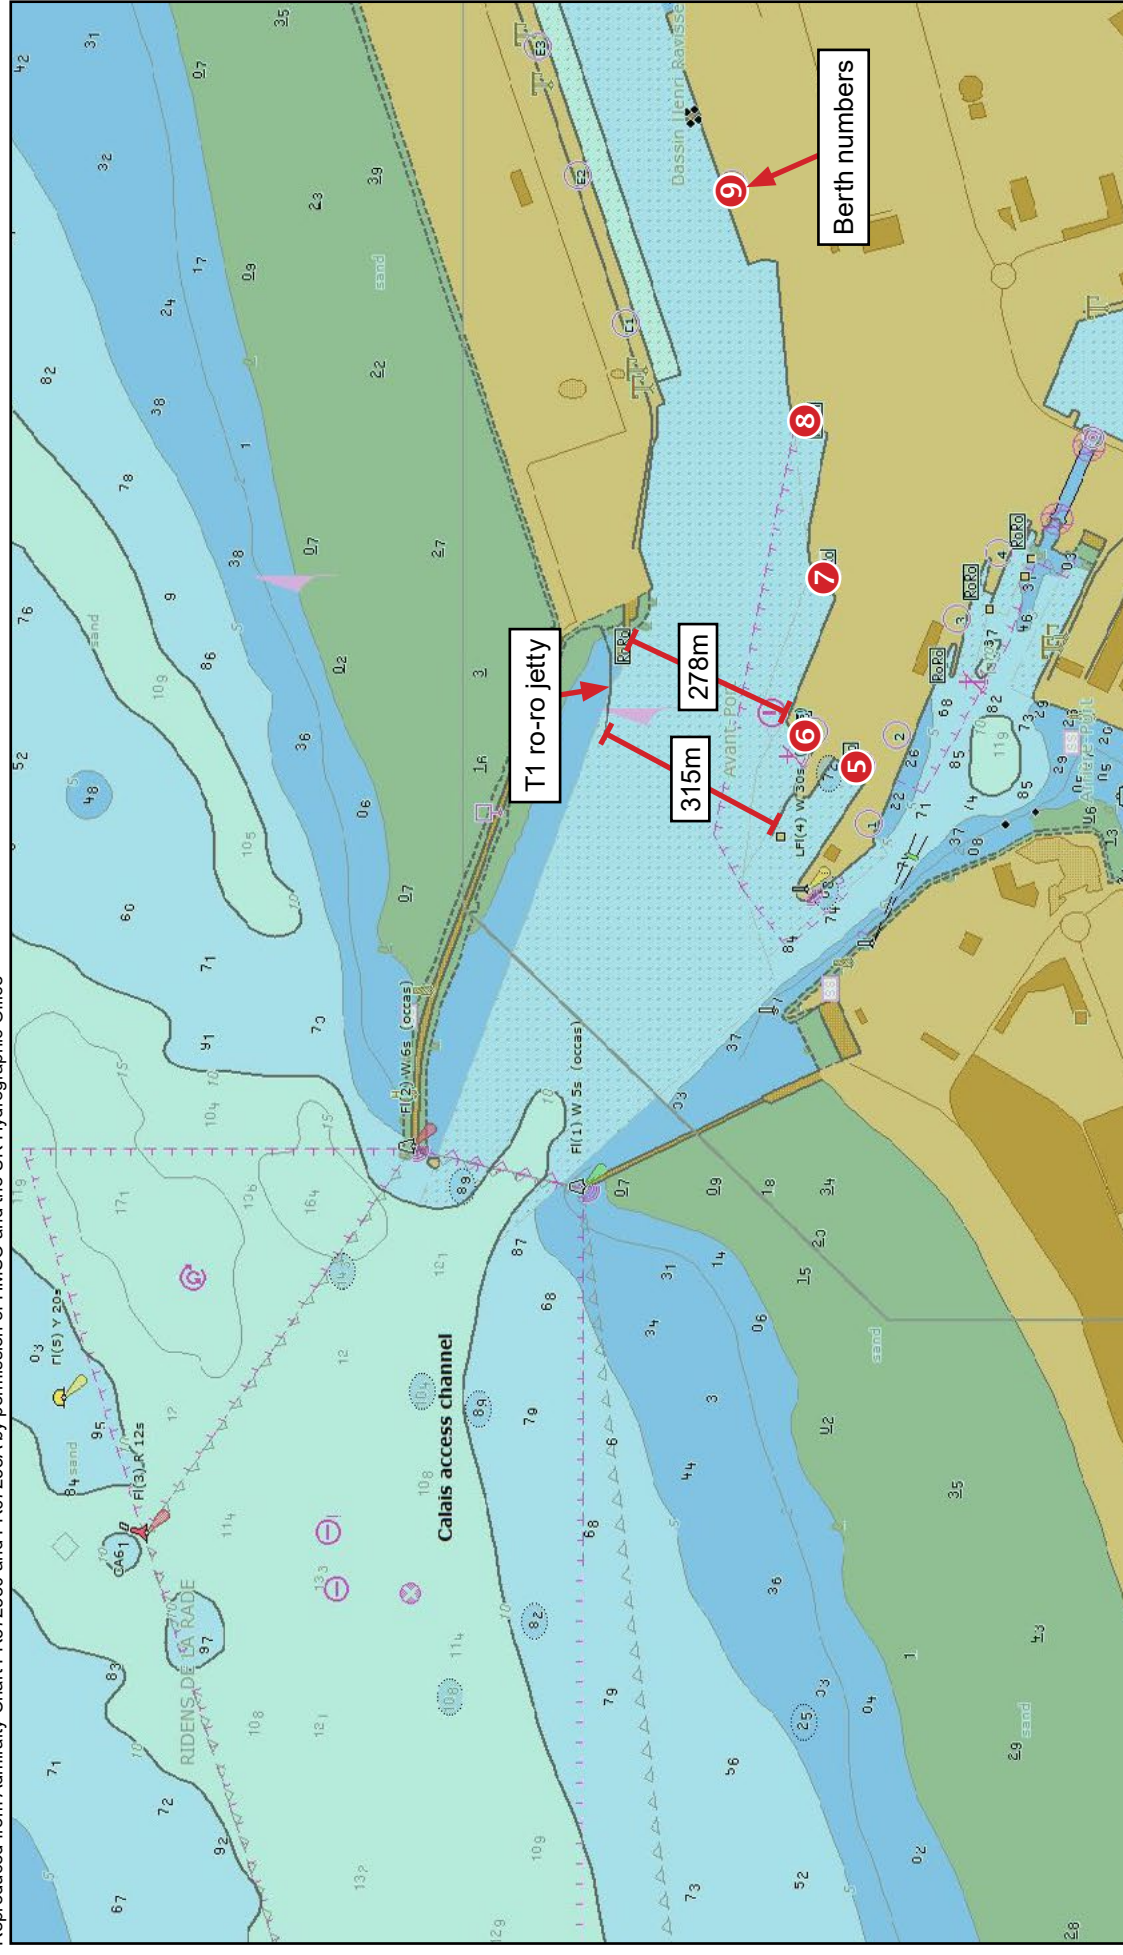
Figure 1: Port of Calais electronic chart extract from cells FR572580 and FR67258A

At 1005 on 10 December 2017, the ro-ro passenger ferry *Pride of Kent* was approaching Calais, France. On the bridge was the master, an officer of the watch (OOW), an assisting officer, and a helmsman. When the ferry was 1½ miles from the port entrance, the master took the conn from the OOW and briefed the bridge team that he would be keeping the vessel upwind during the approach to berth No.6 (**Figure 1**). The wind was from the south-south-west at 25 knots (kts).

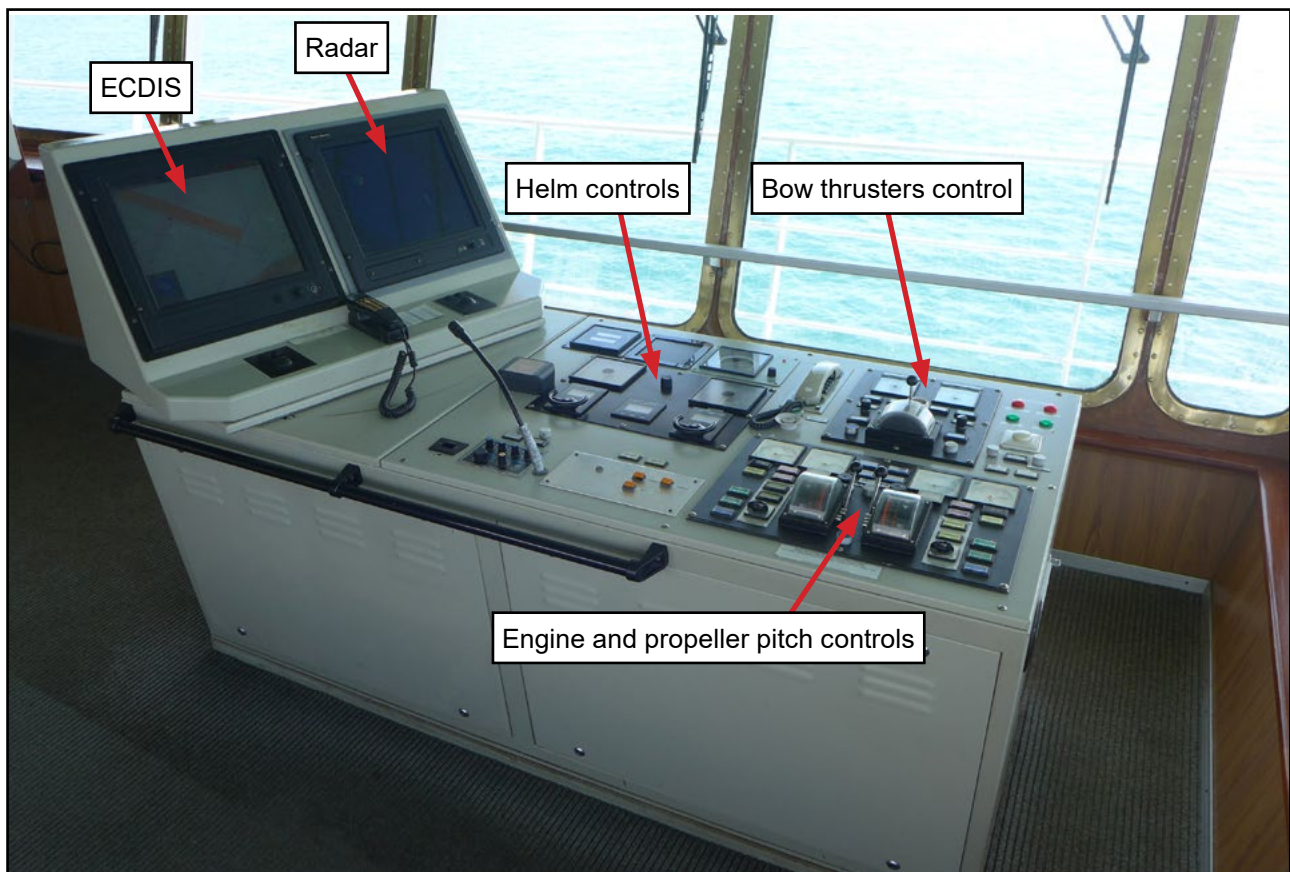
Figure 2: Starboard bridge wing control console

As *Pride of Kent* passed between the breakwaters, the master noticed that the wind speed had increased, and instructed the bridge team to inform him if there were any exceptional gusts. By 1018, the vessel was approaching berth No.6 and the master was controlling the vessel's movement from the starboard bridge wing control console (**Figure 2**). The wind was then between 40 and 50kts on the starboard quarter. As the vessel's bow came close to the linkspan landing pads, the master assessed that he would be unable to keep the stern alongside the berth.

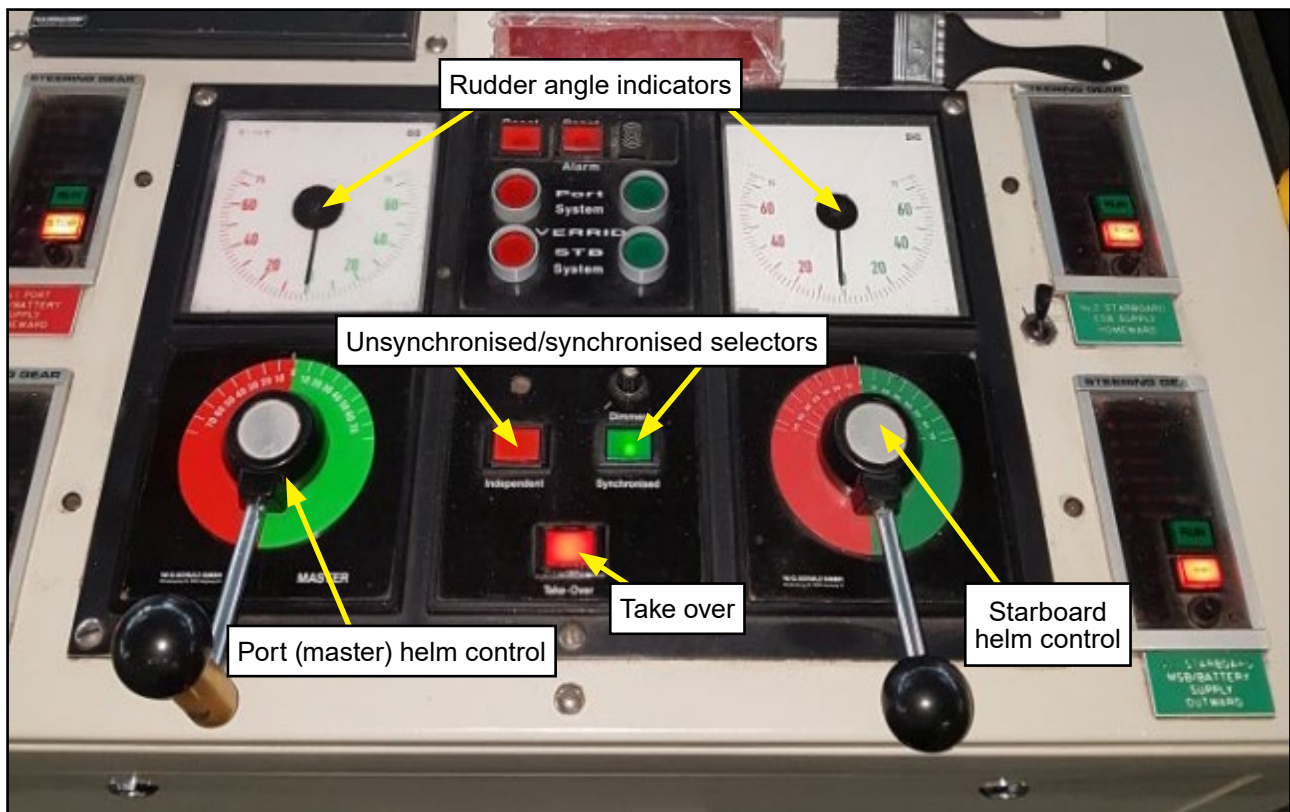
Figure 6: Main console steering control panel (centre console)

At 1144:55, *Pride of Kent's* master put both rudders to amidships as the ferry's heading approached 289° (**Figure 5**). He then requested the helmsman to take steering control at the centre console and steer for the green light on the southern breakwater. The helmsman pressed the take-over button and moved the port (master) control lever⁴ (**Figure 6**) to port 40°. The starboard helm control lever remained at amidships.

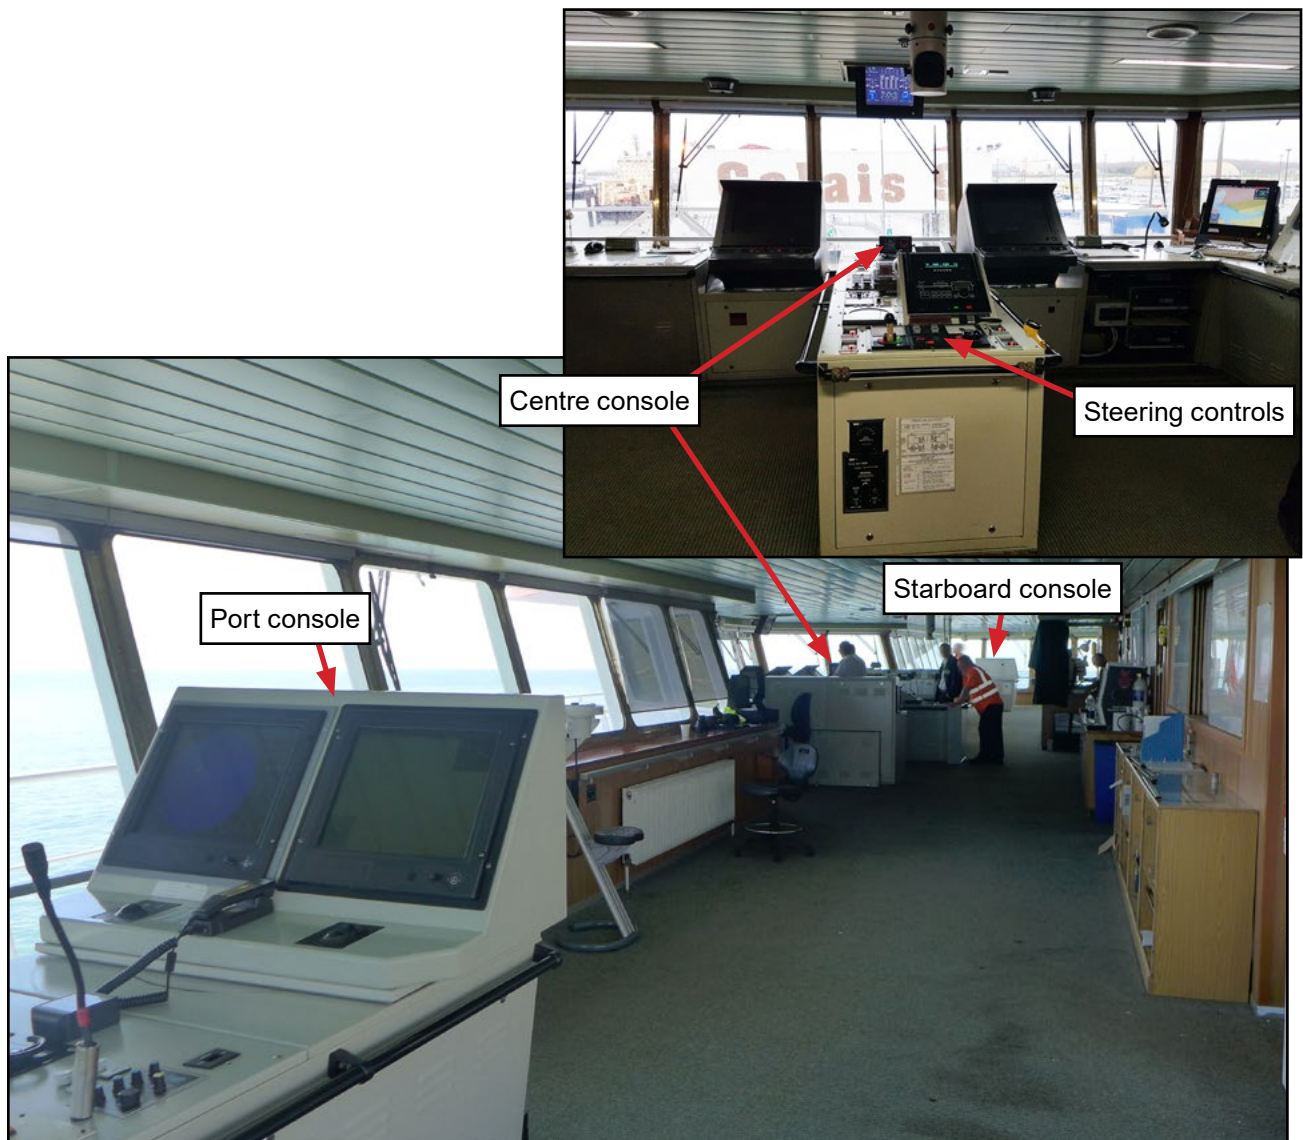
Figure 9: Fully enclosed bridge arrangement

Pride of Kent's enclosed bridge was fitted with three control consoles; one on the centreline and one on each bridge wing (**Figure 9**). Each of the consoles was equipped with a radar display, an ECDIS, VHF radio and control panels for the main engines, propeller pitch, bow thrusters and steering. Only the centre console was fitted with a talkback system for communicating with the engine control room, and a rate of turn indicator.
