Report on the investigation  
into a collision between  
**fv Z.85 – ALEXIS II and mts LS JAMIE**  
on March 31<sup>st</sup> 2021

in TSS Dover Strait  
with serious damage to the fishing vessel.

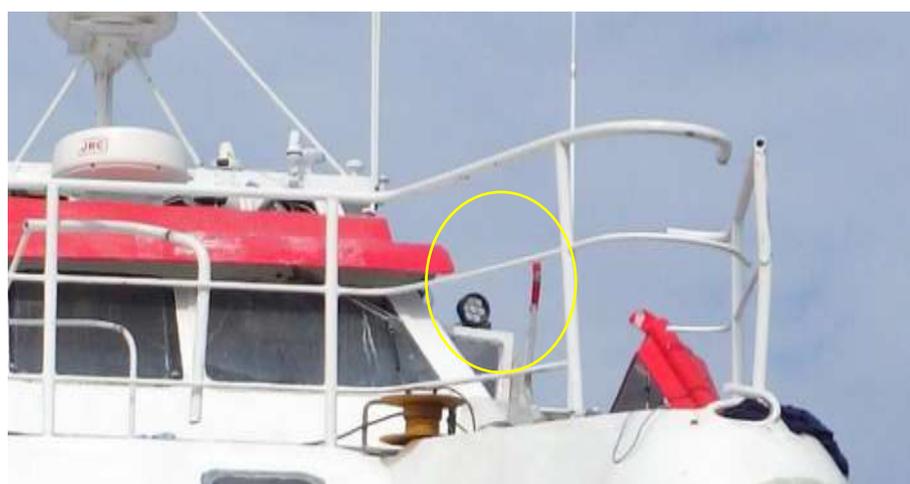
Fv Z.85 - ALEXIS II had turned on her navigation lights, making it visible for other vessels that she was a power-driven vessel underway. Two searchlights were also switched on to locate any debris in the water that could be harmful to the propellers. One searchlight was located at SB, the other one at PS, as indicated in Figure 1.

*Figure 1 - PS search light on board fv Z.85 - ALEXIS II*

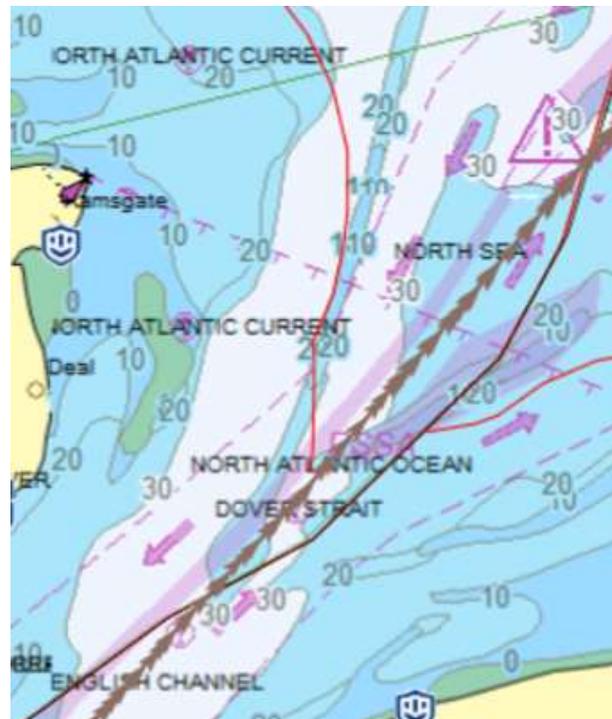
On Wednesday March 31<sup>st</sup>, 2021, around 00:00 hours, chem tanker LS JAMIE was underway from Le Havre anchorage, France, to the port of Saltend, UK. The vessel was following Dover Strait TSS, as shown in Figure 4.

Figure 4 – Track of mts LS JAMIE in Dover Strait TSS

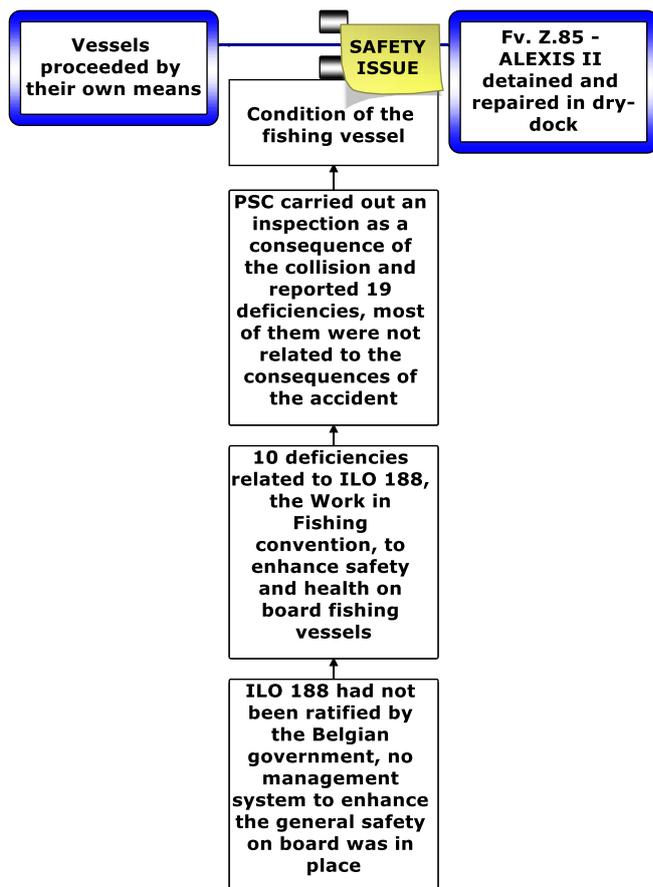
#### *Fv. Z.85 - ALEXIS II detained and repaired in dry-dock*

Incident Barrier	Performance	Barrier Challenge	Remarks
Failed  Condition of the fishing vessel	Vessel	Compliance to regulations	PSC carried out an inspection as a consequence of the collision and reported 19 deficiencies, most of them were not related to the consequences of the accident
	Vessel and owner	General maintenance and operational preparedness	10 deficiencies related to ILO 188, the Work in Fishing convention, to enhance safety and health on board fishing vessels
	Flagstate	Ratification of conventions	ILO 188 had not been ratified by the Belgian government, no management system to enhance the general safety on board was in place

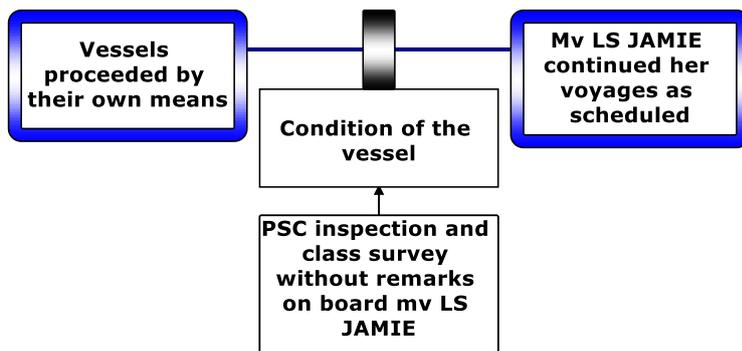
*Mts LS JAMIE continued her voyages as scheduled*

<b>Incident Barrier</b>	<i>Performance</i>	<i>Barrier Challenge</i>	<i>Remarks</i>
<b>Effective</b> Condition of the vessel	Vessel	Compliance to regulations	PSC inspection and class survey without remarks on board mts LS JAMIE

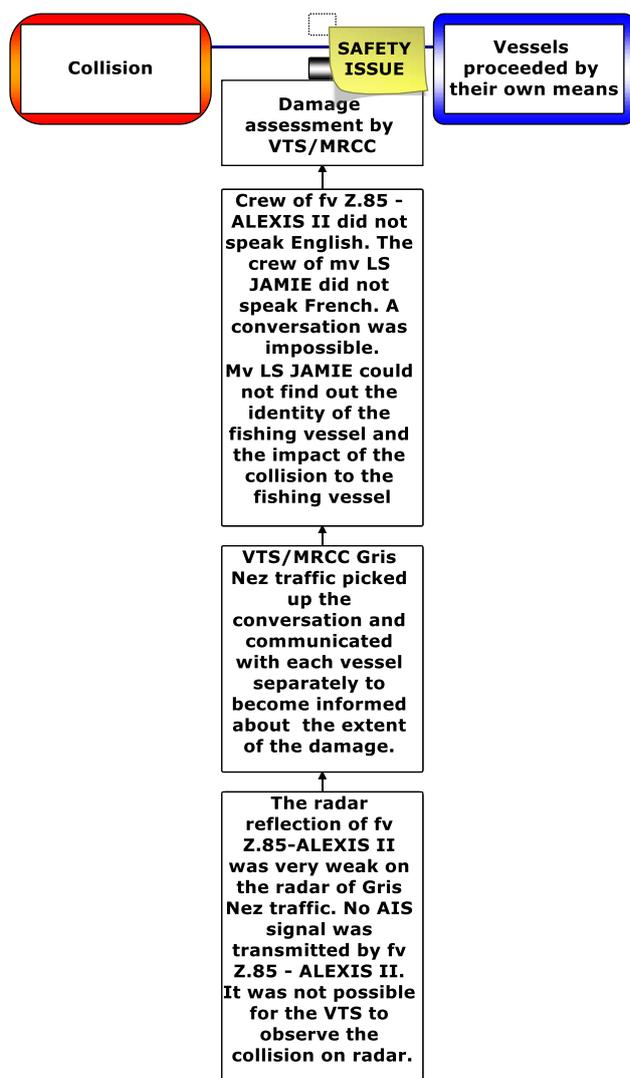
*Vessels proceeded by their own means*

Incident Barrier	Performance	Barrier Challenge	Remarks
Inadequate  Damage assessment by VTS/MRCC	Vessel and owner	Communication	Crew of fv Z.85 - ALEXIS II did not speak English. The crew of mts LS JAMIE did not speak French. A conversation was impossible. Mts LS JAMIE could not find out the identity of the fishing vessel and the impact of the collision to the fishing vessel
	VTS/MRCC	Communication	VTS/MRCC Gris Nez traffic picked up the conversation and communicated with each vessel separately to become informed about the extent of the damage.

VTS/MRCC	Radar observation	The radar reflection of fv Z.85-ALEXIS II was very weak on the radar of Gris Nez traffic. No AIS signal was transmitted by fv Z.85 - ALEXIS II. It was not possible for the MRCC to observe the collision on radar.
--	----------	-------------------	---

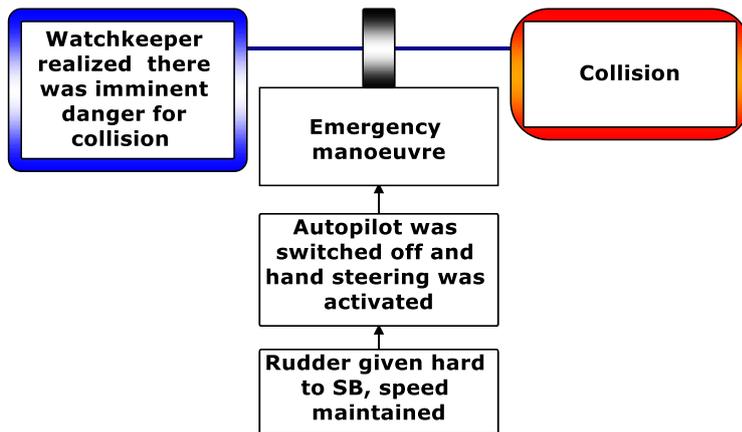
### Collision

Incident Barrier	Performance	Barrier Challenge	Remarks
Effective	Vessel	Emergency response	Autopilot was switched off and hand steering was activated
Emergency manoeuvre	Vessel	Emergency response	Rudder given hard to SB, speed maintained

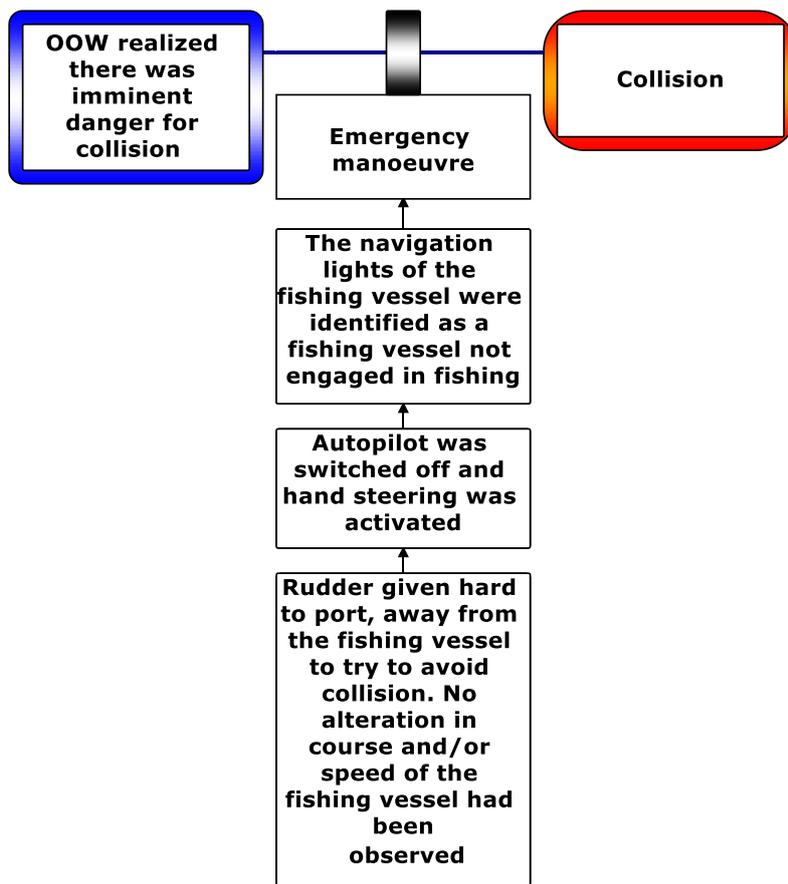
### Collision

Incident Barrier	Performance	Barrier Challenge	Remarks
Effective  Emergency manoeuvre	Vessel	COLREG	The navigation lights of the fishing vessel were identified as a fishing vessel not engaged in fishing
	Vessel	Emergency response	Autopilot was switched off and hand steering was activated
	Vessel	Emergency response	Rudder given hard to port, away from the fishing vessel to try to avoid collision. No alteration in course and/or speed of the fishing vessel had been observed

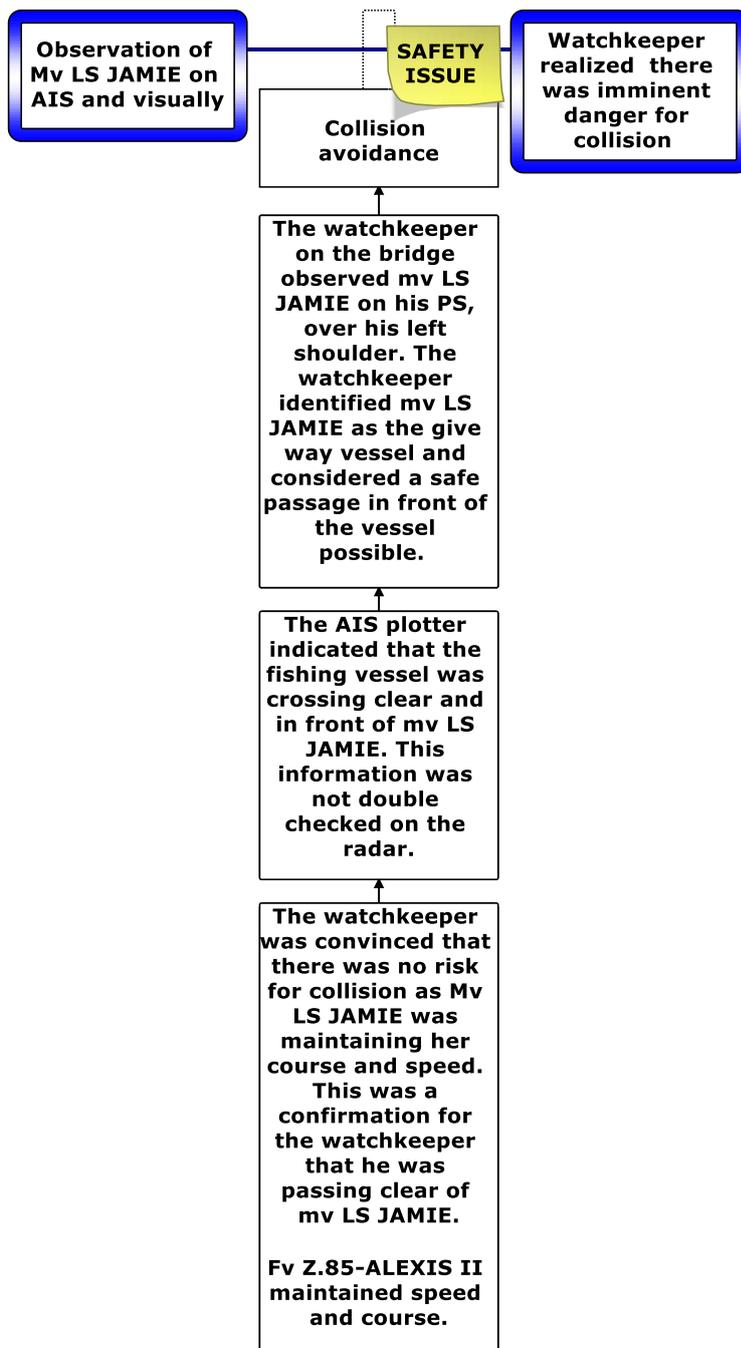
*Watchkeeper realized there was imminent danger for collision*

Incident Barrier	Performance	Barrier Challenge	Remarks
Missing Collision avoidance	Vessel	Watchkeeping	The watchkeeper on the bridge observed mts LS JAMIE on his PS, over his left shoulder. The watchkeeper identified mts LS JAMIE as the give way vessel and considered a safe passage in front of the vessel possible.

Vessel	Watchkeeping and COLREG	The AIS plotter indicated that the fishing vessel was crossing clear and in front of mts LS JAMIE. This information was not double checked on the radar.
	Vessel	Watchkeeping and COLREG	The watchkeeper was convinced that there was no risk for collision as Mts LS JAMIE was maintaining her course and speed. This was a confirmation for the watchkeeper that he was passing clear of mts LS JAMIE.  Fv Z.85-ALEXIS II maintained speed and course.

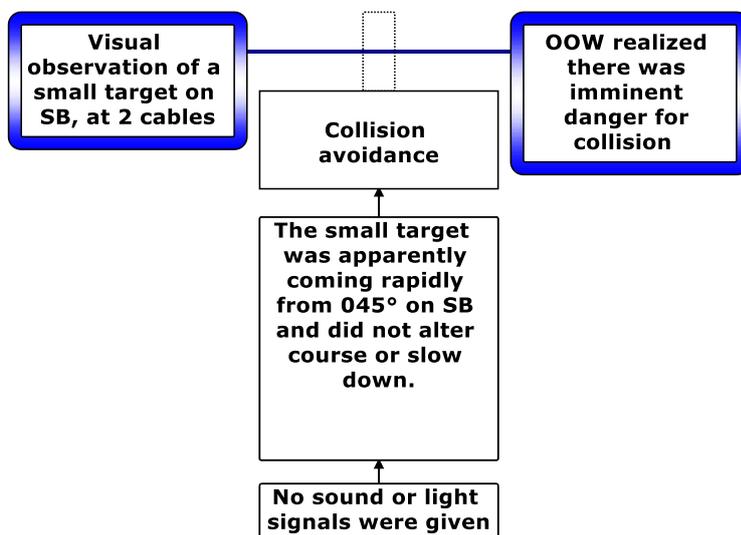
*OOW realized there was imminent danger for collision*

<b>Incident Barrier</b>	<i>Performance</i>	<i>Barrier Challenge</i>	<i>Remarks</i>
<b>Missing</b>  Collision avoidance	Vessel	Watchkeeping	The small target was apparently coming rapidly from 045° on SB and did not alter course or slow down.
	Vessel	Collision avoidance	No sound or light signals were given

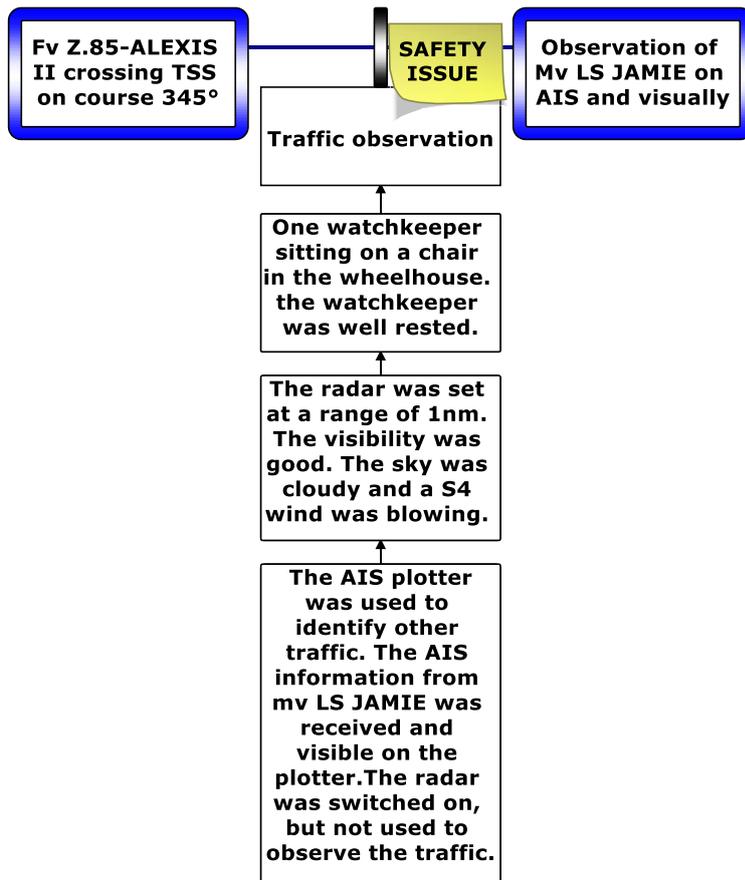
*Observation of Mts LS JAMIE on AIS and visually*

<b>Incident Barrier</b>	<i>Performance</i>	<i>Barrier Challenge</i>	Remarks
<b>Unreliable</b>  Traffic observation	Vessel	Look-out and Watchkeeping	One watchkeeper sitting on a chair in the wheelhouse. the watchkeeper was well rested.
	Vessel	Watchkeeping	The radar was set at a range of 1nm. The visibility was good. The sky was cloudy and a S4 wind was blowing.
	Vessel	Watchkeeping and COLREG	The AIS plotter was used to identify other traffic. The AIS information from mts LS JAMIE was received and visible on the plotter. The radar was switched on, but not used to observe the traffic.

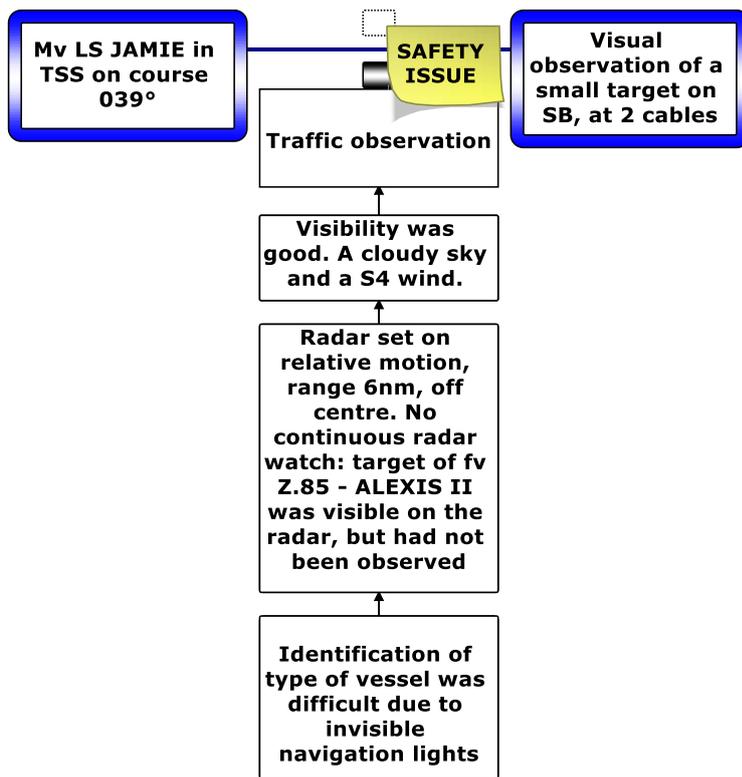
*Visual observation of a small target on SB, at 2 cables*

<b>Incident Barrier</b>	<i>Performance</i>	<i>Barrier Challenge</i>	<i>Remarks</i>
<b>Inadequate</b>  Traffic observation	Weather	Visibility	Visibility was good. A cloudy sky and a S4 wind.
	Vessel	Watchkeeping and COLREG	Radar set on relative motion, range 6nm, off centre. No continuous radar watch: target of fv Z.85 - ALEXIS II was visible on the radar, but had not been observed
	Vessel	Watchkeeping and COLREG	Identification of type of vessel was difficult due to invisible navigation lights

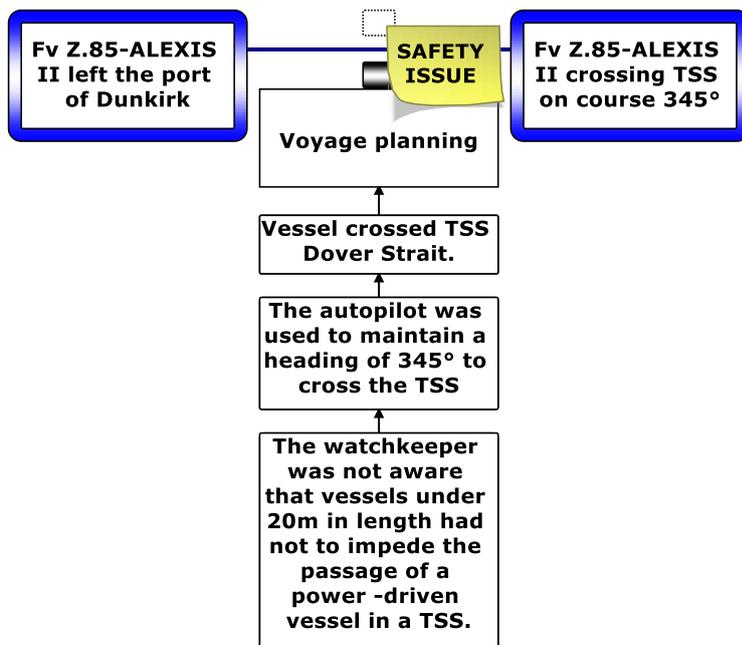
*Fv Z.85-ALEXIS II crossing TSS on course 345°*

<b>Incident Barrier</b>	<i>Performance</i>	<i>Barrier Challenge</i>	<i>Remarks</i>
<b>Inadequate</b>  Voyage planning	Vessel	Route	Vessel crossed TSS Dover Strait.
	Vessel	Route	The autopilot was used to maintain a heading of 345° to cross the TSS
	vessel	COLREG	The watchkeeper was not aware that vessels under 20m in length had not to impede the passage of a power-driven vessel in a TSS.

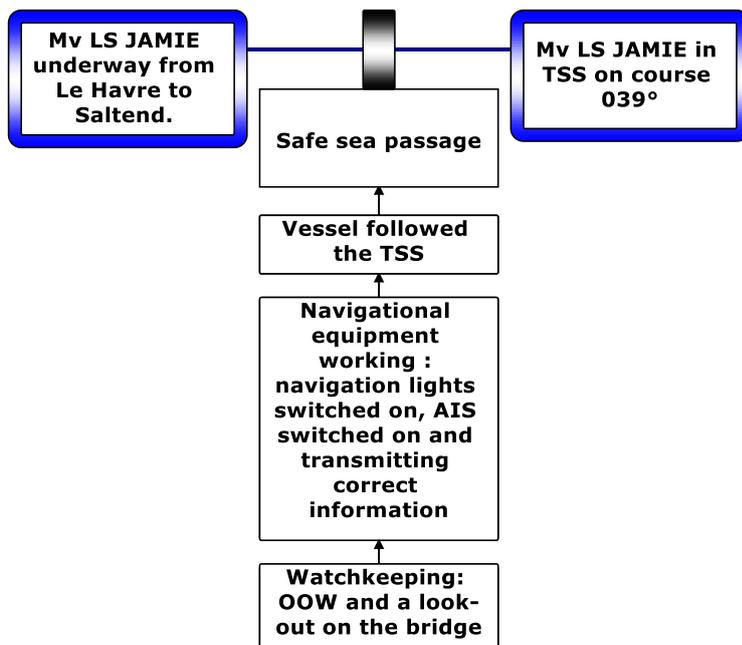
*Mts LS JAMIE in TSS on course 039°*

<b>Incident Barrier</b>	<i>Performance</i>	<i>Barrier Challenge</i>	<i>Remarks</i>
<b>Effective</b>  Safe sea passage	Vessel	Route planning	Vessel followed the TSS
	Vessel	Operational condition	Navigational equipment working : navigation lights switched on, AIS switched on and transmitting correct information
	Vessel	Watchkeeping	Watchkeeping: OOW and a look-out on the bridge

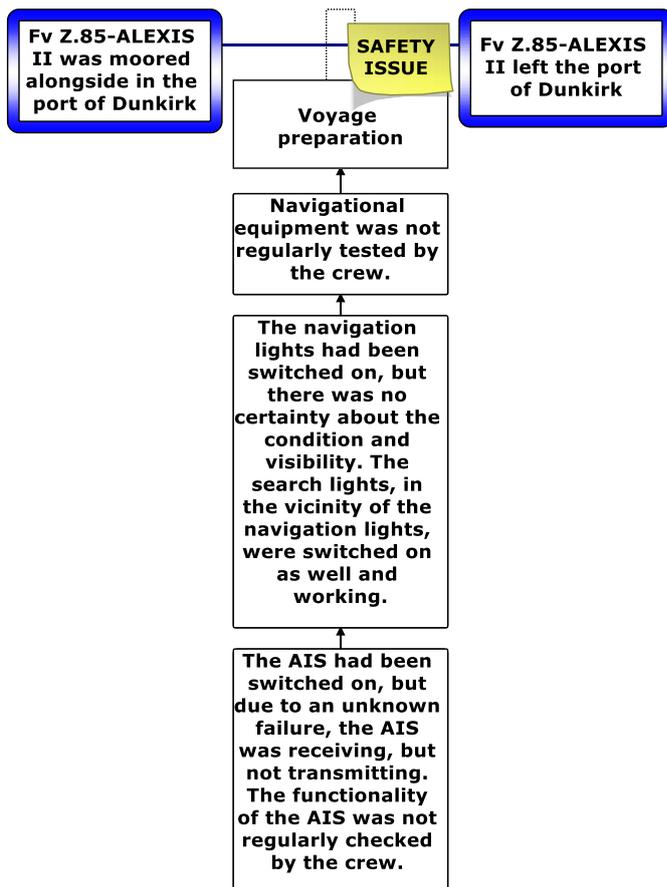
*Fv Z.85-ALEXIS II left the port of Dunkirk*

Incident Barrier	Performance	Barrier Challenge	Remarks
Missing  Voyage preparation	Vessel and owner	Operational condition	Navigational equipment was not regularly tested by the crew.
	Vessel	Operational condition and COLREG	The navigation lights had been switched on, but there was no certainty about the condition and visibility. The search lights, in the vicinity of the navigation lights, were switched on as well and working.
	Vessel and owner	Operational condition	The AIS had been switched on, but due to an unknown failure, the AIS was receiving, but not transmitting. The functionality of the AIS was not regularly checked by the crew.
