Report of safety investigation

GUNAY 2

Safety Investigation Report

GROUNDING **OF THE CARGO VESSEL** ***GUNAY 2*** **ON 21 JANUARY 2009** **ON PLANIER ISLAND, OFF MARSEILLE**

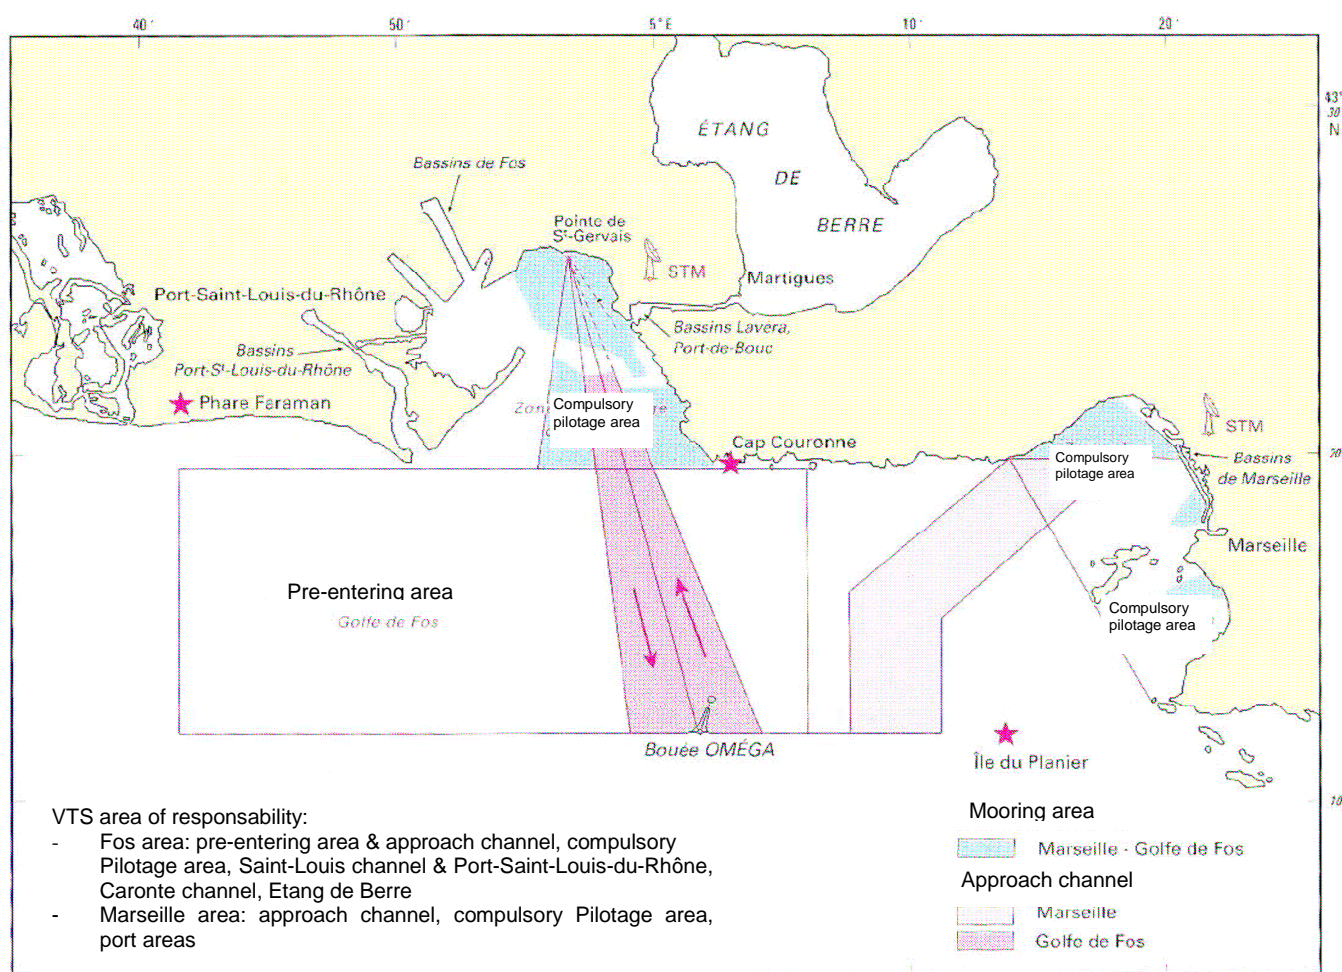
On 20 January 2009, at night with a good visibility, the Turkish cargo vessel *GUNAY 2* had grounded at 9 knots on Planier Island, 2 hours after she had disembarked the Pilot. At this time the wind was north-westerly, Beaufort 5 to 6, the sea was moderate. Very important damages can be noticed on the fore part of the vessel, no pollution had been observed. The vessel had been refloated then she had been towed to Marseille harbour after having got the advice of two evaluation teams and thanks to heavy maritime and airborne assets.

Planier Island is located at 8 miles in the South-south-west of Marseille road. It is out of the Fos and Marseille VTS operation area. It is however inside Cap Couronne Signal Station monitoring area (30 miles).

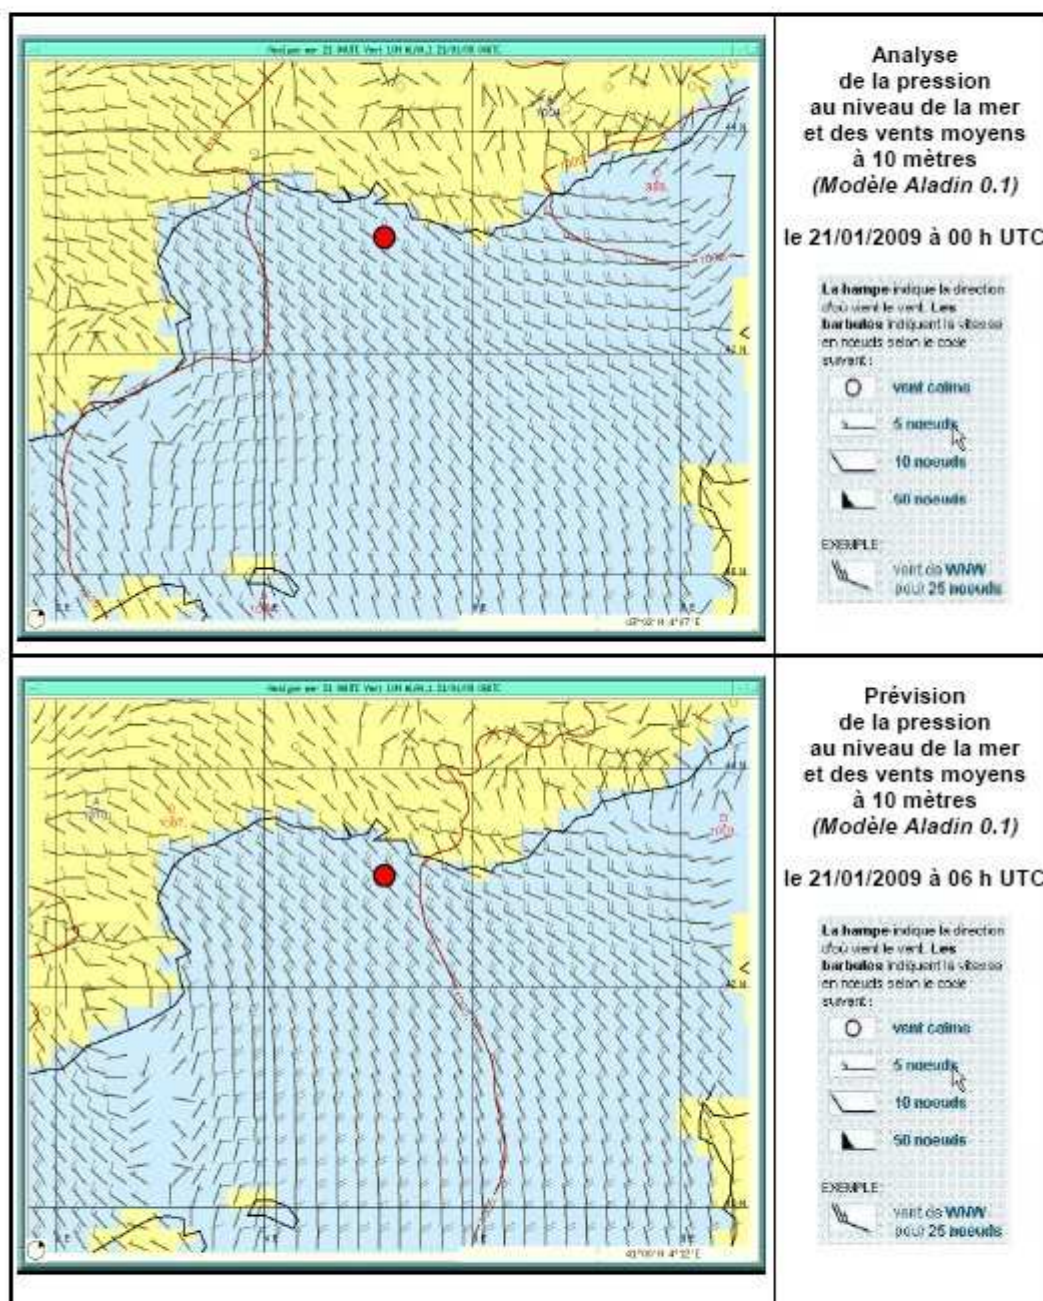
Documents annexes – VENTS

The analysis of the weather conditions indicates in the area and the period mentioned in this report : a stable North-westerly 20 to 25 knots(Beaufort 5 to 6) wind; Moderate sea state with significant waves height of 1.75 m. This moderate sea state was the result of the crossing of the $[H_{1/3}] = 1$ to 1.20 m wind sea waves with a same height south-south-westerly residual swell. This crossed sea could have resulted in pyramid shaped waves higher than the theoretic maximum height ($H_{max} = H_{1/3} \times 2$) topping at about 3.50 m. The visibility was very good and no dangerous phenomenon had been observed.
