Marine safety investigation report

**GROUNDING OF THE OCEANOGRAPHIC VESSEL
MARION DUFRESNE
ON 14 NOVEMBER 2012 IN THE WESTERN APPROACHES
OF ÎLE DE LA POSSESSION (CROZET ARCHIPELAGO)**

Bureau d'enquêtes sur les événements de mer

Report published on : November 2013

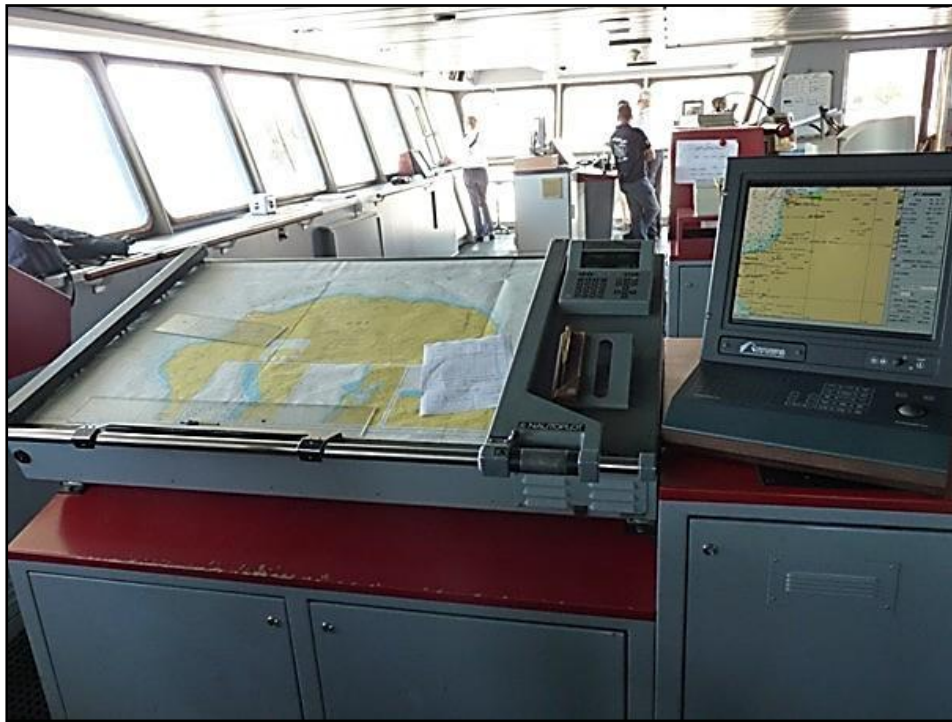
The wheelhouse console located on starboard with the plotter on the left and the ECS on the right.

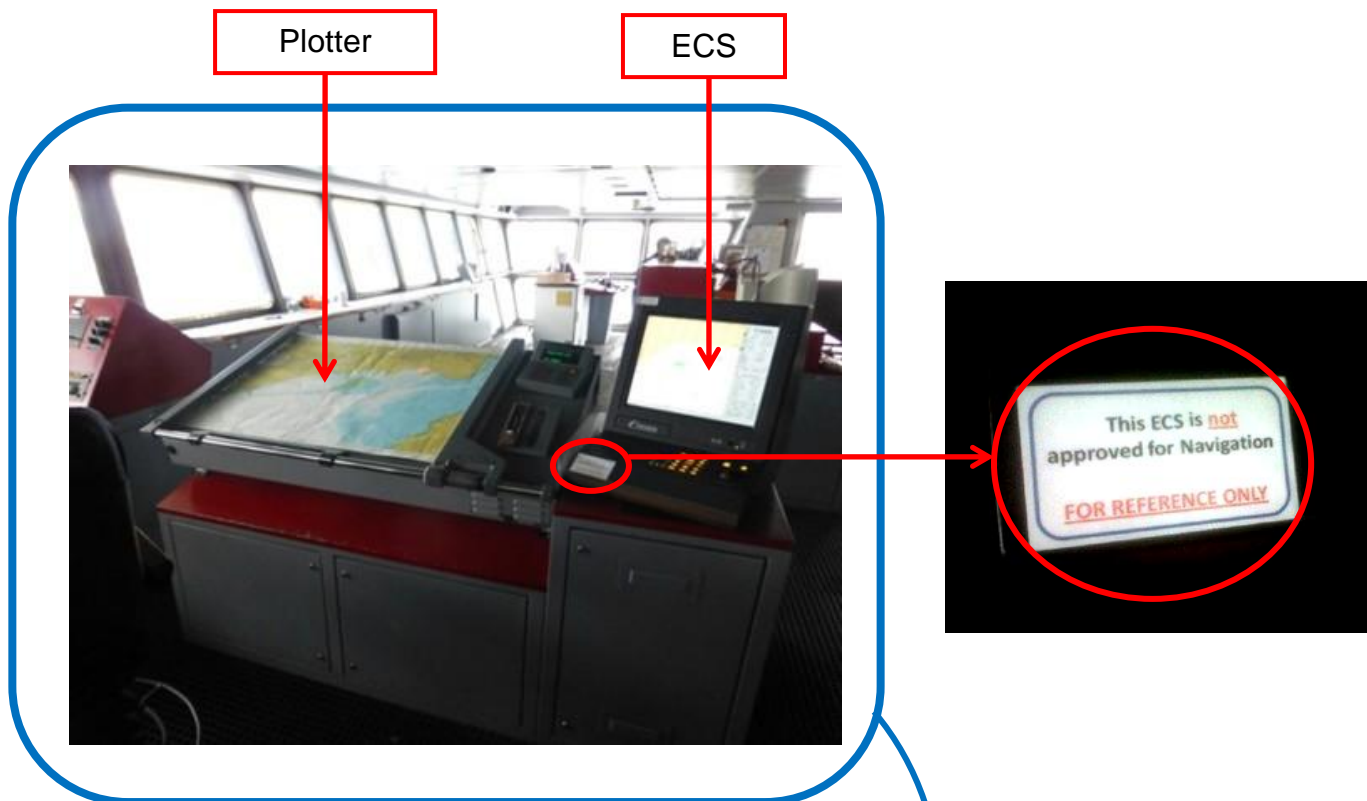
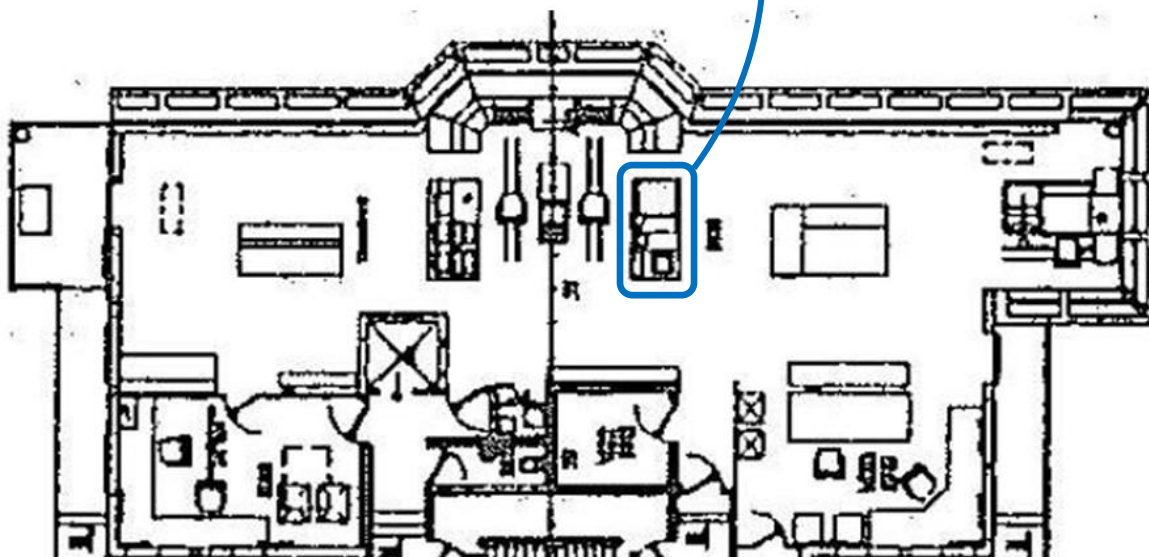
MARION DUFRESNE's ECS , even fitted with official electronic charts, cannot thus meet the chart carriage requirements as defined in the SOLAS Convention.

That was, as it happens, clearly stated on the recommendation displayed on the device (see picture next page).

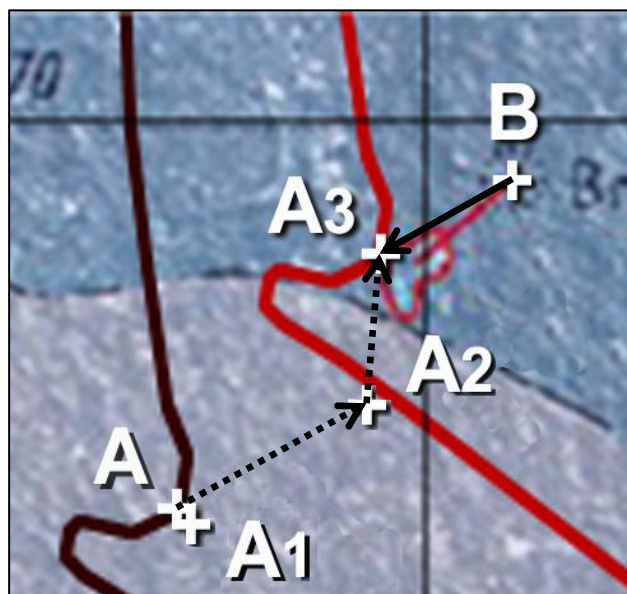
The error between point **B** (« Brisants » (breakers) indicated on chart 6497 before change 13.19.158) and point **A₃** is the result of the repositioning of the reef done by the SHOM which put the hazard closer to the 100m line of soundings.

This information, later than the accident, was not available at the time of the event.

The failure to take into account the difference of horizontal datum for the navigation with the ECS at this position, the poor management of the inaccuracy of the positioning of the breakers and the use of the ECS as the unique navigation aid are elements the addition of which is a **causal factor** of the grounding.

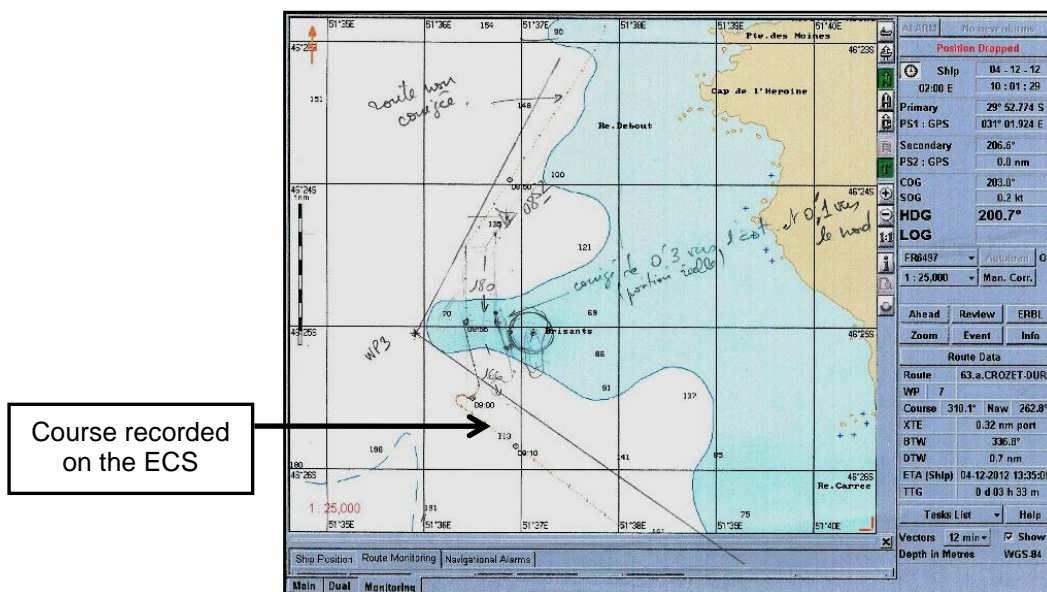
This ECS picture had been recorded at 8.52 am, a moment before the vessel altered course to 180°. The heading was then 213°.

The reference displayed on the device is chart 6497, but the line of soundings appears as a continuous line.
