# MARITIME SAFETY INVESTIGATION REPORT

MV WORLD VOYAGER  
IMO 9871529

**VERY SERIOUS MARITIME CASUALTY**  
**31/05/2025**  
**Occupational accident inside engine room**  
**With loss of one life**

**Final report homologated – 01/09/2025**

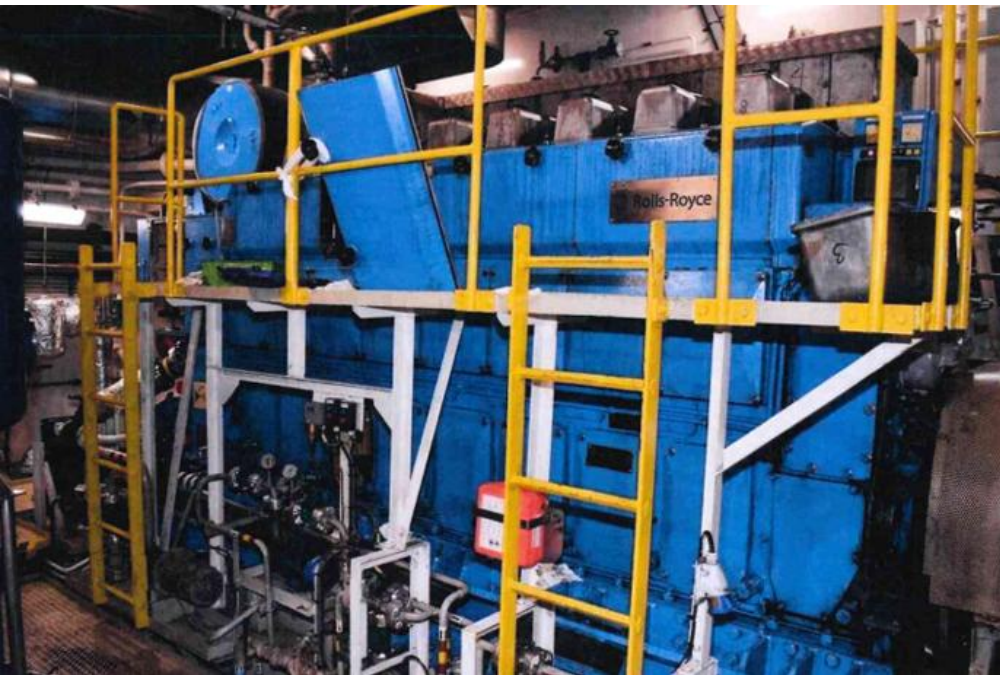
On the 31<sup>st</sup> of May 2025, at 11:20 hours, whilst the Portuguese flagged passenger vessel WORLD VOYAGER (WVO) was made fast alongside at pier 2 Cheviré Amont, Nantes, France, maintenance works were being performed in the engine room – inspection and cleaning of the injector of the starboard main engine, as in figure 1 on the left – view of starboard side of engine in maintenance - cylinder n.93. During the

inspection and cleaning of the injector, the indicator cock was covered by the engine cadet using a metal bucket to avoid oil spillage around the engine room. When the engine was blown, the pressure released launched the metal bucket onto the cadet's head at a high speed. The cadet fell from the top of the engine where he was seated and was immediately assisted by the engine room team. Code Mike sounded on the public announcement system (PA) and medical assistance was called, onboard medic and medical shore team. The shore medical team pronounced the cadet deceased on arrival on board. Figure 2 below, shows the position of motor vessel WORLD VOYAGER (WV) made fast and starboard side alongside at Nantes and on the top left the interior of the engine room – view from the starboard side engine where the maintenance was performed (figure 1).

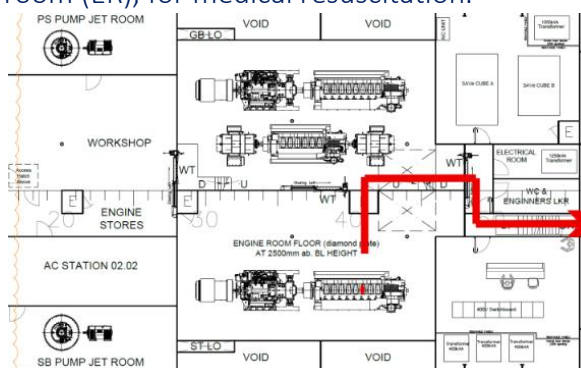
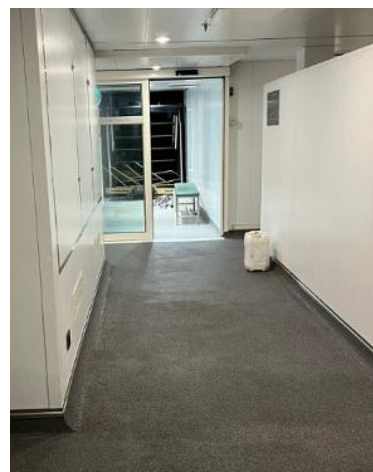
Immediately after the occurrence with the engine cadet vessel's Code Mike sounded on the PA. Ship's doctor went to the engine room and shore medical assistance was called. The engine cadet was transferred – as indicated in figure below - from the engine room to mudroom, on deck 3, on the entrance to engine room (ER), for medical resuscitation.
