**MINISTRY FOR INFRASTRUCTURES AND TRANSPORTS**

## **M/V GRANDE AMERICA**

**Fire on board and subsequent sinking off Cape Finisterre**

**Final Report**

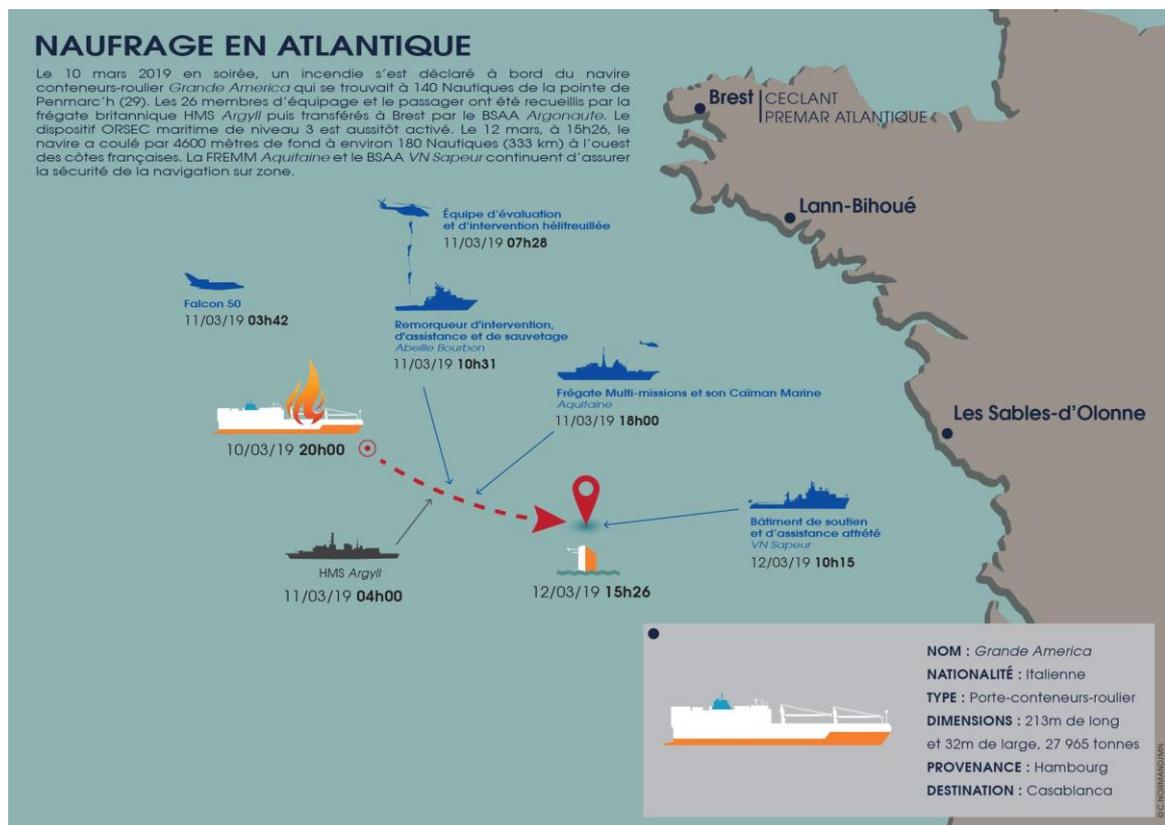
Picture 1: Area of the accident and ship's position (source French Navy)

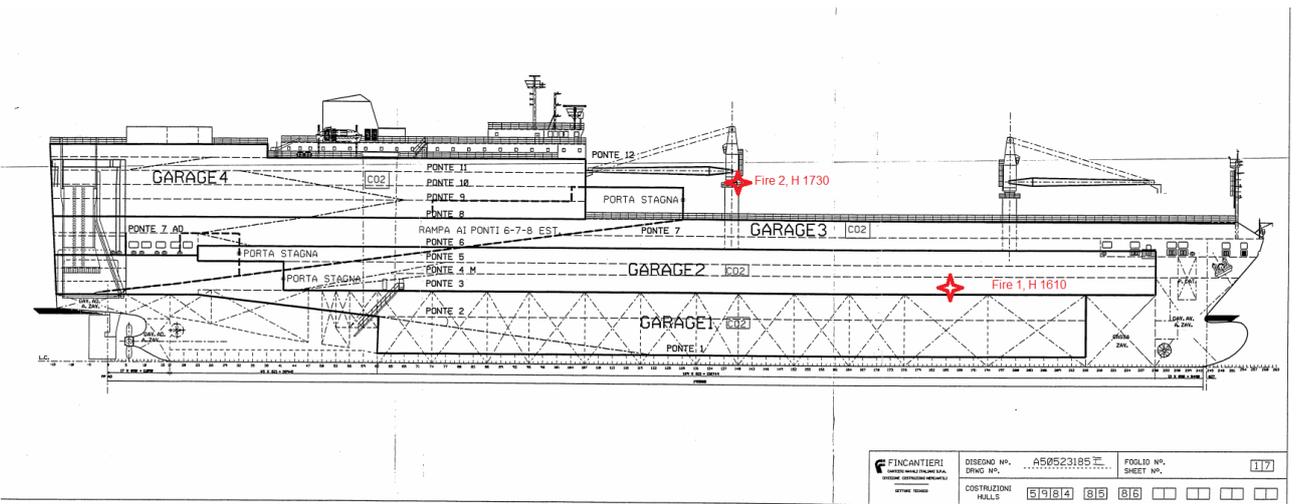
Picture 5: Ex of long ship plan

In particular, the presence of two distinct fires in two decks of the ship placed at a great distance from each other (deck 2 and deck 8 Weather deck) in completely different situations was not well understood and for what reason following the activation of CO2 in the premises garage, the unit went into blackout immediately with the consequent activation of the EDG.

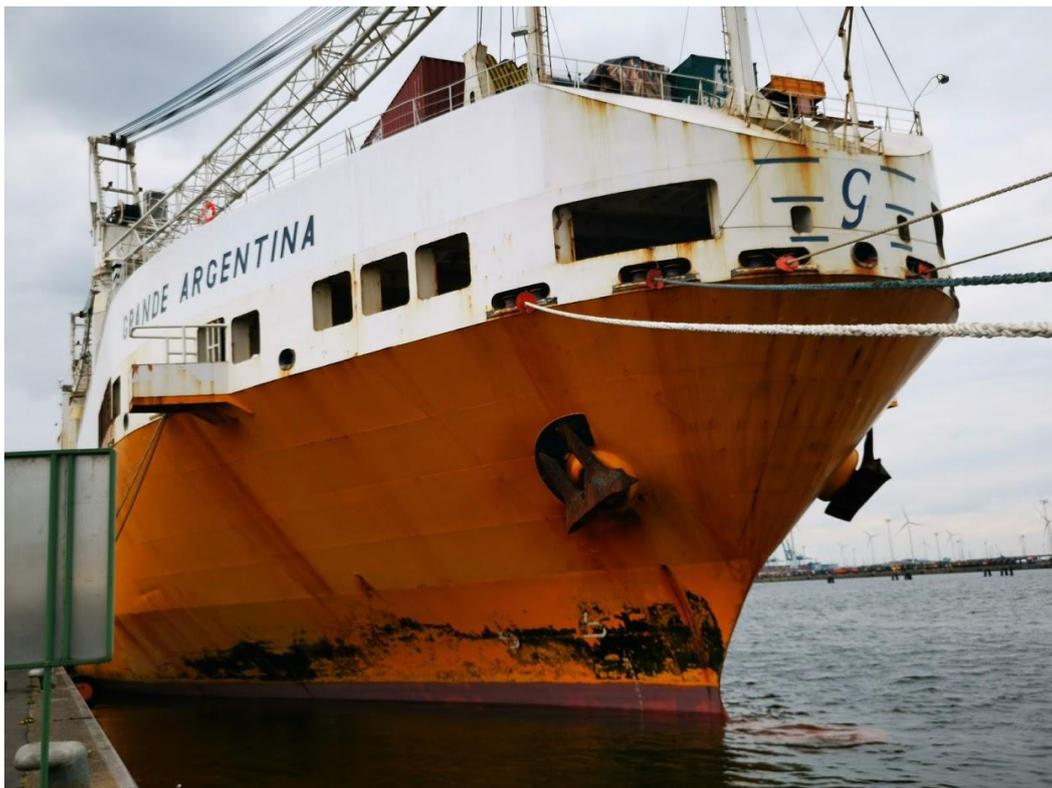
Picture 6: M/V GRANDE ARGENTINA in Antwerp

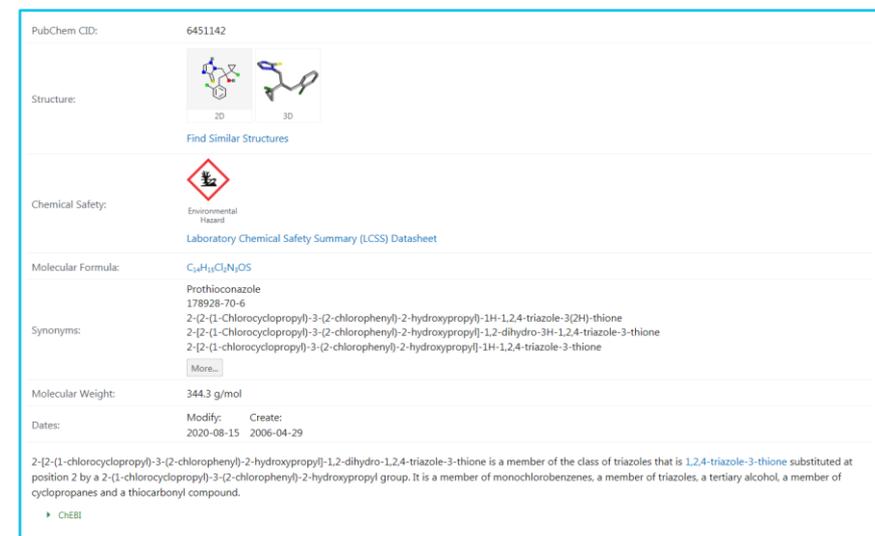
## Prothioconazole

This substance, classified IMO 9 according to IMDG code, as per the safety data sheet and CLH report <sup>1</sup>, is not explosive and has a low degree of flammability, therefore it is difficult to state that the point of origin of the fire may have been exactly that container but rather another container placed nearby containing products with higher flammability characteristics.
