BUGALED BREIZH

Bureau d'enquêtes sur les événements de mer

Technical report
on the investigation
of the

Capsize and foundering
of the trawler
BUGALED BREIZH
on 15th January
South of Lizard Point
(with the loss of 5 lives)

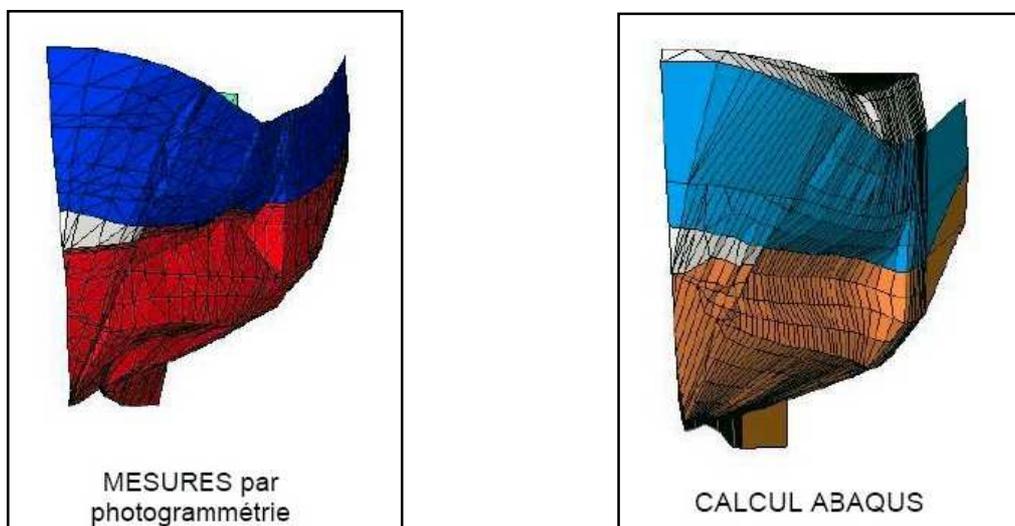
Therefore, the possibility that the structural elements had suffered plastic deformation needed to be examined. In order to simulate this phenomenon, pressure was applied uniformly, then removed. When the pressure reached 4 bar, the permanent deformations observed when the pressure was removed were equivalent in all respects to those observed on the wreck.

These results were then compared to the measurements of the denting made by photogrammetry as translated into the ABAQUS format. The measurements of the denting made by photogrammetry of the wreck and the results of the calculations made using the original plans, by applying, then removing, a uniform pressure of 4 bar to the fish hold and the double bottom below it, were seen to be practically the same.

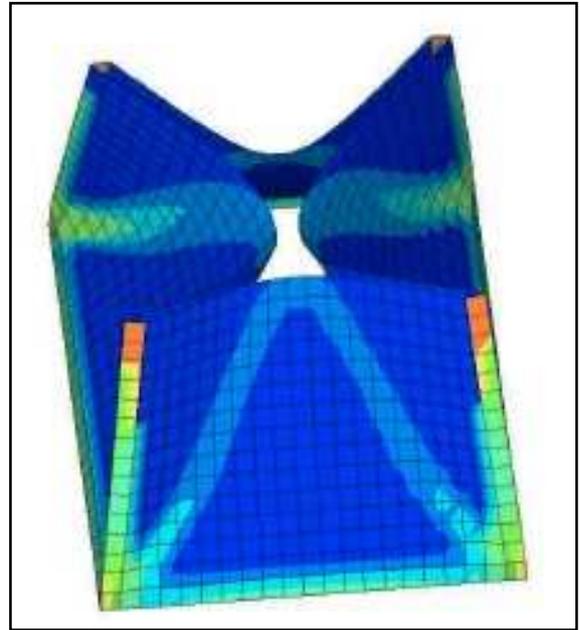
ABAQUS CALCULATION
Depression of 1 bar inside the coaming

Besides this, separate calculations were carried out on the deformation of the coaming around the fish-loading hatch because it would have been too complicated to include this element in the structure. Following the same method as for the calculations on the structure, the coaming was subjected to an internal depression. The simulated deformation was identical to what was observed in reality and occurred when the pressure reached one bar.

Deformation of the starboard fish hold hatchway

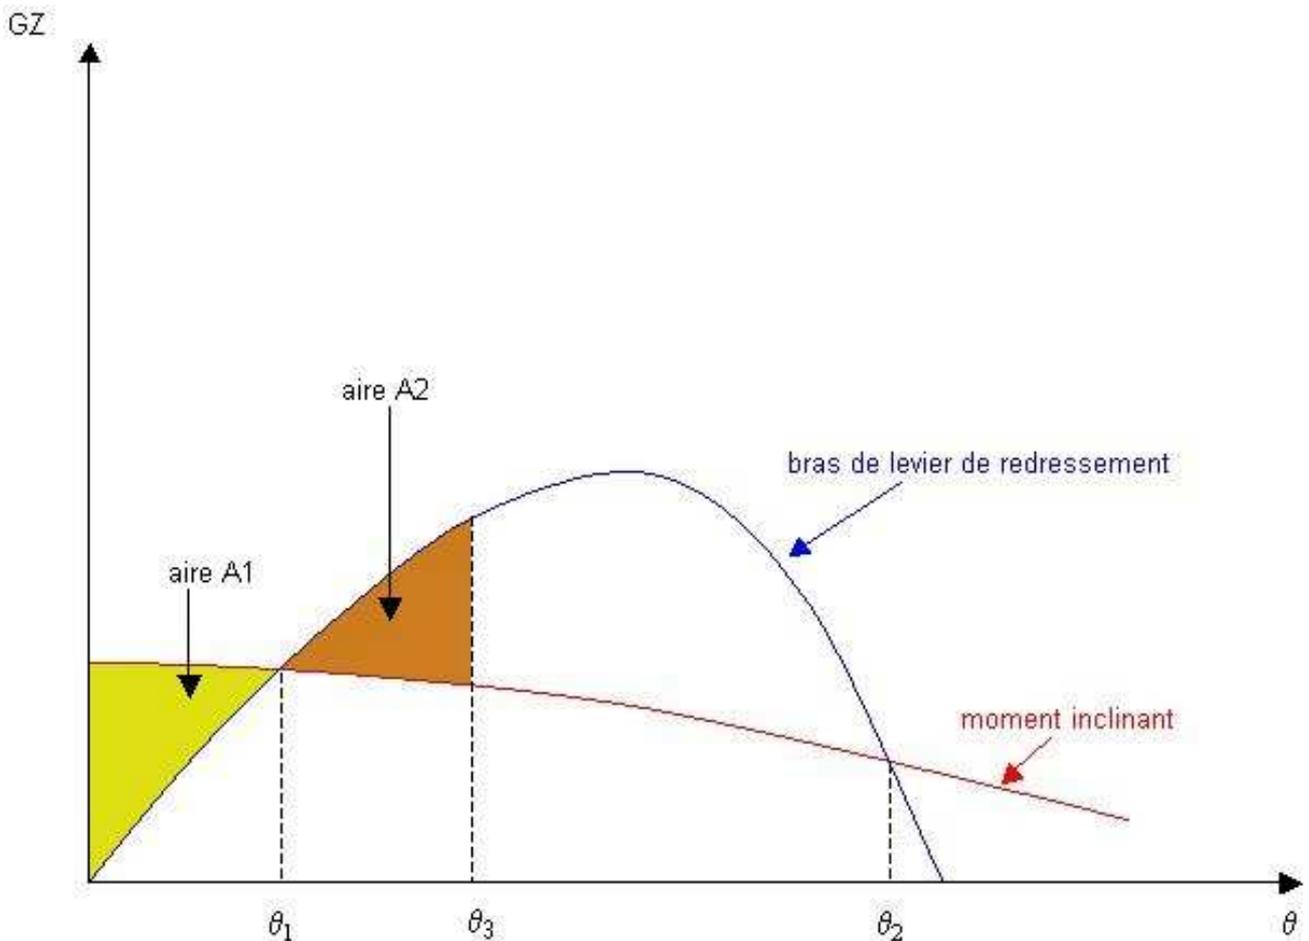
Dynamic stability calculations

If the couple set up by the thrust of the engine and a sideways pull on a warp is considered, the stability criteria, notably the areas under the righting lever curve, decrease compared to those of the vessel in intact condition. The phenomenon is amplified if water is shipped on the after deck. The free board at the after deck rapidly decreases, making downflooding of the crew's quarters possible, leading to foundering of the vessel.

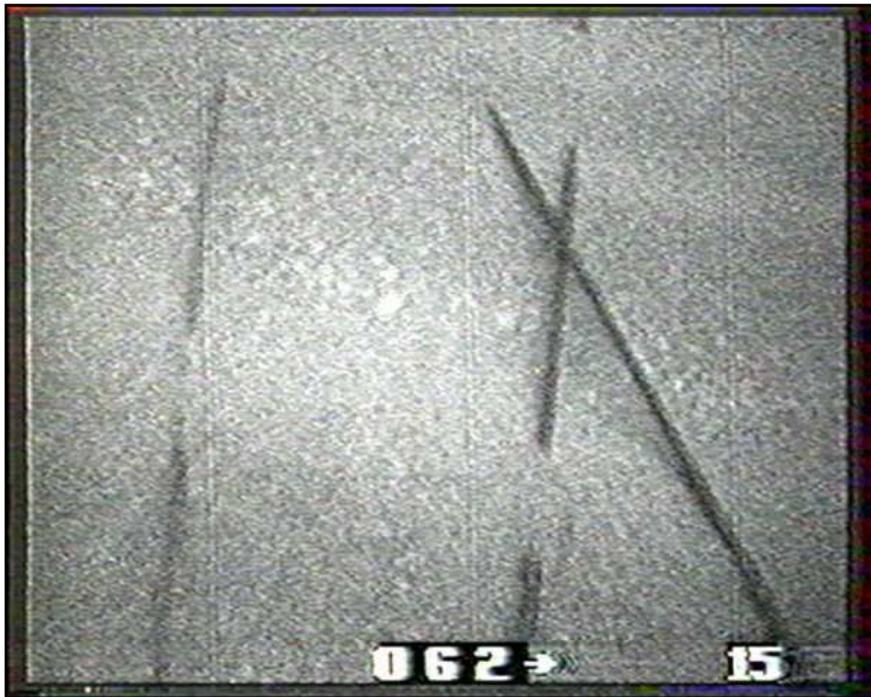
The ballast chains connecting the trawl three way connection to the lower bridles were completely buried in the seabed on the starboard side, while on the port side most of the shackles just emerged from the seabed.

The upper bridles of the trawl net were buried under the seabed for a distance of about thirty metres from the trawl wings. Lower and upper bridles were then visible up to the trawl doors.

On the port side, the upper bridle (diameter 16 mm) can be seen passing over the lower port bridle (diameter 22 mm). After moving parallel to it away from the trawl net, it crosses over the lower bridle twice, in succession, forming a V-shape.

If we continue to follow the lower port bridle, the lower starboard bridle can be seen crossing over it. In order to draw their conclusions, the *BEA*mer investigators had screen captures made from the underwater video sequences; the way they went about interpreting the images deserves an explanation.

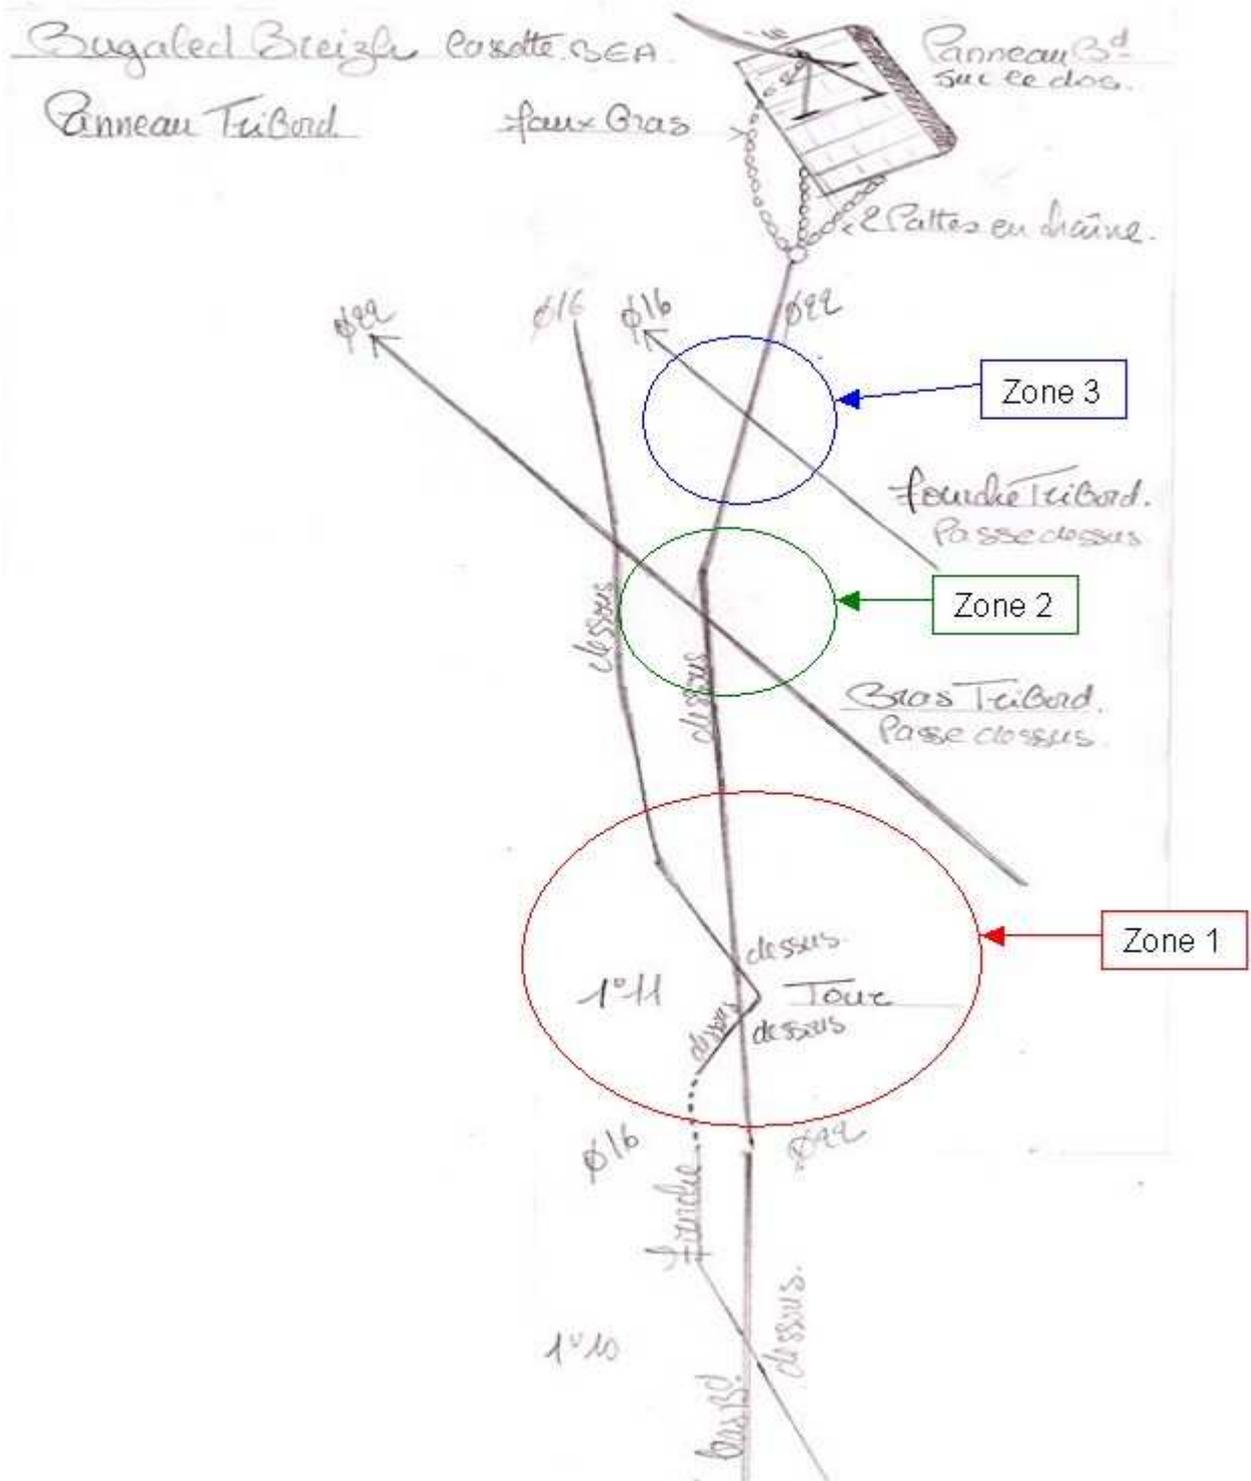
The following sketch indicates the position of the fork legs and bridles as observed after examination of the video footage shot by the *ANDROMEDE*.

Area 1 :

A photograph of this area can be seen in appendix F4; on it, the port fork leg can be seen as it passes under the port bridle towards the right, it then immediately turns back under the bridle and runs parallel to it. The video film shows that the fork leg passed over the bridle 1 or 2 metres before this, looking towards the trawl net; no images were captured of this sequence. The way the port fork leg and bridle are positioned shows that the port otter board flipped over before coming to rest on the bottom with the shackling arms uppermost.

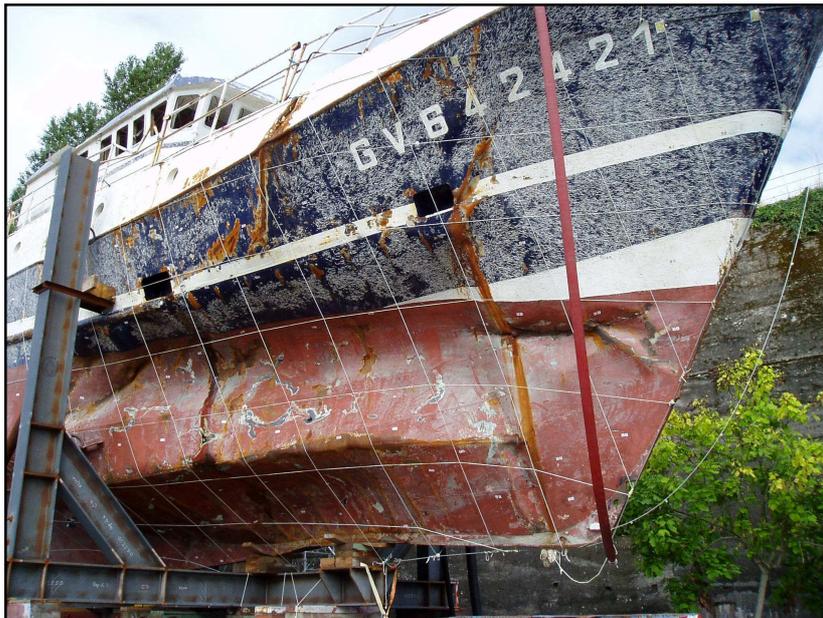
View of the deformation of the starboard side. The photograph shows the deformation in way of the fish hold and the double bottom below it. The bowing of the keel can also be seen.

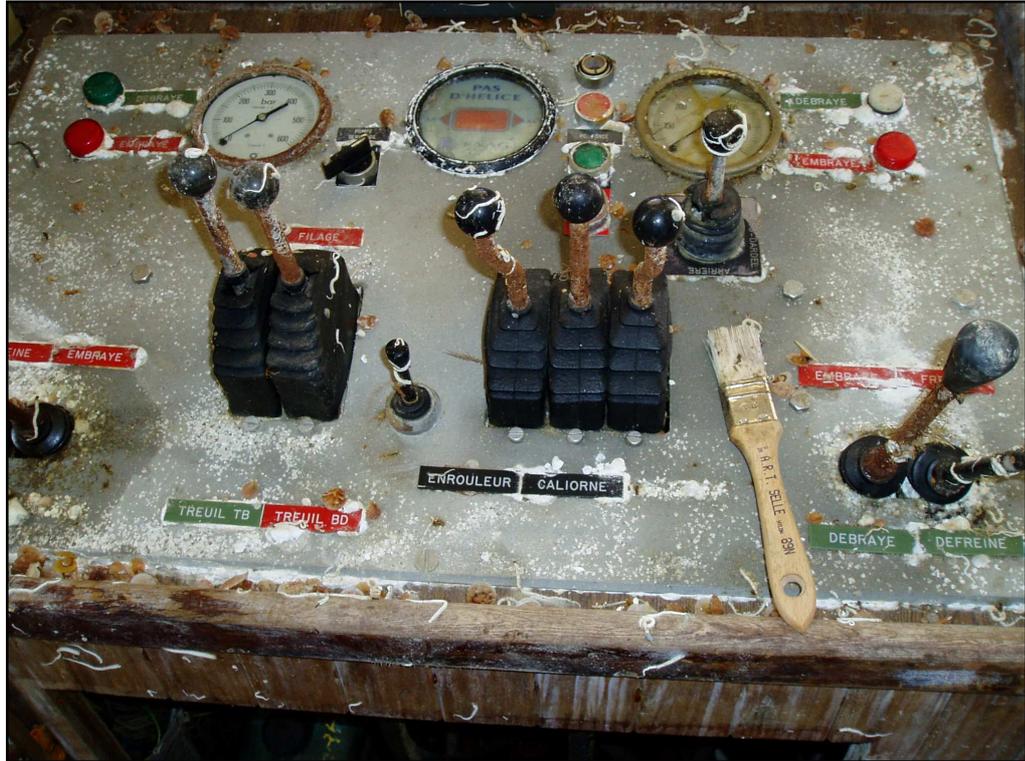
View of the winch control console on the after starboard side of the wheelhouse. The port winch brake lever is located on the far right of the photograph.

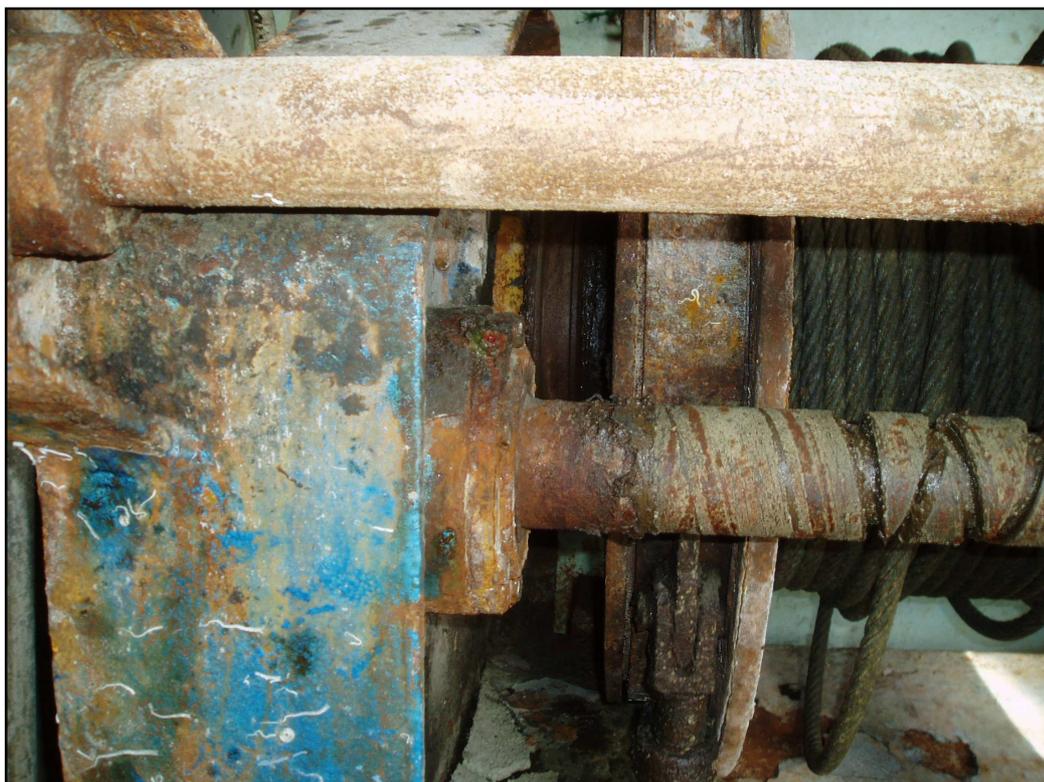
Detail of the port winch clutch jaw.

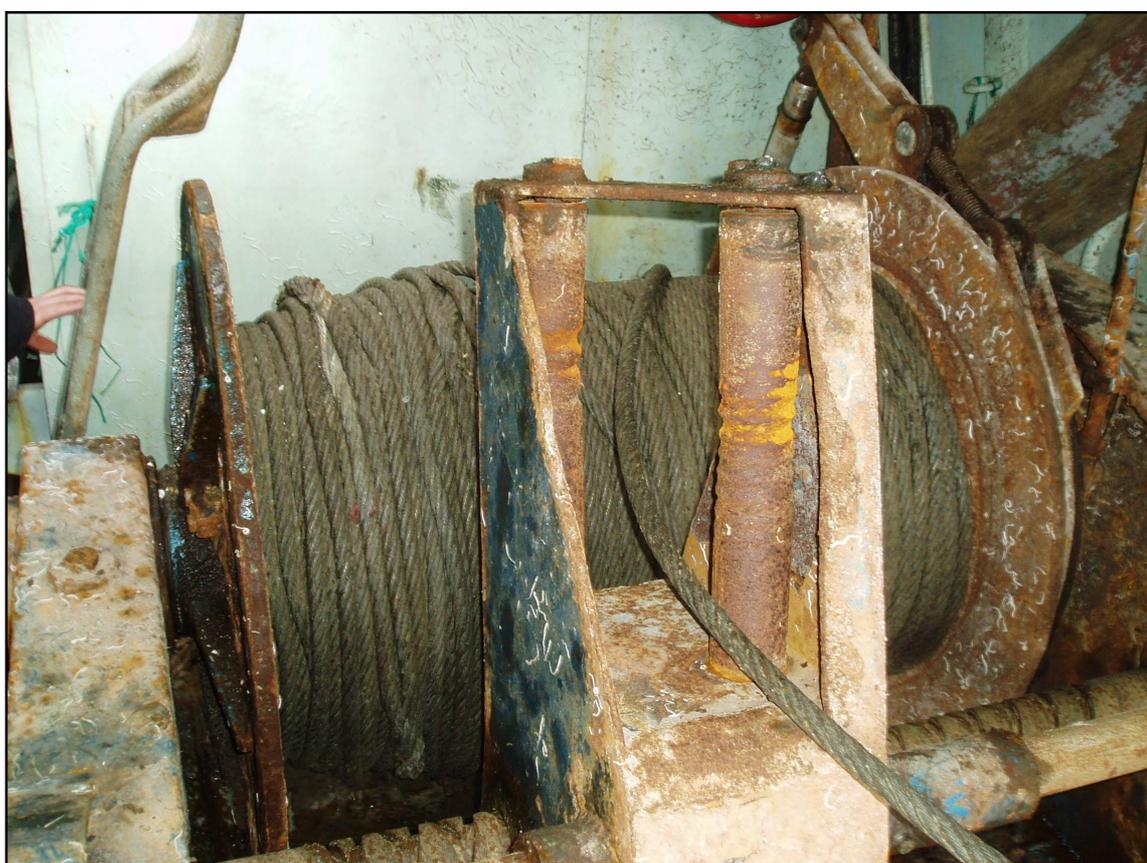
View of the starboard winch cable guide.

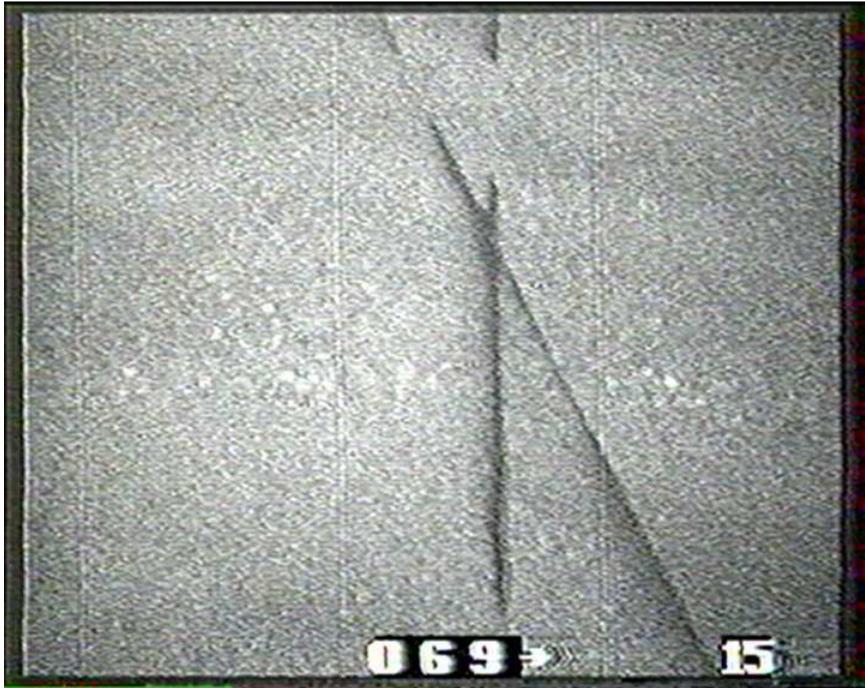
View of the starboard fork leg passing over the port bridle (area 3 described in paragraph 6.4 of the main body of the report).

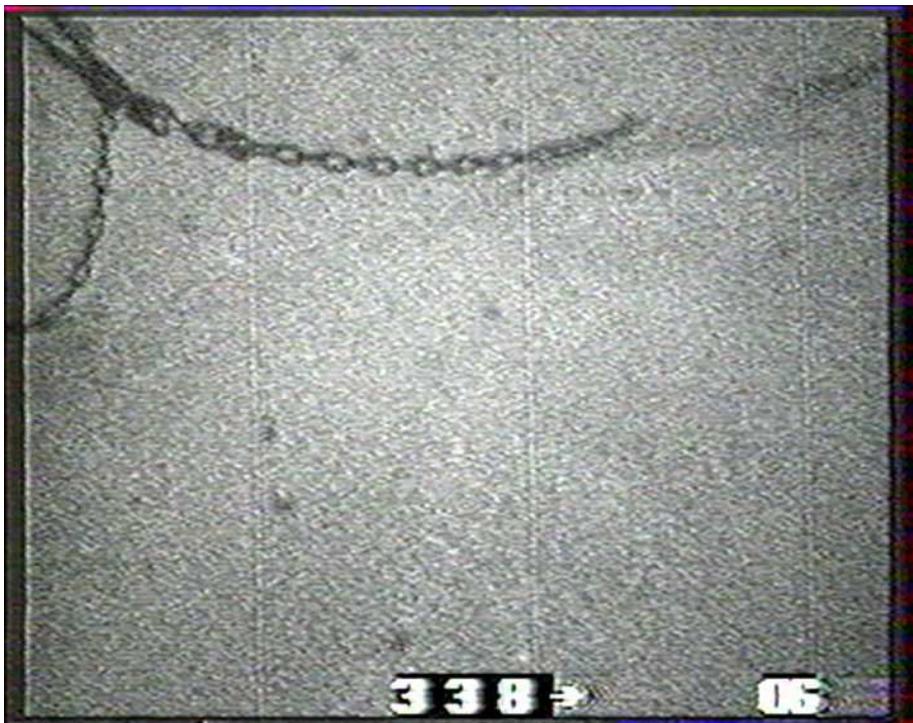
View of the portside three way connection at the top left of the photograph. The chain leading to the right of the photograph is the chain of the upper port bridle.

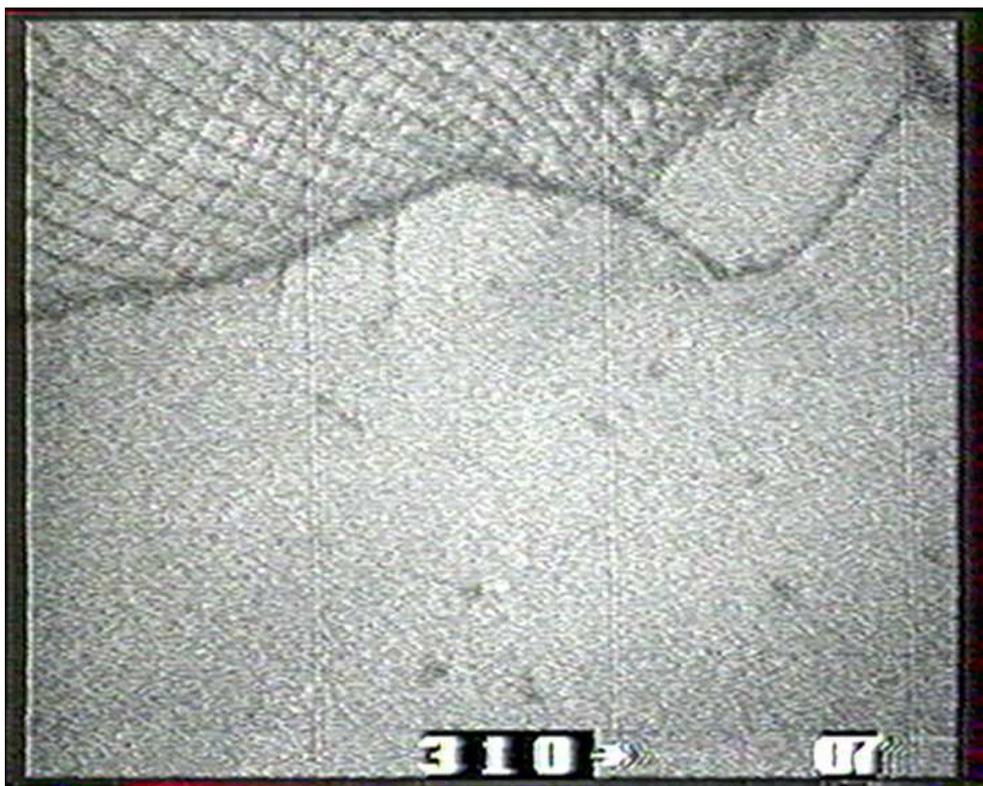
View of the headrope of the trawl on the port three way connection side.

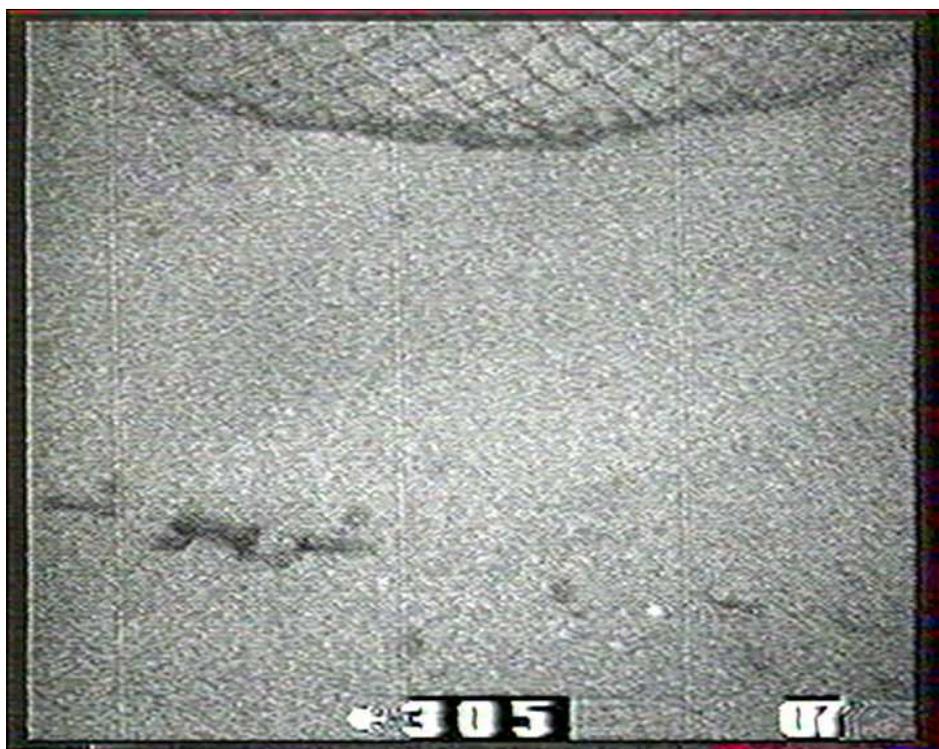
View of the portside three way connection. The chain emerging from the sediment at the bottom of the photograph belongs to the lower bridle.

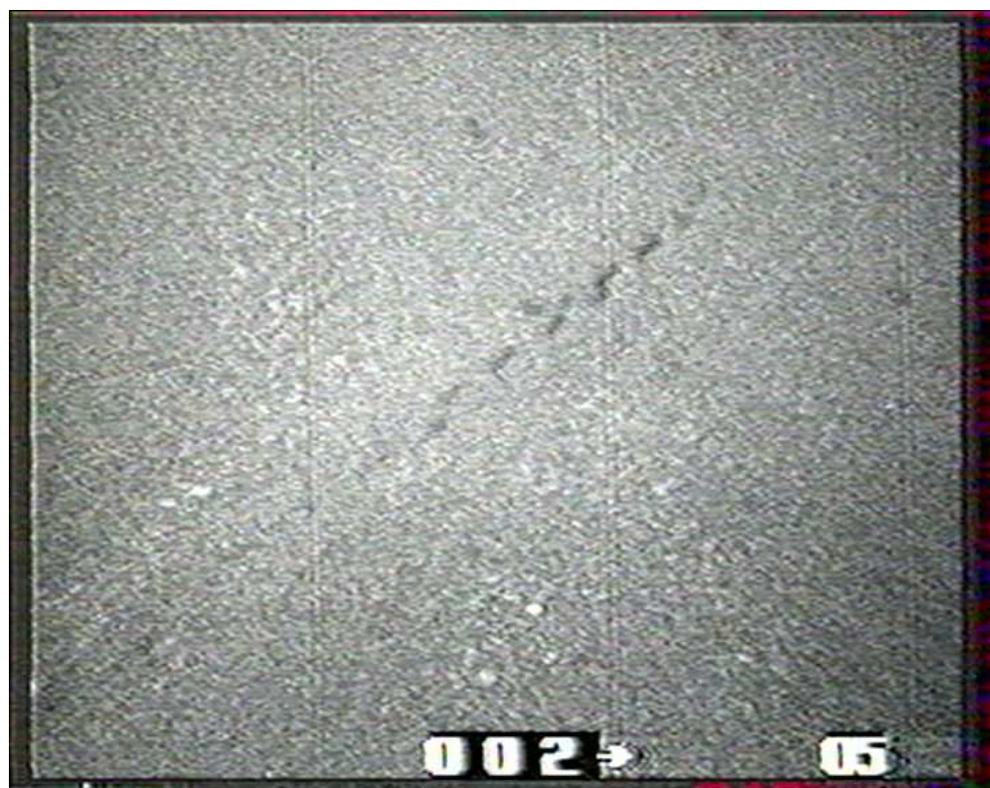
View of the lower port ballast chain showing through the sediment.

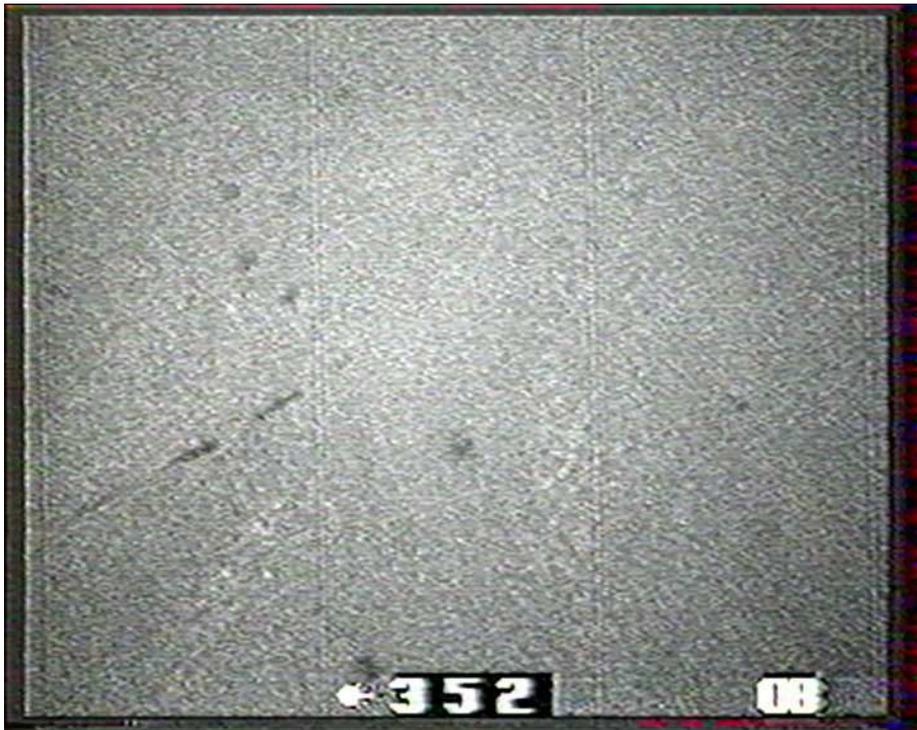
View of the lower port chain showing through the sediment.

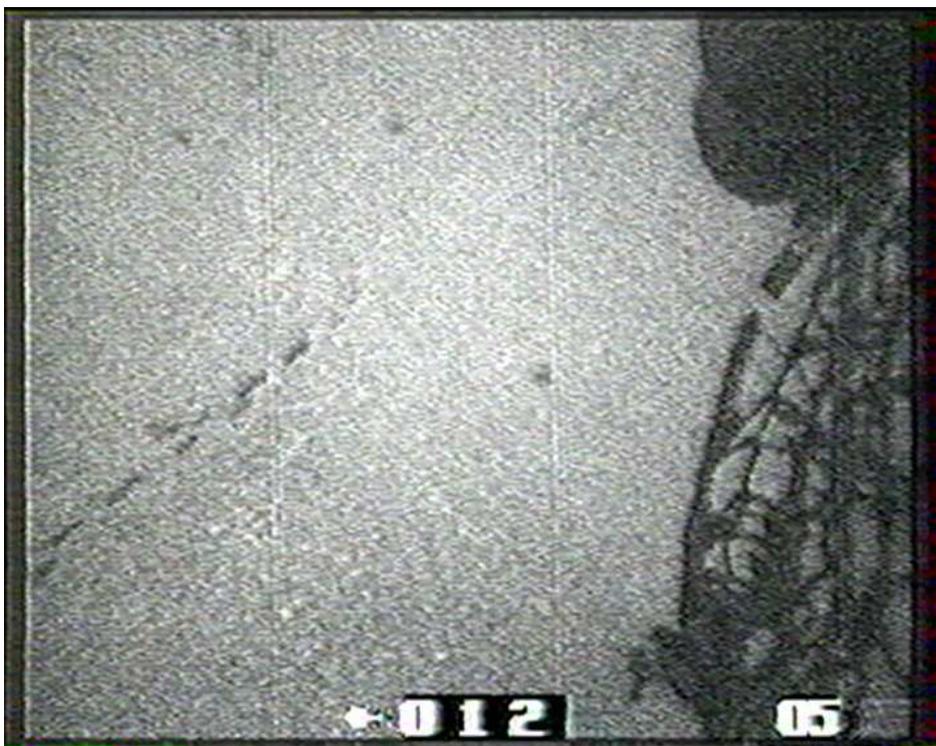
View of the lower port chain located near the starboard upper wing. The head line floats can be made out..
