Supplementary report to the inquiry into

The collision between the car carrier
TRICOLOR
and the container vessel *KARIBA*

**ON 14TH DECEMBER 2002
NEAR WESTHINDER**

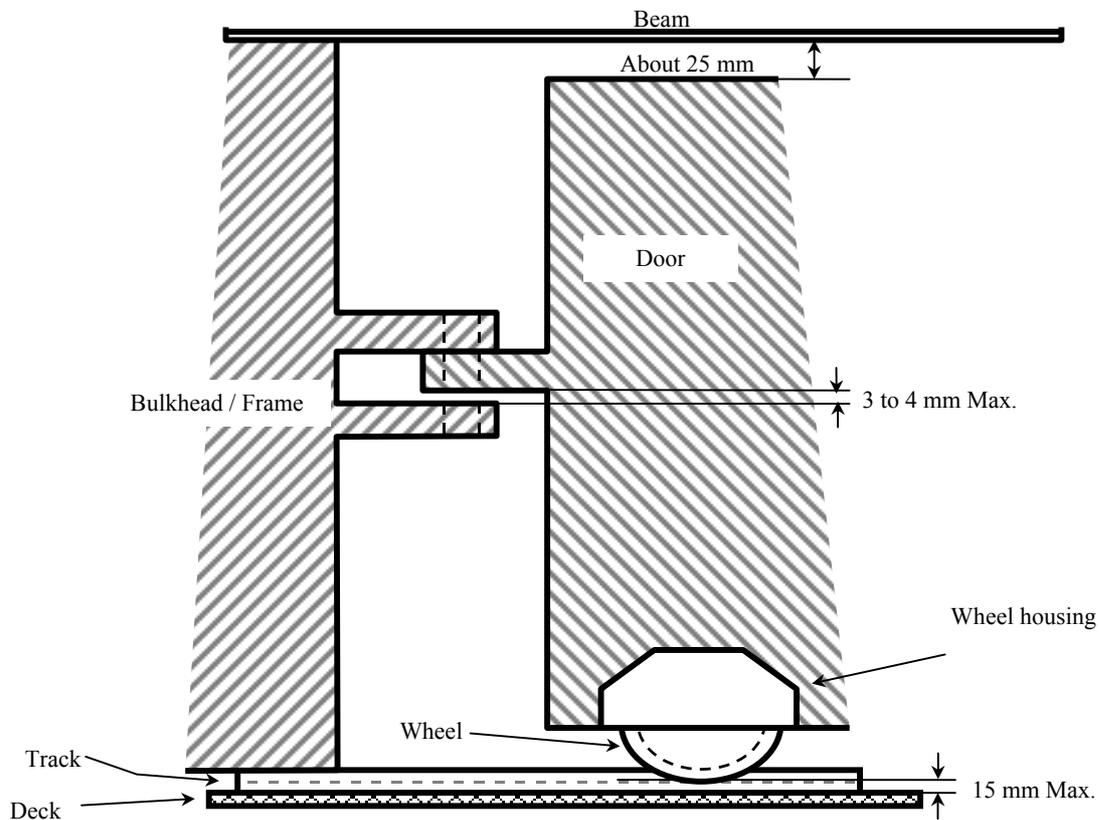
The watertight doors on deck 9 and 11 roll along tracks on two wheels - their upper part being held in place by a guide rail - and are pulled sideways by a chain driven by a hydraulic winch.

The measurements were made on the *TRIANON*. They show that the door cannot move vertically more than 25 mm in its upper part and 15 mm between the wheel and the deck, giving a total of 40 mm; they also show that the play between the locking pin hinge pads on the jamb and the one on the door is about 3 to 4 mm.

Therefore the door cannot come off the track when its hinge pad is between the hinge pads on the jamb.

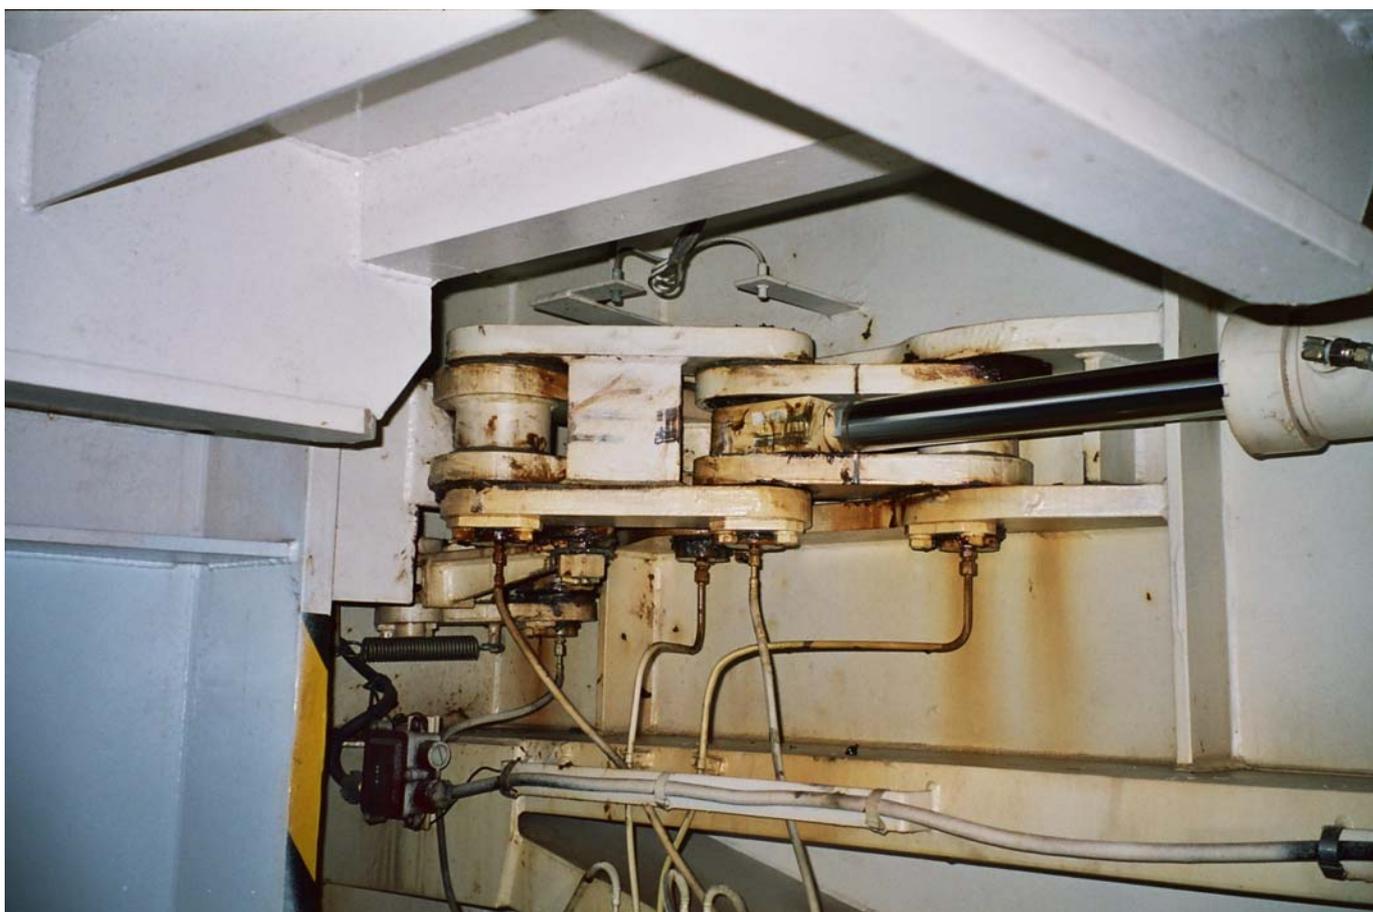
Photo 2 : Position of the hydraulic cylinder rod – door locked.

During the locking phase the rod comes out of the cylinder and pushes a stirrup towards a stop fitted on the bulkhead jamb; at the same time, a spring-loaded unlocking lever snaps into position behind the stop. At the end of the locking operation, the rod is out, the stirrup is pressed up against the stop on the bulkhead jamb and the unlocking lever is positioned behind the stop (see photo 2 in Annex C).

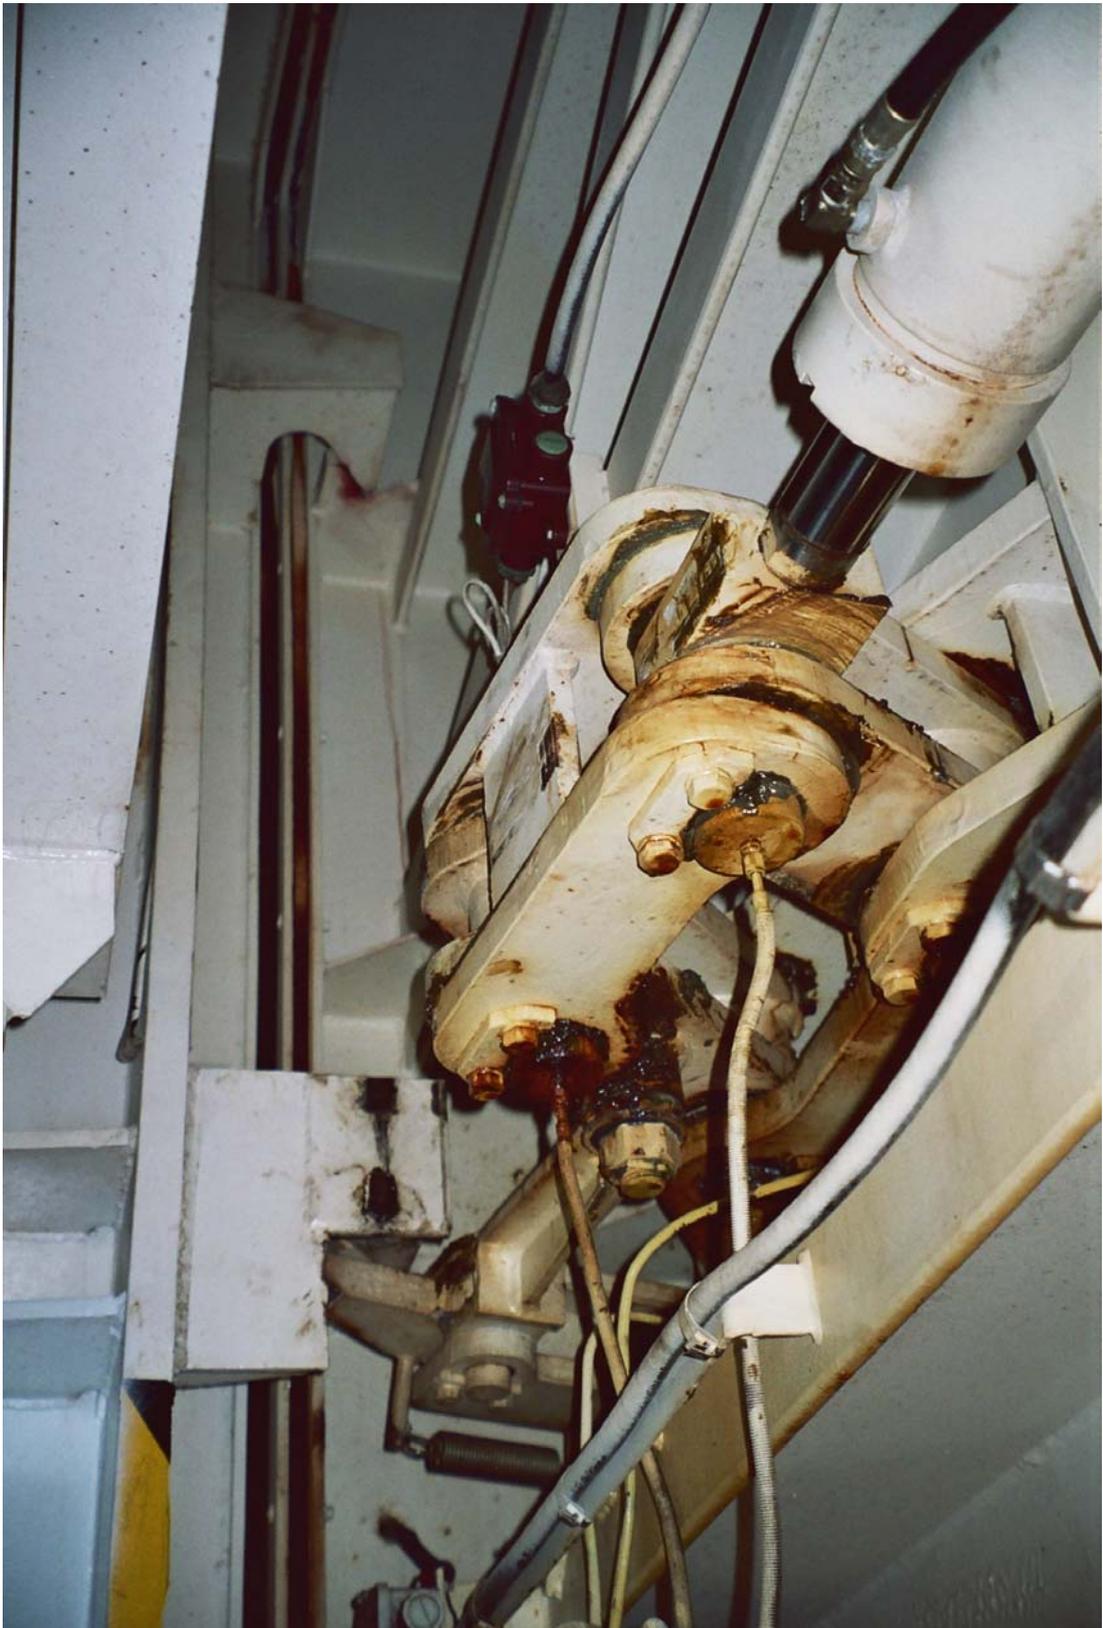
Photo 3 : The hydraulic cylinder during the unlocking phase, with the unlocking lever pulling the door.

starboard and unlocks it (see photo 3 in Annex C). When there are only about 10 centimetres of the rod left outside the cylinder, the spring return on the unlocking lever pulls it clear of the stop : the door is now unlocked and can move backwards on its frame (see photo 4 in Annex C).
