## MARINE SAFETY INVESTIGATION REPORT

Safety investigation into the fatality of a crew member on board the  
Maltese registered bulk carrier

***STARA PLANINA***

MARINE SAFETY INVESTIGATION REPORT NO. 21/2015

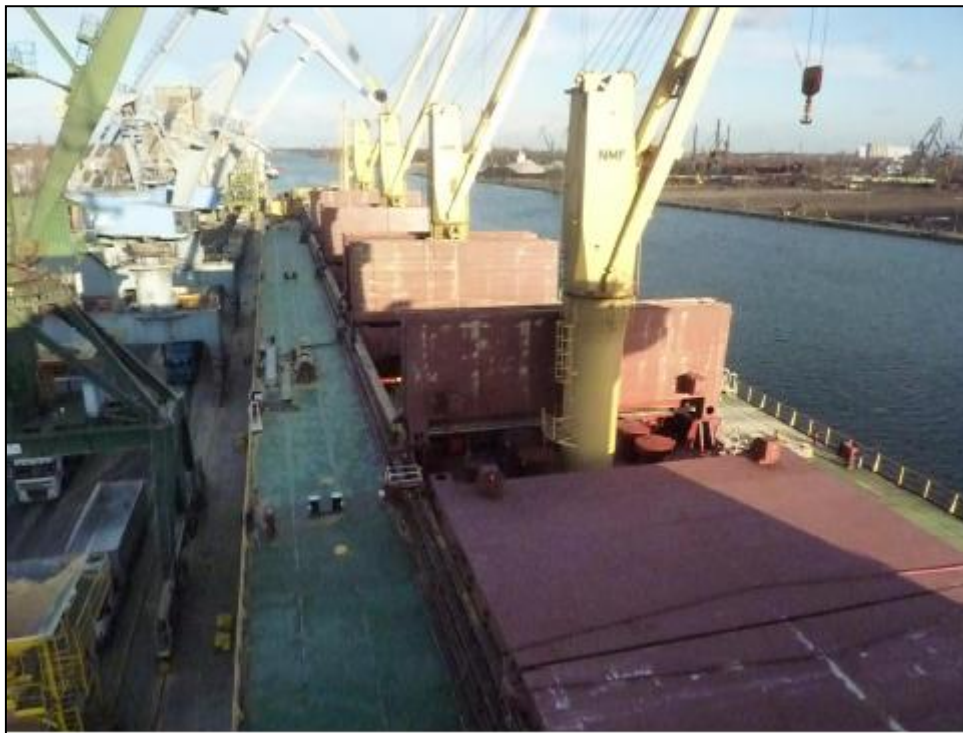
**Figure 1:** *MV Stara Planina*

*Stara Planina* has an overall length of 186.45 m and a beam of 30.0 m. The vessel has five cargo holds with a total trimmed grain capacity of 52,656 m<sup>3</sup>. She is fitted with four cargo deck cranes (Figure 1) and is classed as a handy sized bulk carrier.

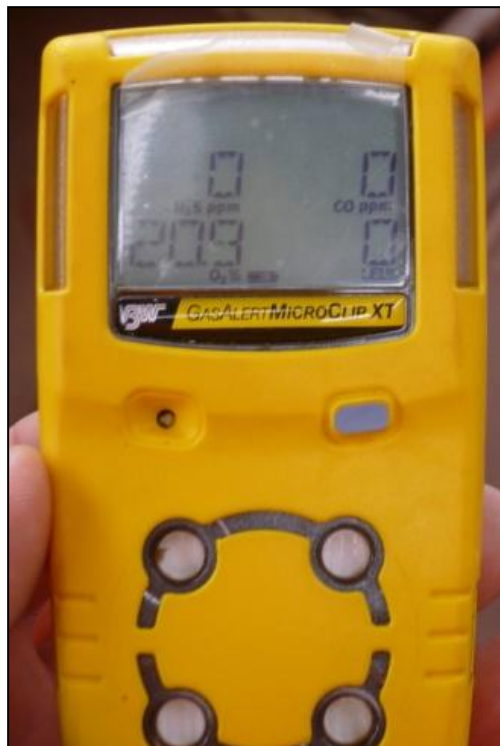
**Figure 2: Personal multigas analyser**

At 1300, the chief mate ordered the second mate to open the cargo hold hatch covers. The second mate, along with an AB, opened all hatch covers and reported back to the chief mate at about 1330 that the job was completed. The chief mate considered the cargo surveyor's requested for the cargo holds to be ventilated as unusual. He became concerned and proceeded to sample the air in the cargo holds by lowering a personal multigas analyser (Figure 2) on a length of rope.
