# MÆRSK BATTLER

Marine accident report on MAERSK BATTLER's loss of tow and the foundering of MÆRSK SEARCHER and MÆRSK SHIPPER on 21 and 22 December 2016

The report is issued on 30 August 2017

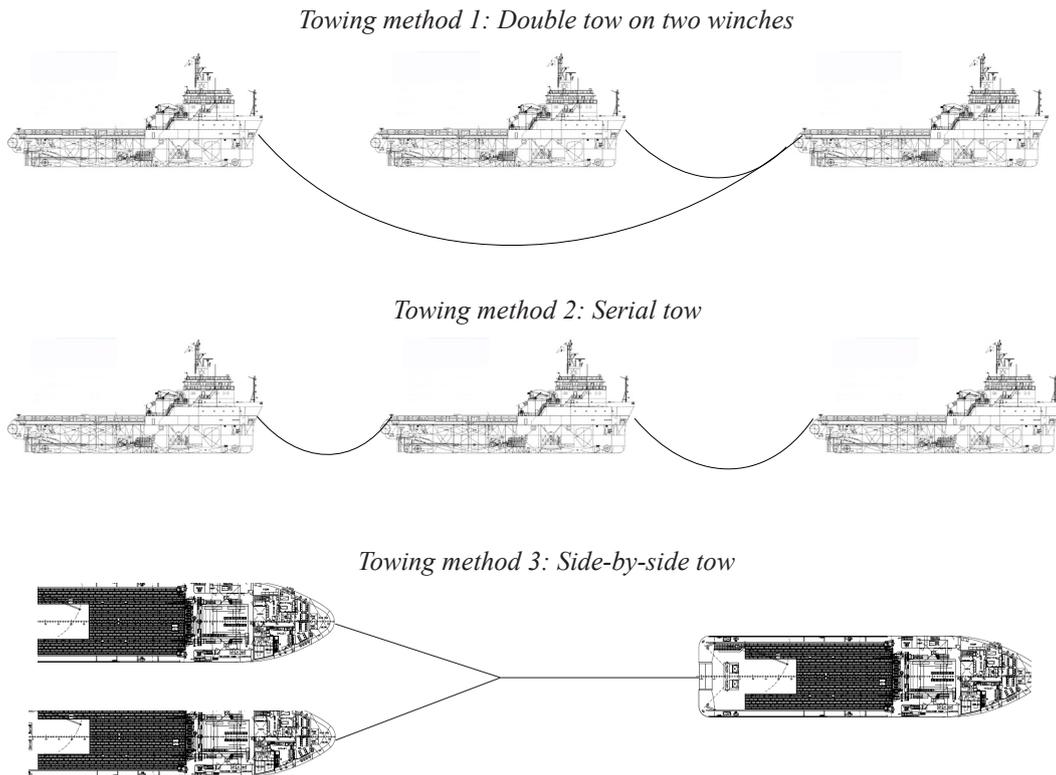
Figure 2: The three towing methods considered for the towage of MÆRSK SEARCHER and MÆRSK SHIPPER  
Source: DMAIB

At the MoC meeting, the participants discussed mainly two potential towing setups: 1) A double-tow where both S-type ships were individually connected to MAERSK CHANCELLOR and 2) A tow where the two ships were connected in series (figure 2).

The first setup, the double-tow, was recommended by an external towing company, but required a specific winch setup, which was not available on MAERSK CHANCELLOR, and therefore not possible. The second towing setup with the ships connected in series required the middle ship to be manned and operational in order to control the winches with the connecting wire to the last ship. A third towing setup with the S-type ships being towed side by side was also discussed, but was discarded due to some identified risks of the superstructures making contact during tow (figure 2).

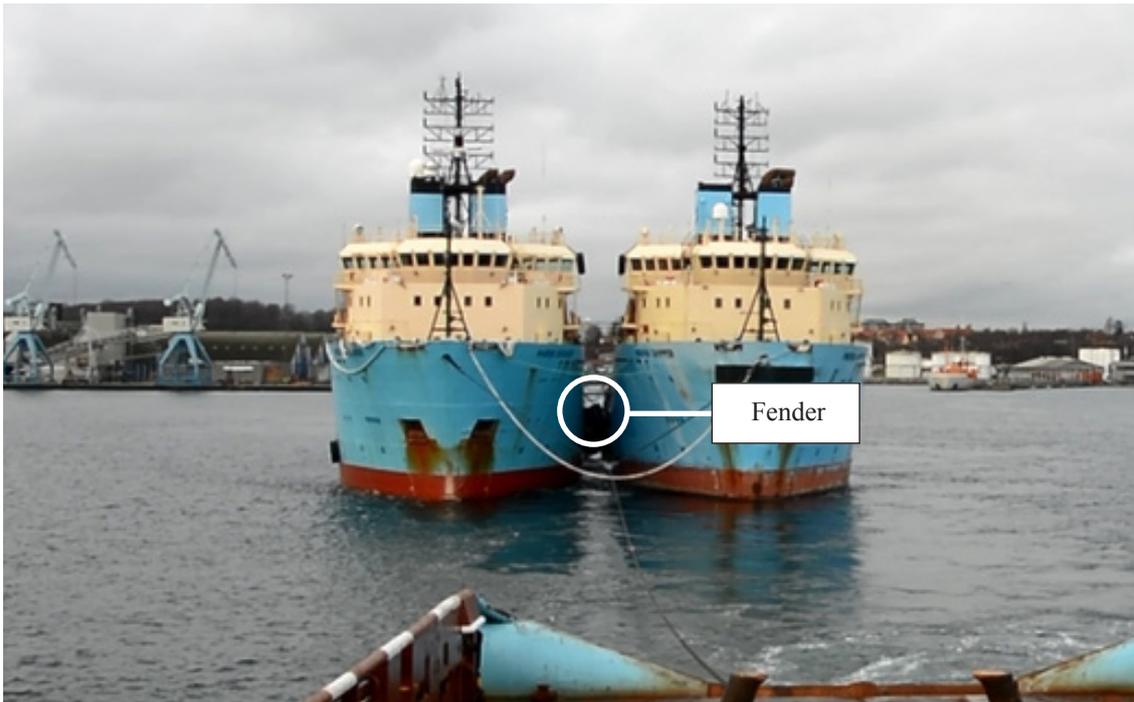
Figure 4: Towage at departure from Fredericia on 12 December 2016  
Source: Private photo

MÆRSK BATTLER departed Fredericia on 12 December 2016 at approx. 1130 (figure 4), and the towage exited the port area and proceeded to the Skaw Roads, where MÆRSK BATTLER was to take stores. The weather was clear and the two ships under tow were lying steady in the water next to each other. MÆRSK BATTLER took stores on 14 December and proceeded south through the North Sea. The crew continued to experience problems with receiving emails and updating the SPOS<sup>2</sup>, and they therefore relied on the master retrieving weather forecasts on his personal mobile phone when the ships were within reception reach of a mobile signal.

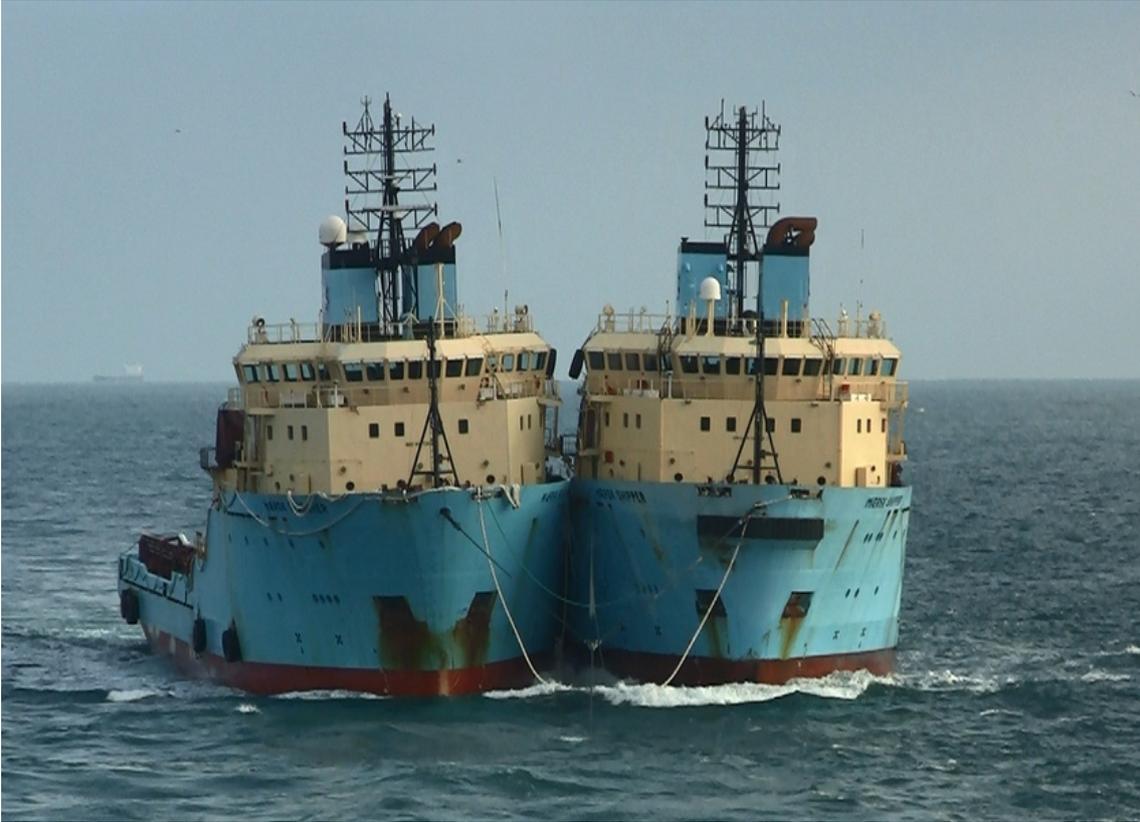
*Figure 5: Towage at noon on 20 December 2016 in the English Channel. Left: MÆRSK SEARCHER.  
Source: Private photo*

On 20 December, the swell increased as the towage was proceeding through the English Channel. The weather conditions were not unusual for that time of year in that particular area and were not considered problematic for the towage operation. In order to adapt to the weather conditions, the main tow wire was paid out to 630 m. The crew noticed that the fenders (figure 4) keeping the towed ships apart had vanished. MÆRSK SEARCHER and MÆRSK SHIPPER had direct contact, but were steady in the water (figure 5). As both vessels were to be recycled, it was not considered a problem that the ships suffered slight damage above the waterline when making contact. However, the master decided that,

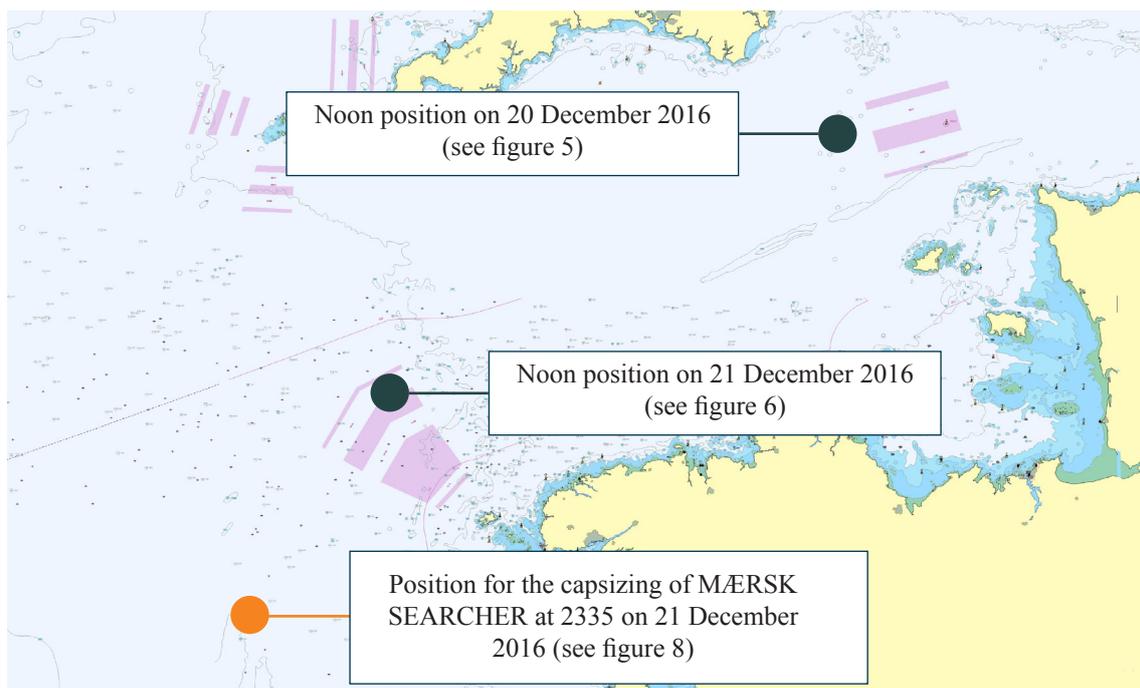
Figure 7: Position for the capsizing of MÆRSK SEARCHER.  
Source: DMAIB

On the night of 21 December, the master was on duty on the bridge along with a watch-keeping AB. The ships were acting as they had done all day, rolling and colliding with each other and having a slight list towards each other. At 2325, the AB suddenly noticed that MÆRSK SEARCHER was lying deeper in the water than before and was listing heavily. He communicated this observation to the master, who immediately realized that MÆRSK SEARCHER was about to capsize. However, the crew on MÆRSK BATTLE had no means to recover this situation. Ten minutes after the AB made this observation, MÆRSK SEARCHER capsized (figure 7).

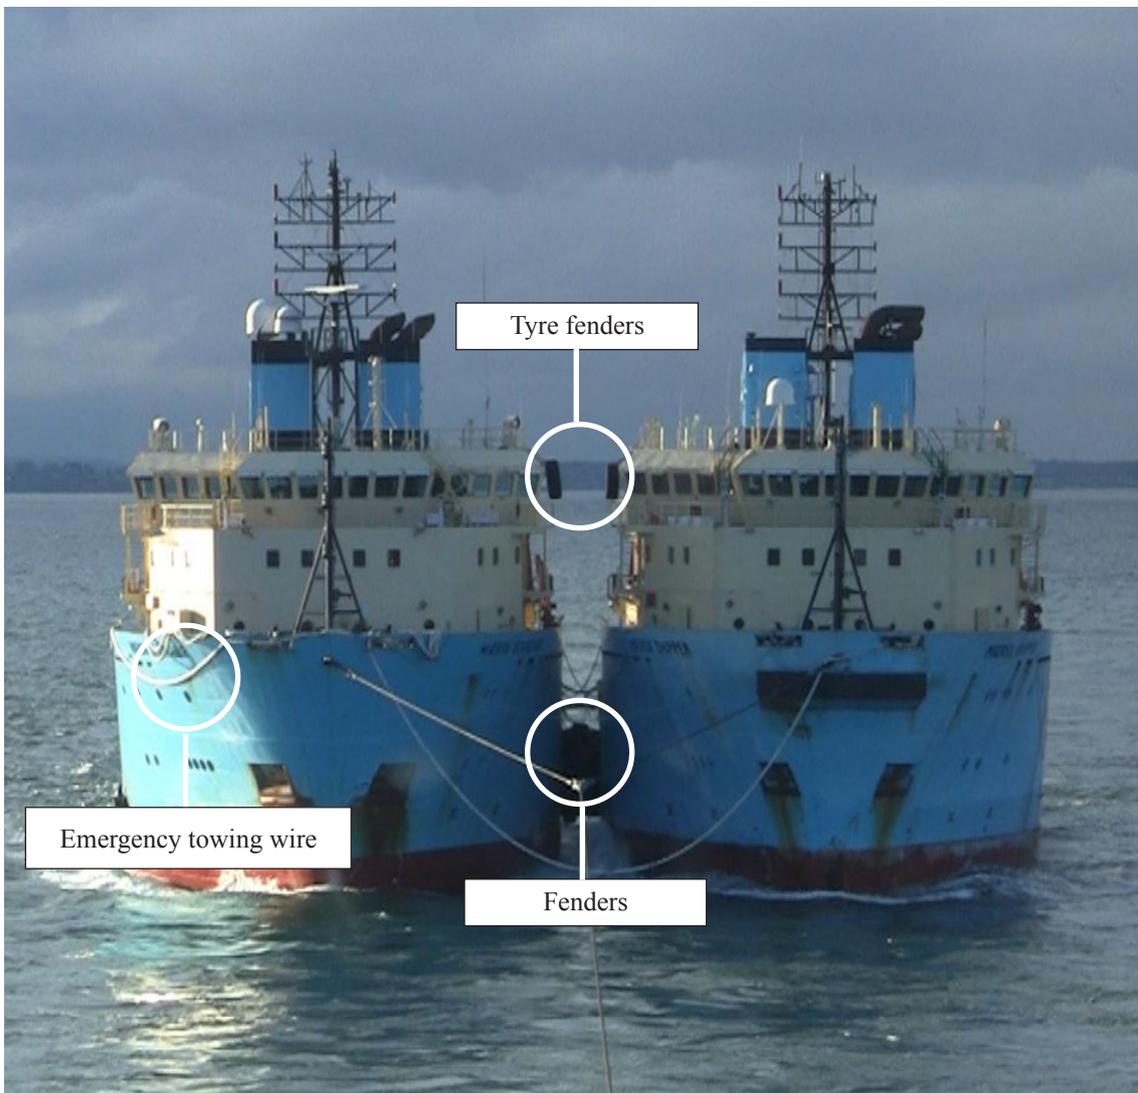
Figure 13: Risk mitigating equipment in the towing arrangement for MAERSK CHANCELLOR, MÆRSK SHIPPER and MÆRSK SEARCHER.

The towing arrangement was supplemented by equipment with the purpose of mitigating the risk of collision between MÆRSK SHIPPER and MÆRSK SEARCHER and the risk of loss of tow due to failure on the main towing wire (figures 13). The following sections will describe the setup and effect of emergency towing gear and fenders.

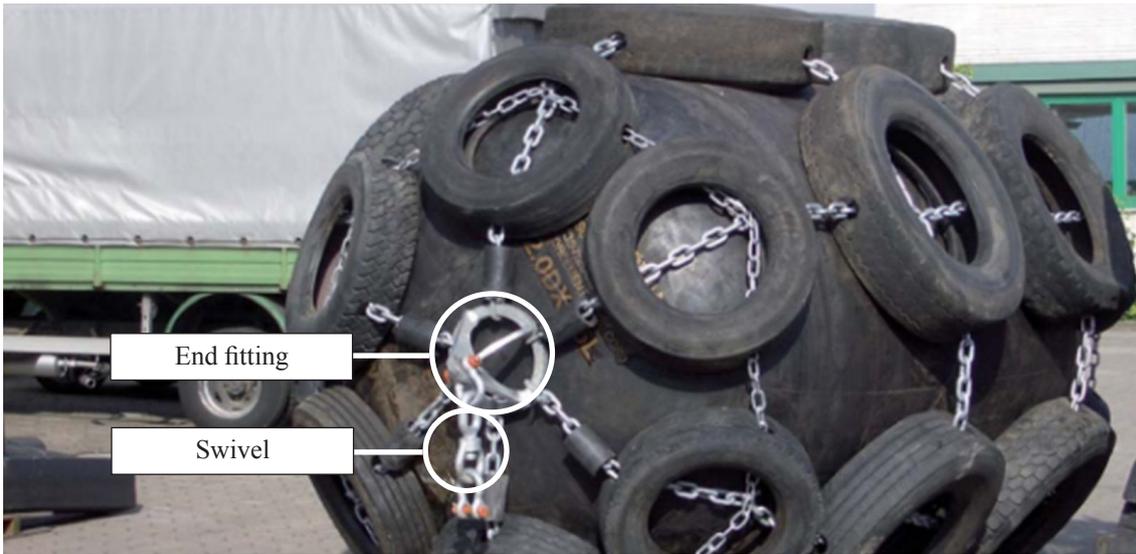
Figure 16: End fitting on a standard pneumatic fender (not related to the accident).  
Source: Willbrandt Gummitechnik

The end fittings of this type of fender – both pneumatic and foam-filled ones – usually comprise a towing ring, which serves the purpose of connecting the sling or chain tyre protection net and steel eye or bracket for lifting and installation. Usually, a swivel is connected to the end fitting to allow the fender to rotate around its longitudinal axis when installed (figure 16, next page).

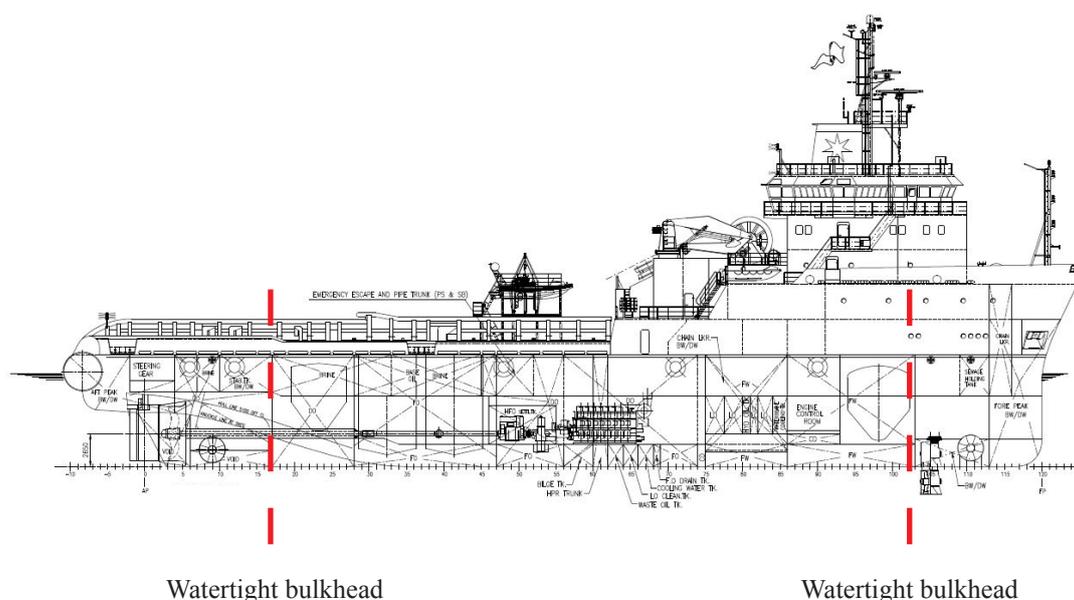
Figure 21: Excerpt of general arrangement, MÆRSK SHIPPER and MÆRSK SEARCHER. Transverse watertight bulkheads indicated. Source: Maersk Supply Service

Figure 21 below shows the layout of the ships, which was typical for anchor handling tugs: The accommodation was placed forward, a winch garage aft of that, and the working deck aft. Below the upper deck, the engine rooms were located amidships, the
