MARINE SAFETY INVESTIGATION REPORT

Safety investigation into the serious injury on board the
Maltese registered general cargo

HOPA

MARINE SAFETY INVESTIGATION REPORT NO. 07/2014

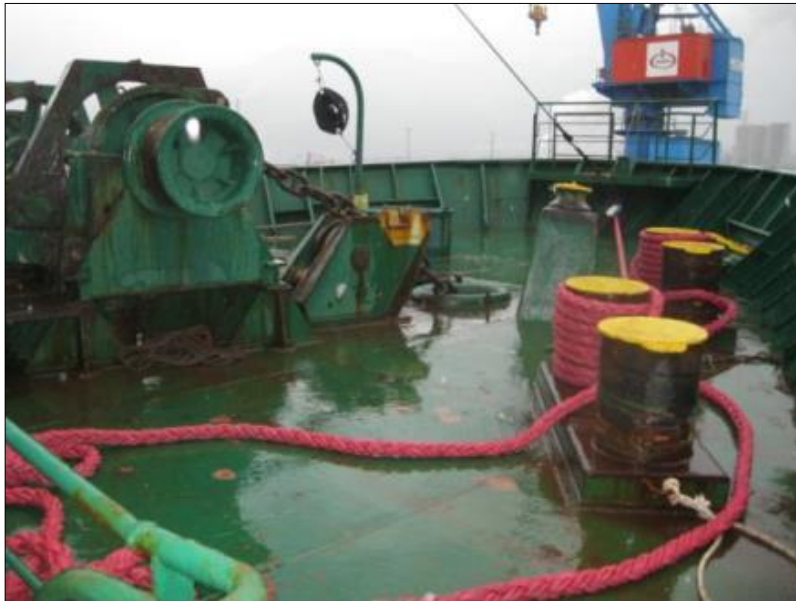
Each side of the forecastle deck (Figures 2 and 3) is fitted with two sets of double bitts, one set of rollers, and an anchor windlass fitted with capstans for the handling of mooring ropes. The forecastle bulwark has one set of triple fairlead running fore and aft, one chock, one fairlead chock on each side, together with one Panama chock fitted in the centre. The full set of mooring equipment on the forecastle deck is tabulated below (Table 1). The forecastle deck did not have any 'snap back zones markings'.

Figure 2: General starboard side view of the forecastle deck

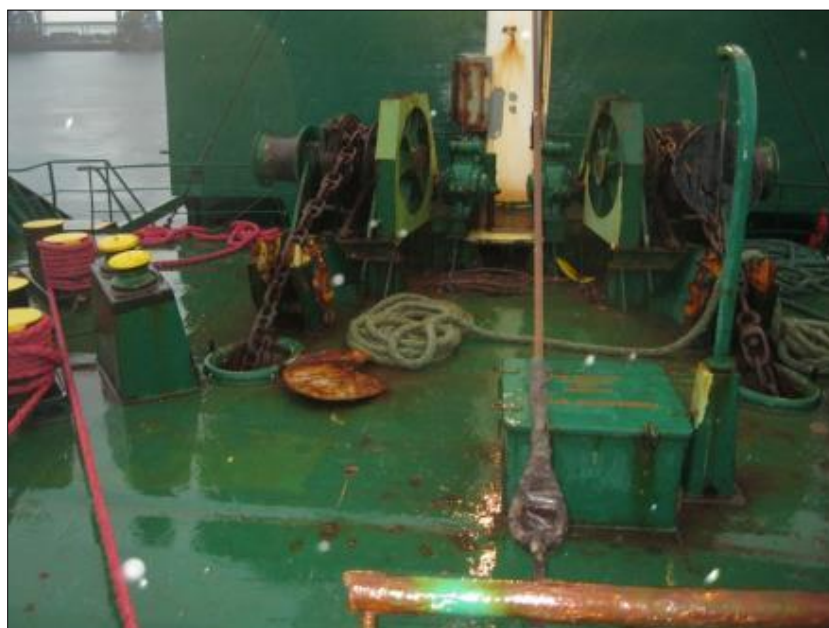
Figure 3: Fore to aft view of the forecastle deck
