Simplified report of safety investigation

**COLLISION BETWEEN THE FRENCH TRAWLER *BILLABONG*
AND THE FINNISH TANKER VESSEL *PURHA*
ON 9 NOVEMBER 2012 OFF BELLE-ÎLE**

Bureau d'enquêtes sur les événements de mer

Report published : May 2013

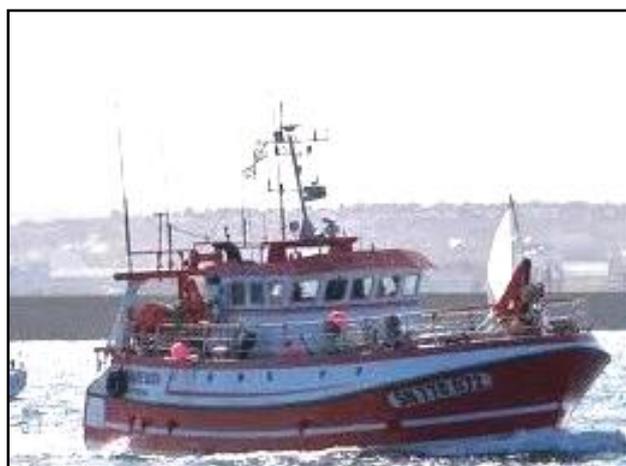
BILLABONG :

Length overall: 16.50 m;
Breadth: 5.81 m ;
Gross tonnage: 48,25 Tx ;
Power: 294 kW ;
Registration: LO 691333 ;
Year of building: 1986.

Steel-hull trawler, fitted for second category coast fishery with a four men crew (the skipper asked for a reduction to a three member crew for 48 hour fishing periods in 2008. The request was signed by the Safety Centre but has not been submitted to the DDTM (Local Maritime administration Director)). On 7 November 2012, DDTM asked the skipper to sort out his minimum safe manning certificate, which had been done on 26 November 2012.

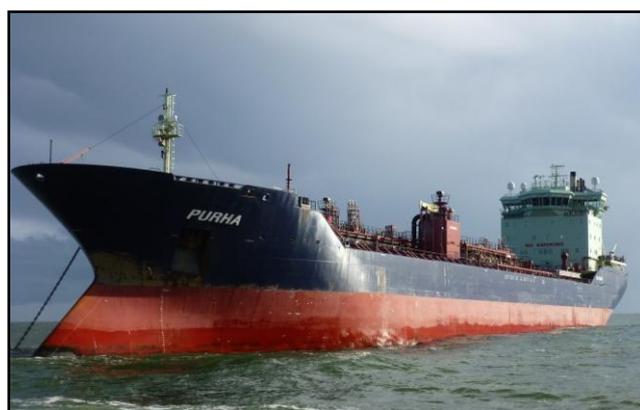
PURHA :

Tanker/chemical tanker vessel built in China in 2003. Owned and operated by Neste Shipping Oy, she is classed by Det Norske Veritas.

Flag: Finnish ;
IMO registration number: 9255268 ;
Length overall: 169.50 m ;
Breadth: 23.75 m;
Gross tonnage: 15980;
Main engine power: 9450 kW ;
Bow thruster: 1200 kW.
